Fetters Run (College to Fair) Field Assessment

March 25, 2020

Hull & Associates, Inc.

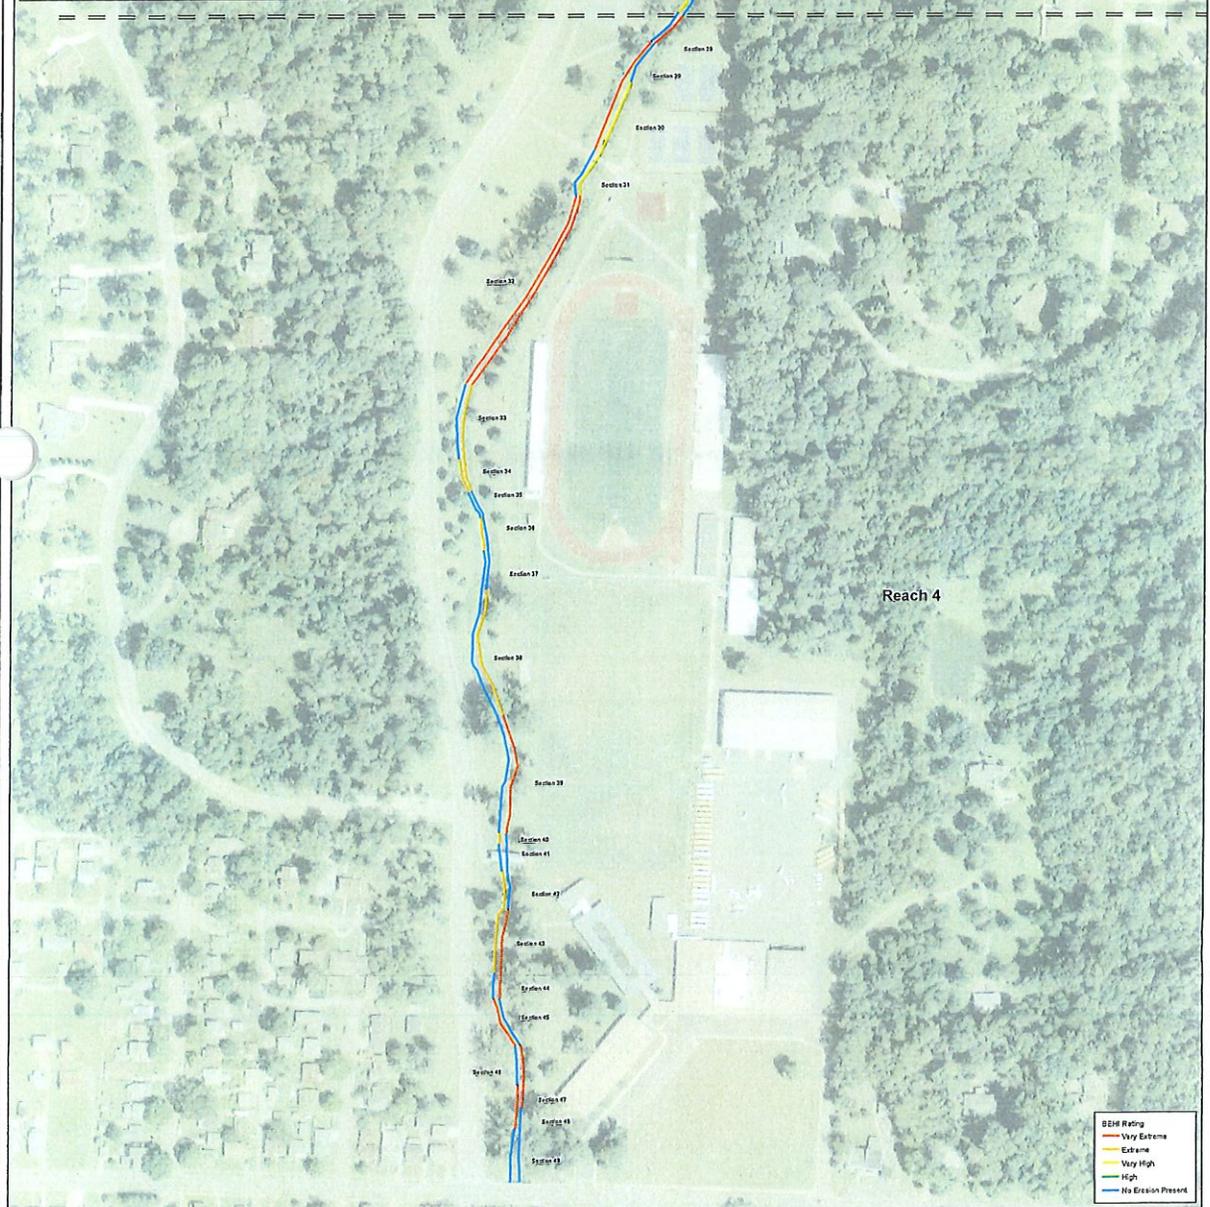
Figure
2b

Section 43	Left	53	58.5	Very Extreme				
	Section 44	Right	55	58.5	Very Extreme				
	Section 44	Left	112	62.5	Very Extreme				
	Section 45	Right	83	57	Very Extreme				
	Section 45	Left	-	-	-				
	Section 46	Right	40	57	Very Extreme				
	Section 46	Left	44	58.5	Very Extreme				
	Section 47	Right	40	58.5	Very Extreme				
	Section 47	Left	-	-	-

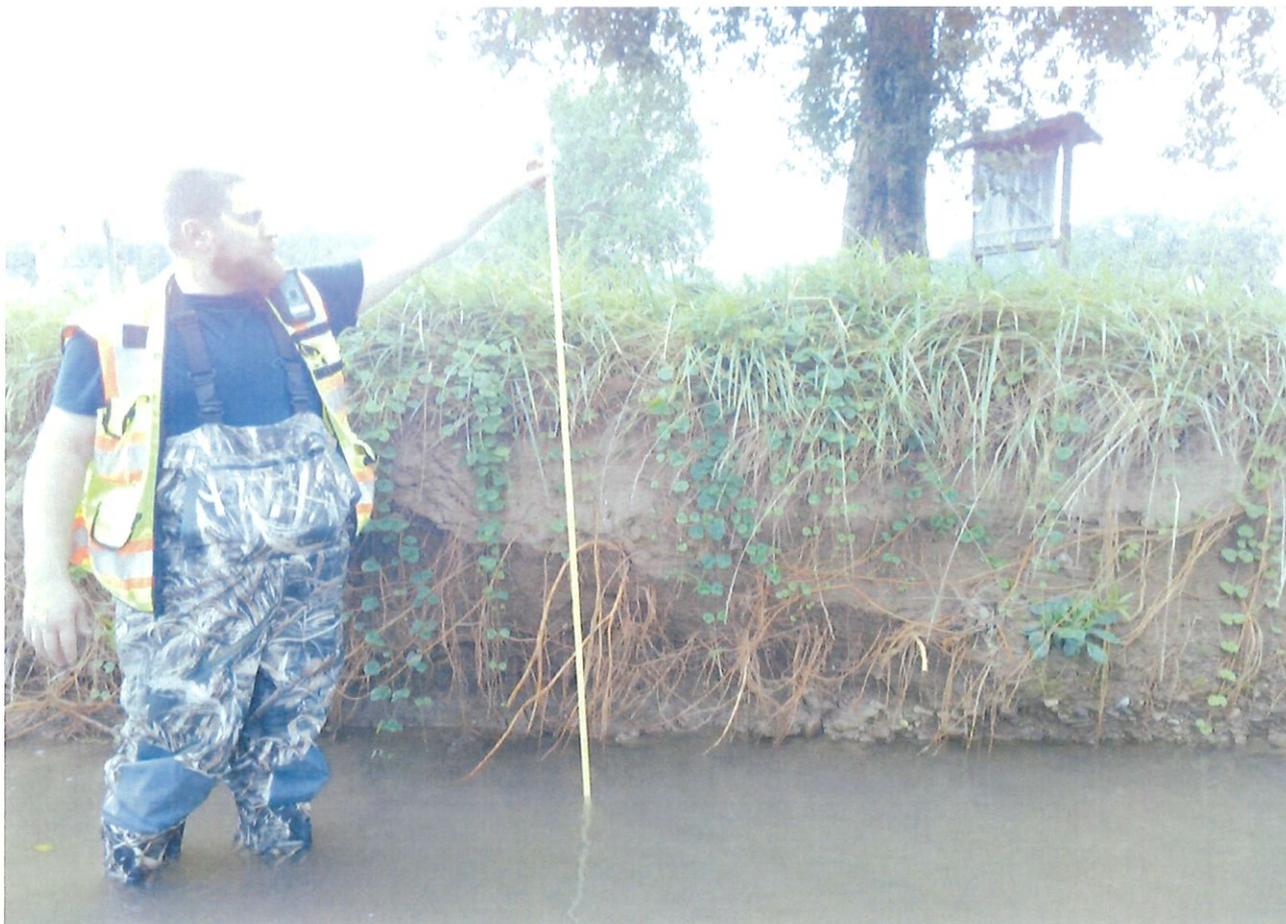
Station: **Section 2, Right Bank**

Bank Erosion Hazard Index (BEHI)						
Stream: Fetters Run			Location: Lancaster, Fairfield County, Ohio			
Station: Section 2, Right Bank			Observers: H. Hayter, B. Petru, P. Renner			
Date: 8/1/2019		Stream Type:		Valley Type:		
Study Bank Height to Bankfull Height (C)						BEHI Score (Fig. 3-7)
Study Bank Height (ft) =	4.96 (A)	Bankfull Height (ft) =	2.63 (B)	$(A) / (B) =$	1.89 (C)	7.5
Root Depth to Study Bank Height (E)						
Root Depth (ft) =	1.33 (D)	Study Bank Height (ft) =	4.96 (A)	$(D) / (A) =$	0.27 (E)	6.5
Weighted Root Density (G)						
Root Density as % =	20.00 (F)	$(F) \times (E) =$			5.3629 (G)	9.0
Bank Angle (H)						
Bank Angle as Degrees =	120 (H)				10.0	
Surface Protection (I)						
Surface Protection as % =	0% (I)				10.0	
Bank Material Adjustment:						
Bedrock (Overall Very Low BEHI) Boulders (Overall Low BEHI) Cobble (Subtract 10 points if uniform medium to large cobble) Gravel or Composite Matrix (Add 5-10 points depending on percentage of bank material that is composed of sand) Sand (Add 10 points) Silt/Clay (no adjustment unless primarily clay, then subtract 20 points)

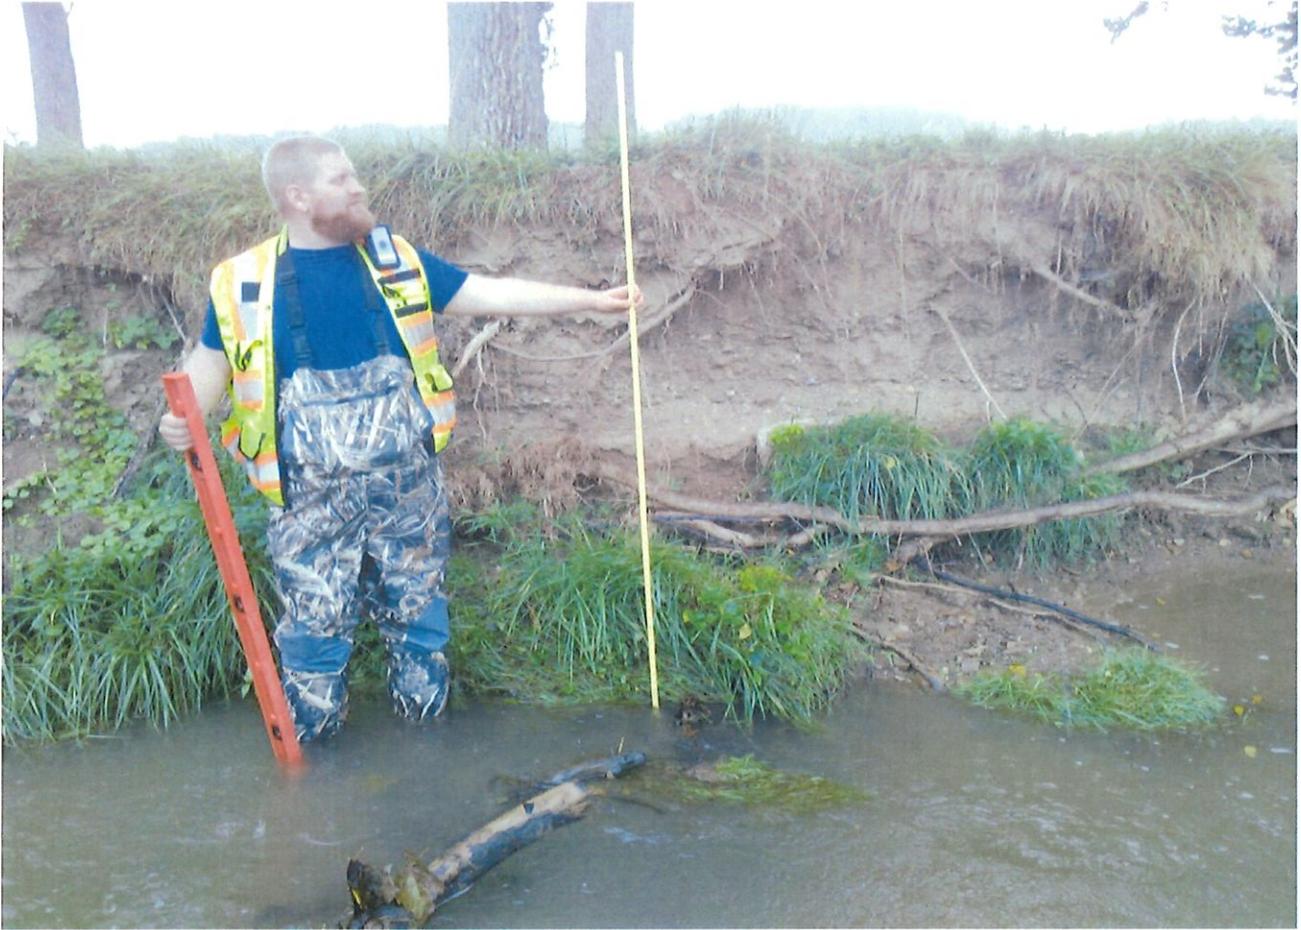
Station: **Section 3, Left Bank**

Bank Erosion Hazard Index (BEHI)						
Stream: Fetters Run			Location: Lancaster, Fairfield County, Ohio			
Station: Section 3, Left Bank			Observers: H. Hayter, B. Petru, P. Renner			
Date: 8/1/2019		Stream Type:		Valley Type:		
Study Bank Height to Bankfull Height (C)						BEHI Score (Fig. 3-7)
Study Bank Height (ft) =	6.00 (A)	Bankfull Height (ft) =	2.58 (B)	$(A) / (B) =$	2.33 (C)	8.5
Root Depth to Study Bank Height (E)						
Root Depth (ft) =	1.00 (D)	Study Bank Height (ft) =	6.00 (A)	$(D) / (A) =$	0.17 (E)	7.5
Weighted Root Density (G)						
Root Density as % =	10.00 (F)	$(F) \times (E) =$			1.66667 (G)	10.0
Bank Angle (H)						
Bank Angle as Degrees =	111 (H)				8.5	
Surface Protection (I)						
Surface Protection as % =	20% (I)				7.0	
Bank Material Adjustment:						
Bedrock (Overall Very Low BEHI) Boulders (Overall Low BEHI) Cobble (Subtract 10 points if uniform medium to large cobble) Gravel or Composite Matrix (Add 5–10 points depending on percentage of bank material that is composed of sand) Sand (Add 10 points) Silt/Clay (no adjustment unless primarily clay, then subtract 20 points)				Bank Material Adjustment		10

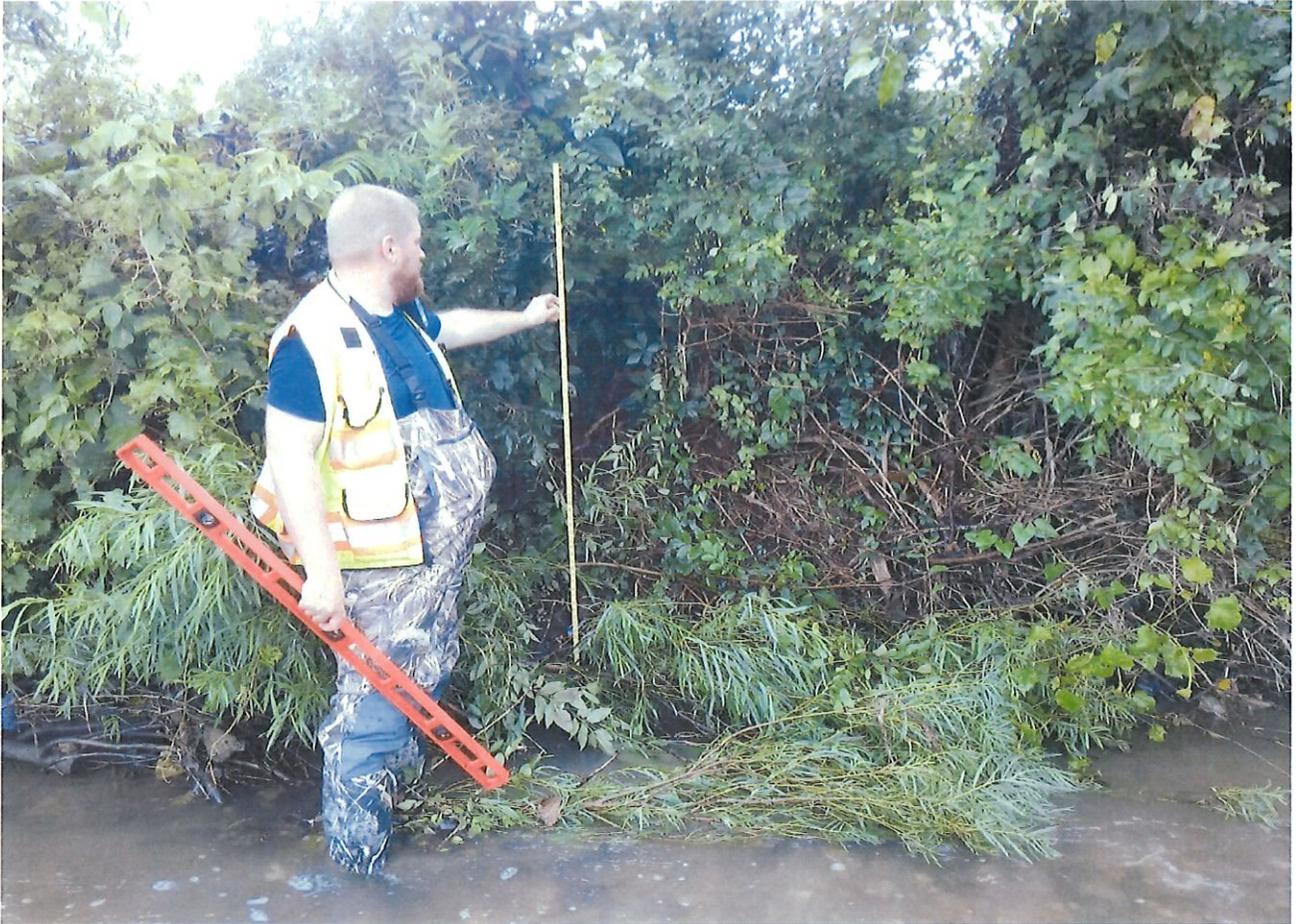
Station: **Section 5, Left Bank**

Bank Erosion Hazard Index (BEHI)						
Stream: Fetters Run			Location: Lancaster, Fairfield County, Ohio			
Station: Section 5, Left Bank			Observers: H. Hayter, B. Petru, P. Renner			
Date: 8/1/2019		Stream Type:		Valley Type:		
Study Bank Height to Bankfull Height (C)						BEHI Score (Fig. 3-7)
Study Bank Height (ft) =	4.66 (A)	Bankfull Height (ft) =	1.90 (B)	$(A) / (B) =$	2.45 (C)	8.5
Root Depth to Study Bank Height (E)						
Root Depth (ft) =	1.10 (D)	Study Bank Height (ft) =	4.66 (A)	$(D) / (A) =$	0.24 (E)	7.0
Weighted Root Density (G)						
Root Density as % =	30.00 (F)	$(F) \times (E) =$			7.08155 (G)	9.0
Bank Angle (H)						
Bank Angle as Degrees =	45 (H)				3.0	
Surface Protection (I)						
Surface Protection as % =	80% (I)				2.0	
Bank Material Adjustment:						
<ul style="list-style-type: none"> Bedrock (Overall <i>Very Low</i> BEHI) Boulders (Overall <i>Low</i> BEHI) Cobble (Subtract 10 points if uniform medium to large cobble) Gravel or Composite Matrix (Add 5–10 points depending on percentage of bank material that is composed of sand) Sand (Add 10 points) Silt/Clay (no adjustment unless primarily clay, then subtract 20 points) 				Bank Material Adjustment	10

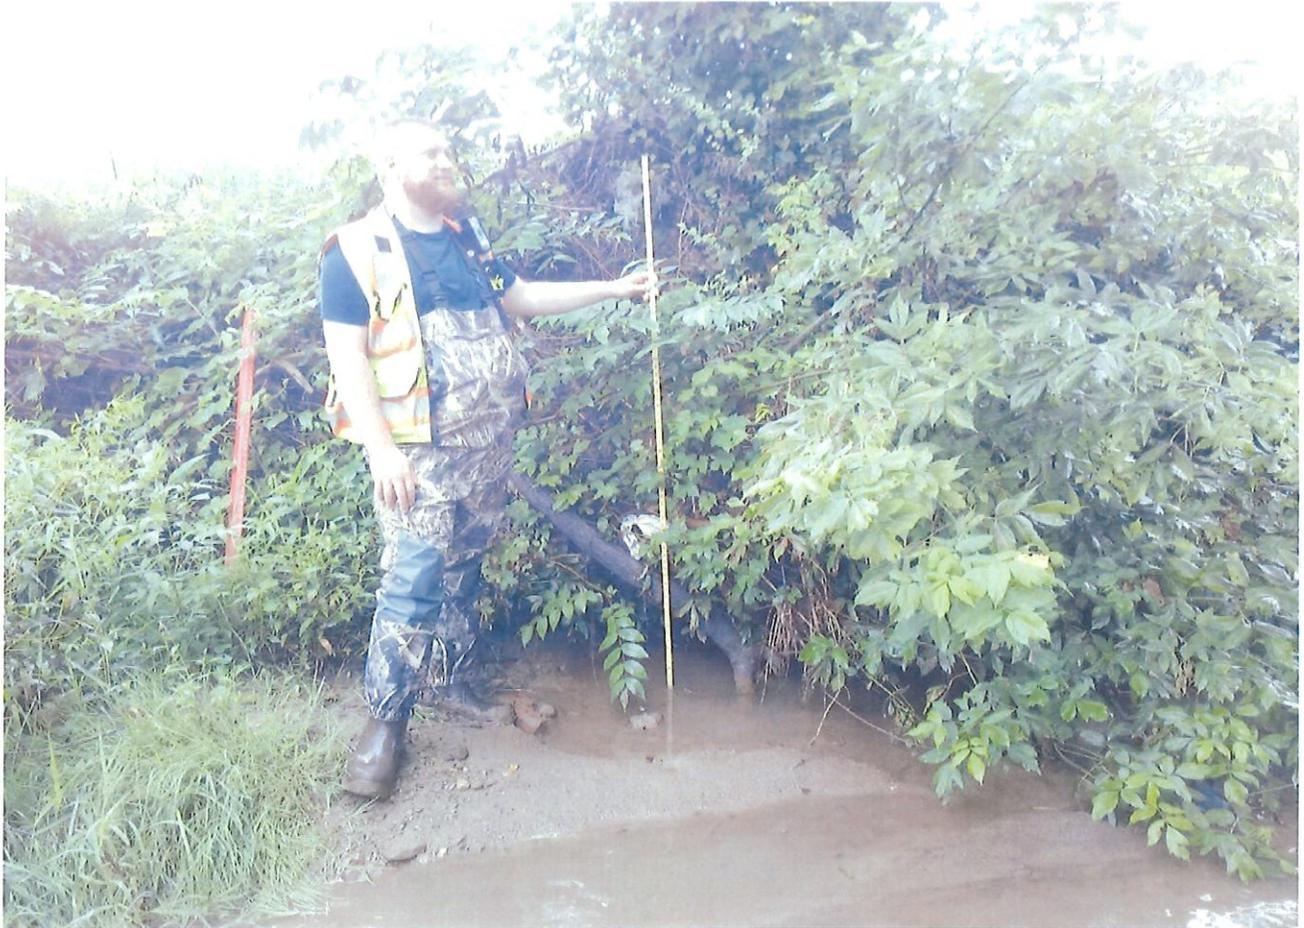
Bank Erosion Hazard Index (BEHI)						
Stream: Fetters Run			Location: Lancaster, Fairfield County, Ohio			
Station: Section 6, Left Bank			Observers: H. Hayter, B. Petru, P. Renner			
Date: 8/1/2019		Stream Type:		Valley Type:		
Study Bank Height to Bankfull Height (C)						BEHI Score (Fig. 3-7)
Study Bank Height (ft) =	4.66 (A)	Bankfull Height (ft) =	1.90 (B)	$(A) / (B) =$	2.45 (C)	8.5
Root Depth to Study Bank Height (E)						
Root Depth (ft) =	1.10 (D)	Study Bank Height (ft) =	4.66 (A)	$(D) / (A) =$	0.24 (E)	7.0
Weighted Root Density (G)						
Root Density as % =	30.00 (F)	$(F) \times (E) =$			7.08155 (G)	9.0
Bank Angle (H)						
Bank Angle as Degrees =	45 (H)				3.0	
Surface Protection (I)						
Surface Protection as % =	80% (I)				2.0	
Bank Material Adjustment:						
Bedrock (Overall Very Low BEHI) Boulders (Overall Low BEHI) Cobble (Subtract 10 points if uniform medium to large cobble) Gravel or Composite Matrix (Add 5–10 points depending on percentage of bank material that is composed of sand) Sand (Add 10 points) Silt/Clay (no adjustment unless primarily clay, then subtract 20 points)					Bank Material Adjustment	10

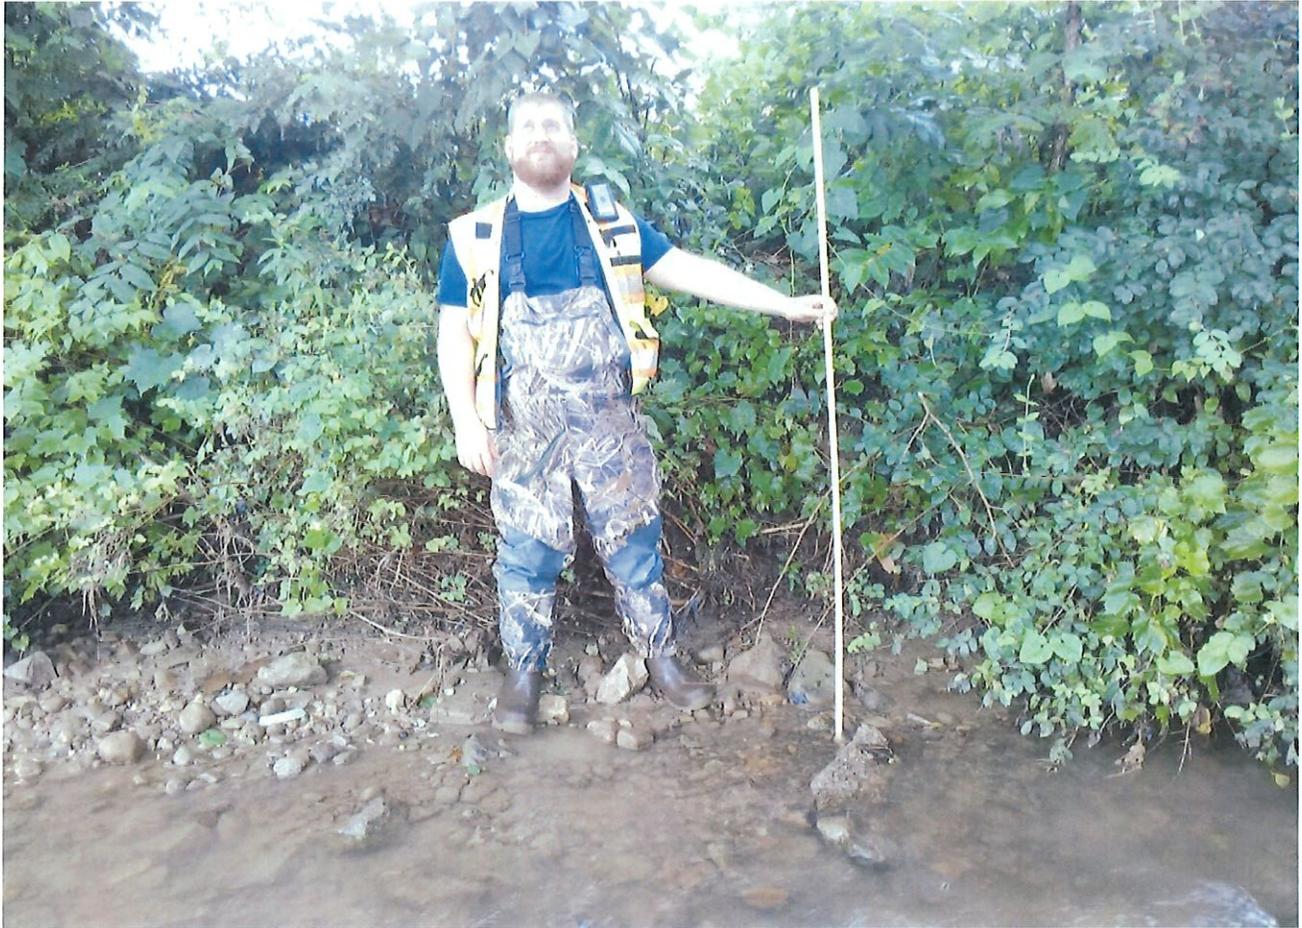
Bank Erosion Hazard Index (BEHI)						
Stream: Fetters Run			Location: Lancaster, Fairfield County, Ohio			
Station: Section 6, Right Bank			Observers: H. Hayter, B. Petru, P. Renner			
Date: 8/1/2019		Stream Type:		Valley Type:		
Study Bank Height to Bankfull Height (C)						BEHI Score (Fig. 3-7)
Study Bank Height (ft) =	5.50 (A)	Bankfull Height (ft) =	3.40 (B)	$(A) / (B) =$	1.62 (C)	6.0
Root Depth to Study Bank Height (E)						
Root Depth (ft) =	1.10 (D)	Study Bank Height (ft) =	5.50 (A)	$(D) / (A) =$	0.20 (E)	7.0
Weighted Root Density (G)						
Root Density as % =	25.00 (F)			$(F) \times (E) =$	5 (G)	9.5
Bank Angle (H)						
		Bank Angle as Degrees =	45 (H)			3.0
Surface Protection (I)						
		Surface Protection as % =	75% (I)			2.5
Bank Material Adjustment:						
Bedrock (Overall Very Low BEHI) Boulders (Overall Low BEHI) Cobble (Subtract 10 points if uniform medium to large cobble) Gravel or Composite Matrix (Add 5–10 points depending on percentage of bank material that is composed of sand) Sand (Add 10 points) Silt/Clay (no adjustment unless primarily clay, then subtract 20 points)				Bank Material Adjustment		10

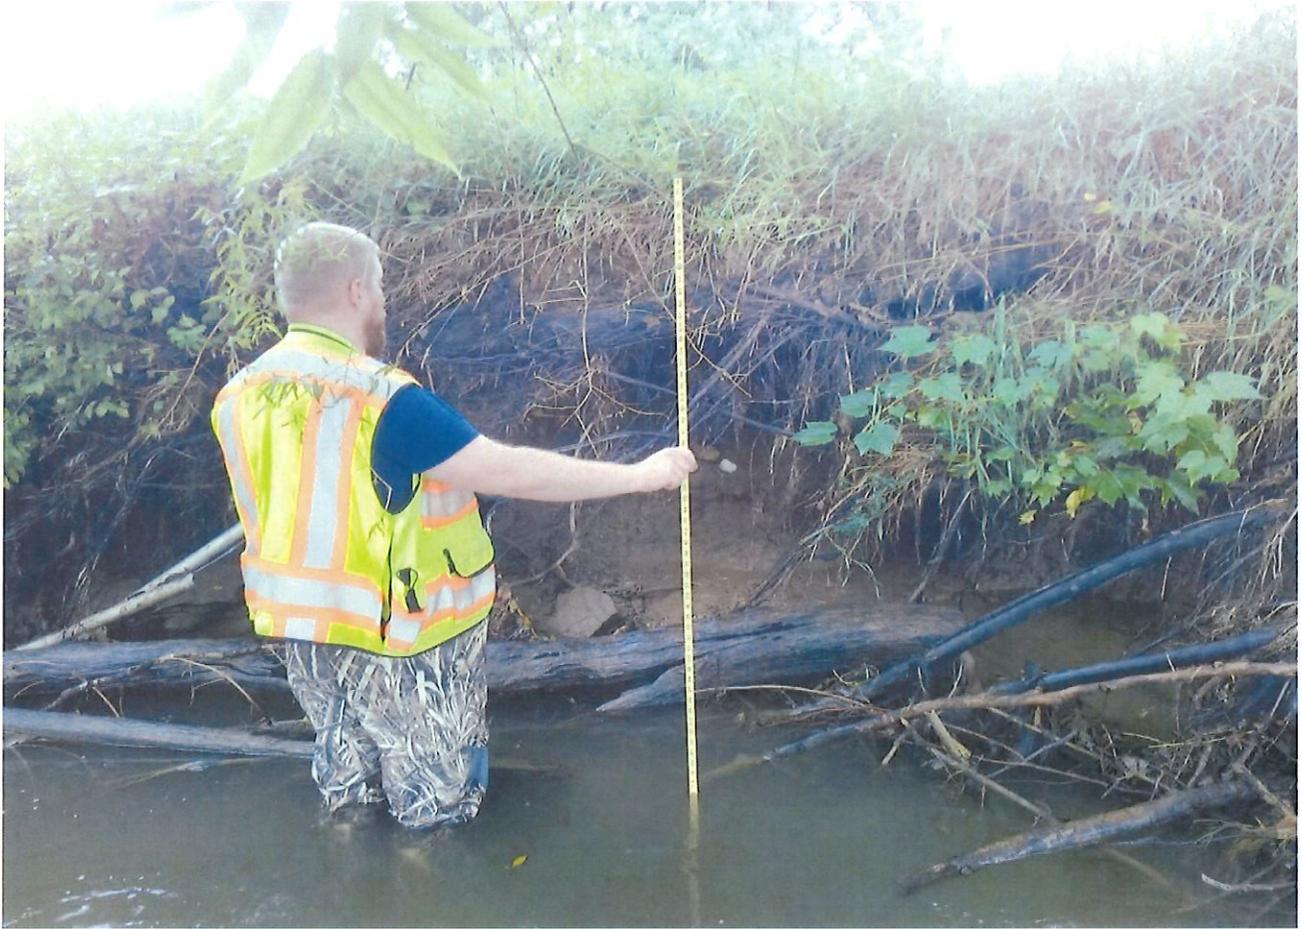
Bank Erosion Hazard Index (BEHI)																																																																					
Stream: Fetters Run			Location: Lancaster, Fairfield County, Ohio																																																																		
Station: Section 7, Right Bank			Observers: H. Hayter, B. Petru, P. Renner																																																																		
Date: 8/1/2019		Stream Type:		Valley Type:																																																																	
Study Bank Height to Bankfull Height (C)						BEHI Score (Fig. 3-7)																																																															
Study Bank Height (ft) =	6.25 (A)	Bankfull Height (ft) =	2.83 (B)	$(A) / (B) =$	2.21 (C)	8.5																																																															
Root Depth to Study Bank Height (E)																																																																					
Root Depth (ft) =	1.30 (D)	Study Bank Height (ft) =	6.25 (A)	$(D) / (A) =$	0.21 (E)	7.0																																																															
Weighted Root Density (G)																																																																					
Root Density as % =	20.00 (F)			$(F) \times (E) =$	4.16 (G)	9.5																																																															
Bank Angle (H)																																																																					
		Bank Angle as Degrees =			148 (H)	10.0																																																															
Surface Protection (I)																																																																					
		Surface Protection as % =			10% (I)	10.0

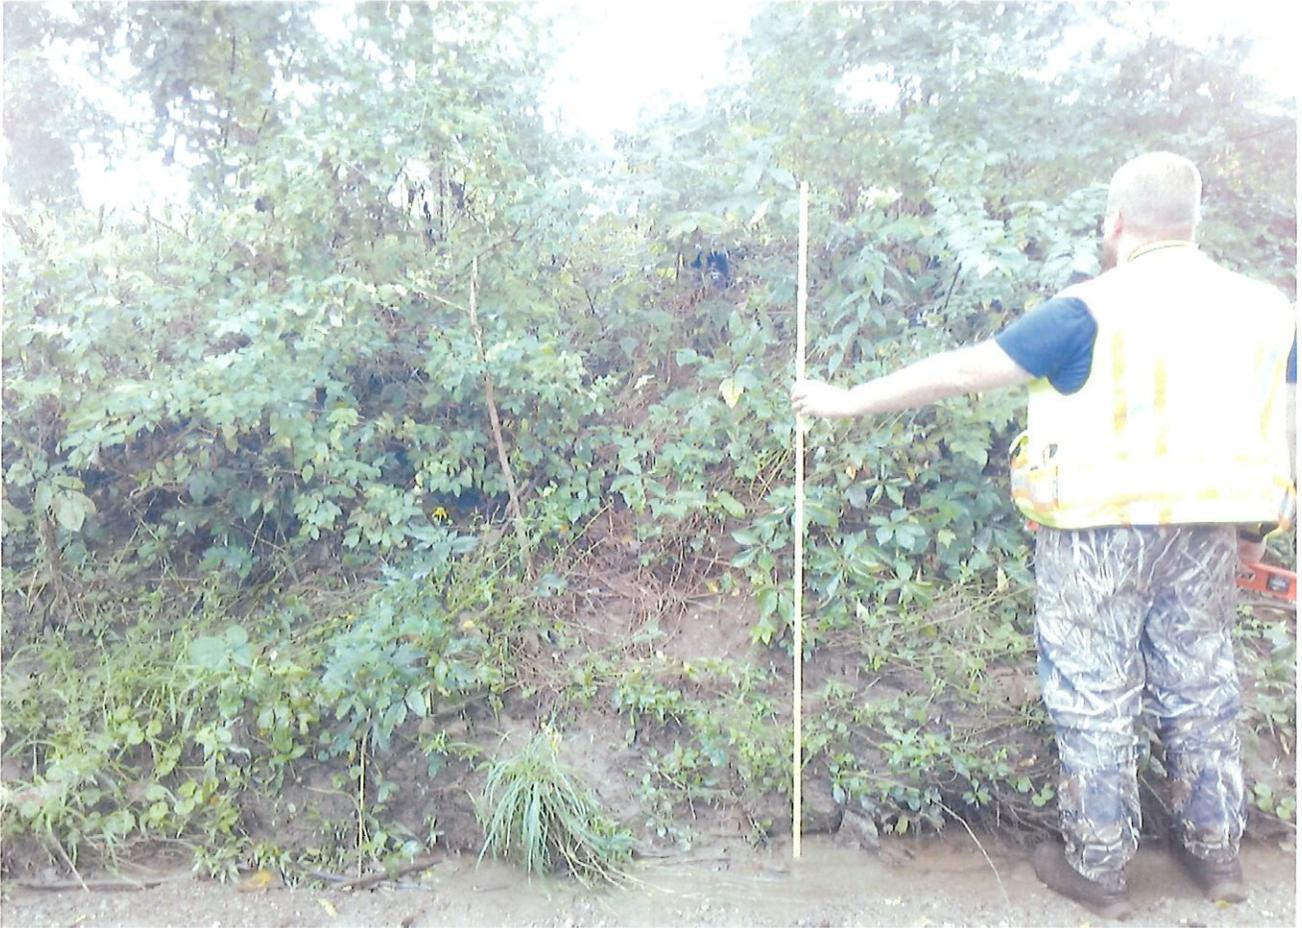
Bank Erosion Hazard Index (BEHI)						
Stream: Fetters Run			Location: Lancaster, Fairfield County, Ohio			
Station: Section 8, Left Bank			Observers: H. Hayter, B. Petru, P. Renner			
Date: 8/1/2019		Stream Type:		Valley Type:		
Study Bank Height to Bankfull Height (C)						BEHI Score (Fig. 3-7)
Study Bank Height (ft) =	6.30 (A)	Bankfull Height (ft) =	4.00 (B)	$(A) / (B) =$	1.58 (C)	6.0
Root Depth to Study Bank Height (E)						
Root Depth (ft) =	0.50 (D)	Study Bank Height (ft) =	6.30 (A)	$(D) / (A) =$	0.08 (E)	8.5
Weighted Root Density (G)						
Root Density as % =	10.00 (F)	$(F) \times (E) =$			0.79365 (G)	10.0
Bank Angle (H)						
Bank Angle as Degrees =	55 (H)				4.0	
Surface Protection (I)						
Surface Protection as % =	60% (I)				3.5	
Bank Material Adjustment:						
Bedrock (Overall Very Low BEHI) Boulders (Overall Low BEHI) Cobble (Subtract 10 points if uniform medium to large cobble) Gravel or Composite Matrix (Add 5–10 points depending on percentage of bank material that is composed of sand) Sand (Add 10 points) Silt/Clay (no adjustment unless primarily clay, then subtract 20 points)					Bank Material Adjustment	10

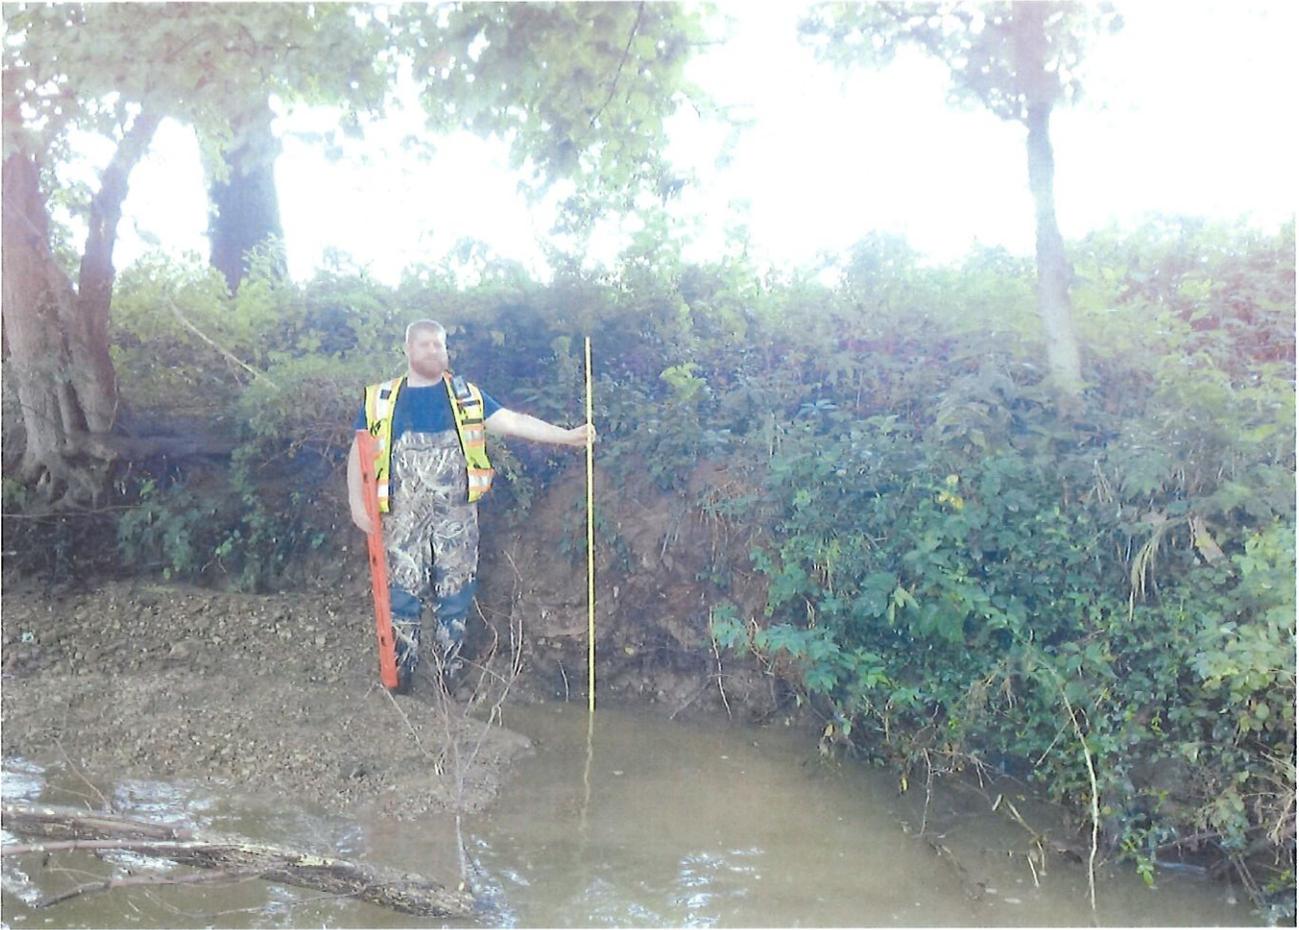
Bank Erosion Hazard Index (BEHI)						
Stream: Fetters Run			Location: Lancaster, Fairfield County, Ohio			
Station: Section 8, Right Bank			Observers: H. Hayter, B. Petru, P. Renner			
Date: 8/1/2019		Stream Type:		Valley Type:		
Study Bank Height to Bankfull Height (C)						BEHI Score (Fig. 3-7)
Study Bank Height (ft) =	8.42 (A)	Bankfull Height (ft) =	3.75 (B)	$(A) / (B) =$	2.25 (C)	8.5
Root Depth to Study Bank Height (E)						
Root Depth (ft) =	1.00 (D)	Study Bank Height (ft) =	8.42 (A)	$(D) / (A) =$	0.12 (E)	8.5
Weighted Root Density (G)						
Root Density as % =	20.00 (F)	$(F) \times (E) =$			2.3753 (G)	9.5
Bank Angle (H)						
Bank Angle as Degrees =	45 (H)				3.5	
Surface Protection (I)						
Surface Protection as % =	50% (I)				4.5	
Bank Material Adjustment:						
Bedrock (Overall Very Low BEHI) Boulders (Overall Low BEHI) Cobble (Subtract 10 points if uniform medium to large cobble) Gravel or Composite Matrix (Add 5–10 points depending on percentage of bank material that is composed of sand) Sand (Add 10 points) Silt/Clay (no adjustment unless primarily clay, then subtract 20 points)			Bank Material Adjustment		10

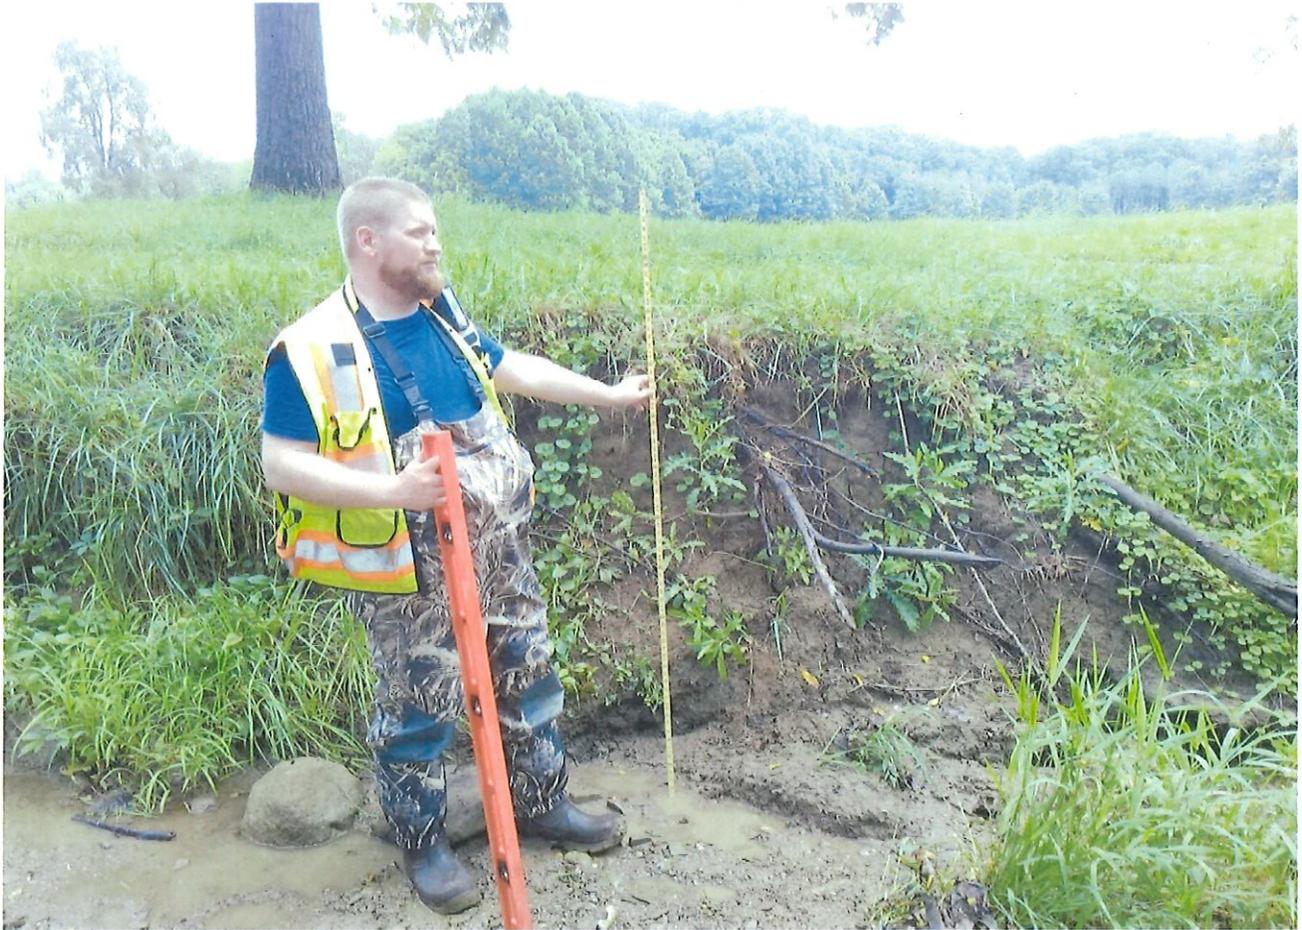
Bank Erosion Hazard Index (BEHI)						
Stream: Fetters Run			Location: Lancaster, Fairfield County, Ohio			
Station: Section 9, Left Bank			Observers: H. Hayter, B. Petru, P. Renner			
Date: 8/1/2019		Stream Type:		Valley Type:		
Study Bank Height to Bankfull Height (C)						BEHI Score (Fig. 3-7)
Study Bank Height (ft) =	6.00 (A)	Bankfull Height (ft) =	1.50 (B)	(A) / (B) =	4.00 (C)	10.0
Root Depth to Study Bank Height (E)						
Root Depth (ft) =	1.40 (D)	Study Bank Height (ft) =	6.00 (A)	(D) / (A) =	0.23 (E)	7.0
Weighted Root Density (G)						
Root Density as % =	15.00 (F)			(F) × (E) =	3.5 (G)	9.5
Bank Angle (H)						
Bank Angle as Degrees =			70 (H)			5.0
Surface Protection (I)						
Surface Protection as % =			30% (I)			6.0
Bank Material Adjustment:						
Bedrock (Overall Very Low BEHI) Boulders (Overall Low BEHI) Cobble (Subtract 10 points if uniform medium to large cobble) Gravel or Composite Matrix (Add 5–10 points depending on percentage of bank material that is composed of sand) Sand (Add 10 points) Silt/Clay (no adjustment unless primarily clay, then subtract 20 points)				Bank Material Adjustment		10

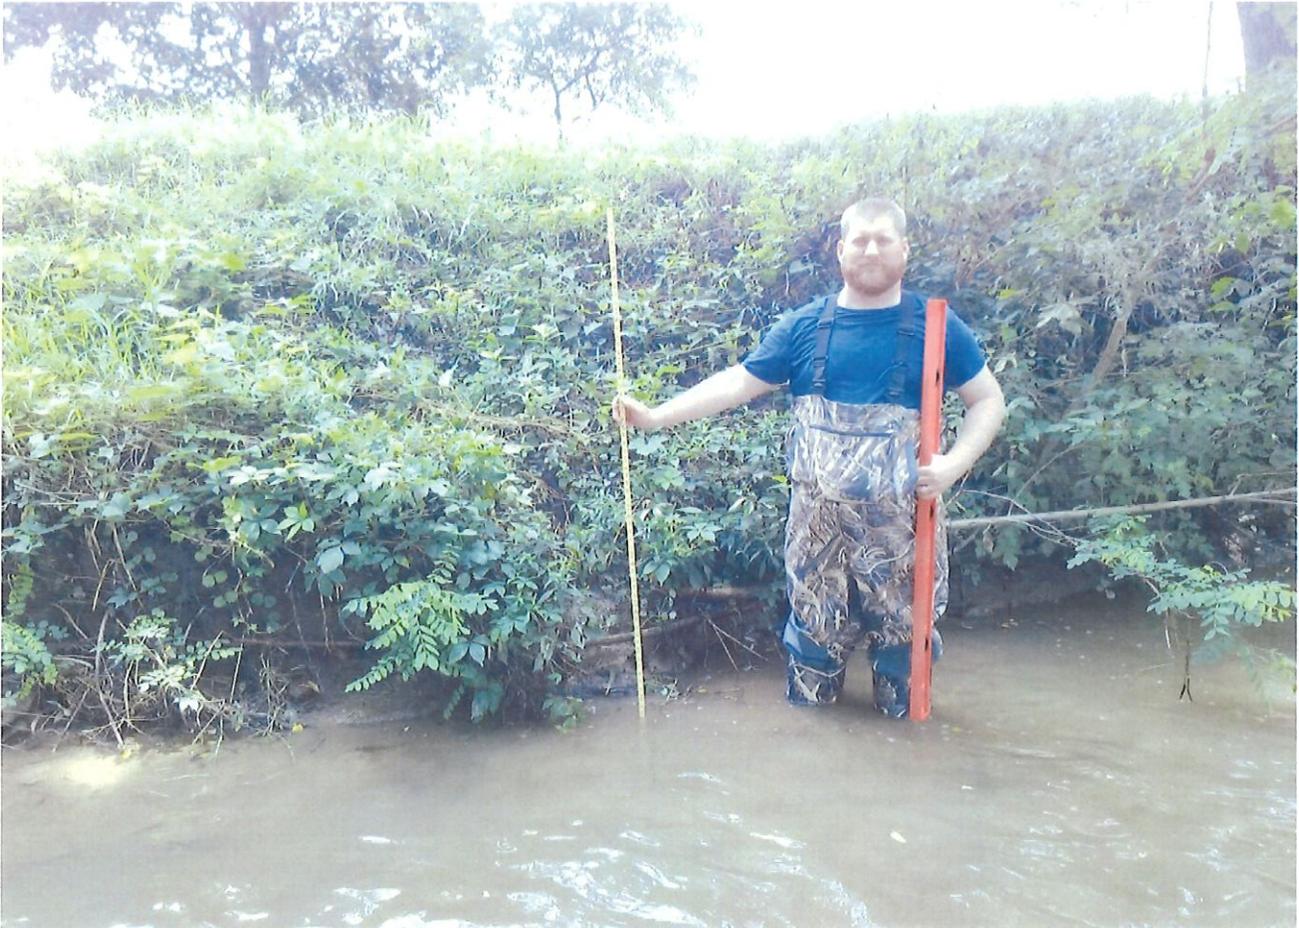
Bank Erosion Hazard Index (BEHI)						
Stream: Fetters Run			Location: Lancaster, Fairfield County, Ohio			
Station: Section 10, Left Bank			Observers: H. Hayter, B. Petru, P. Renner			
Date: 8/1/2019		Stream Type:		Valley Type:		
Study Bank Height to Bankfull Height (C)						BEHI Score (Fig. 3-7)
Study Bank Height (ft) =	8.42 (A)	Bankfull Height (ft) =	2.33 (B)	$(A) / (B) =$	3.61 (C)	10.0
Root Depth to Study Bank Height (E)						
Root Depth (ft) =	0.50 (D)	Study Bank Height (ft) =	8.42 (A)	$(D) / (A) =$	0.06 (E)	9.0
Weighted Root Density (G)						
Root Density as % =	30.00 (F)	$(F) \times (E) =$			1.78147 (G)	9.5
Bank Angle (H)						
Bank Angle as Degrees =	35 (H)				3.0	
Surface Protection (I)						
Surface Protection as % =	70% (I)				3.0	
Bank Material Adjustment:						
Bedrock (Overall Very Low BEHI) Boulders (Overall Low BEHI) Cobble (Subtract 10 points if uniform medium to large cobble) Gravel or Composite Matrix (Add 5-10 points depending on percentage of bank material that is composed of sand) Sand (Add 10 points) Silt/Clay (no adjustment unless primarily clay, then subtract 20 points)				Bank Material Adjustment		10

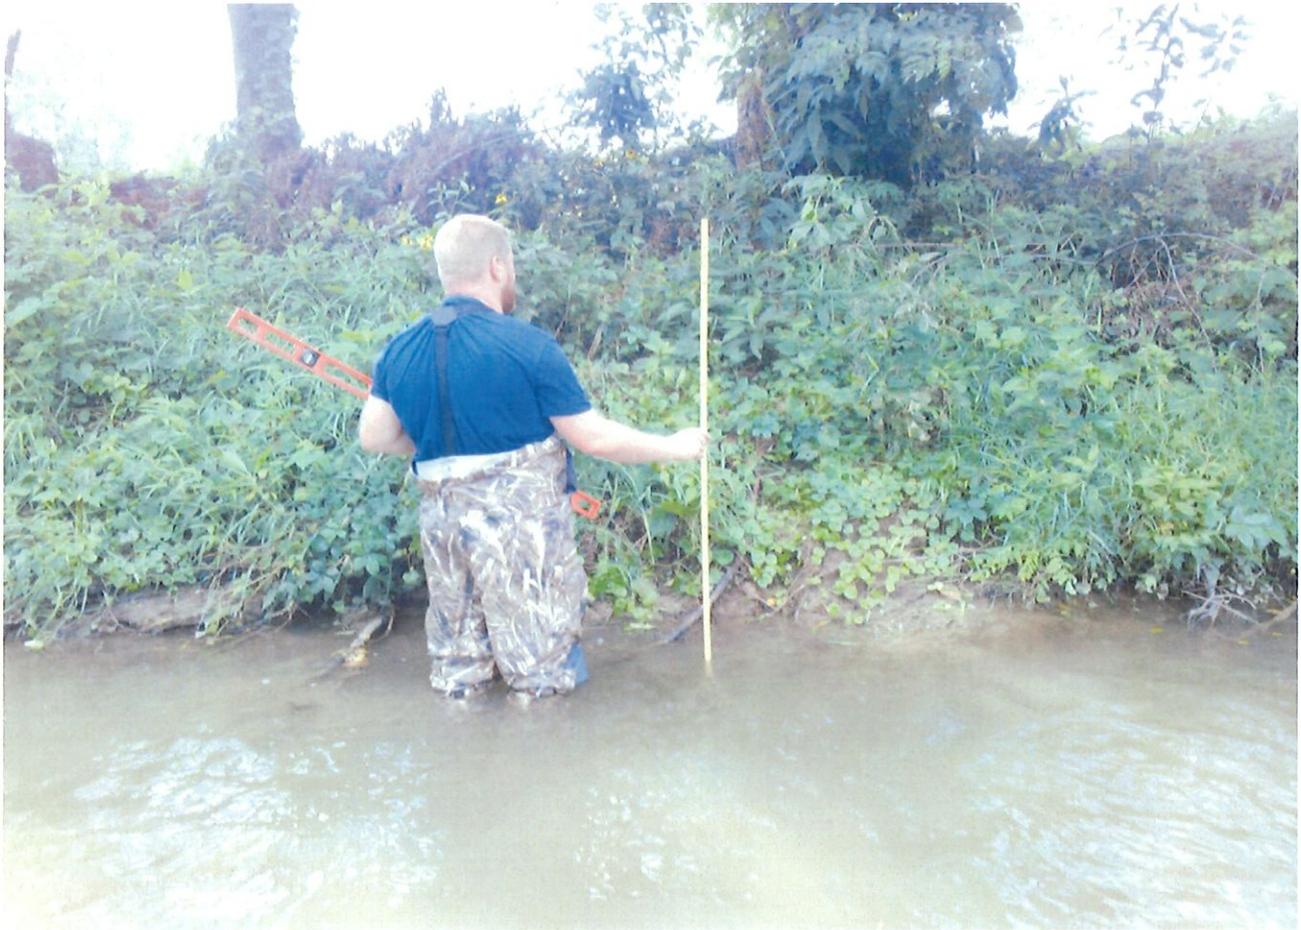
Bank Erosion Hazard Index (BEHI)						
Stream: Fetters Run			Location: Lancaster, Fairfield County, Ohio			
Station: Section 10, Right Bank			Observers: H. Hayter, B. Petru, P. Renner			
Date: 8/1/2019		Stream Type:		Valley Type:		
Study Bank Height to Bankfull Height (C)						BEHI Score (Fig. 3-7)
Study Bank Height (ft) =	9.17 (A)	Bankfull Height (ft) =	3.00 (B)	$(A) / (B) =$	3.06 (C)	9.5
Root Depth to Study Bank Height (E)						
Root Depth (ft) =	0.66 (D)	Study Bank Height (ft) =	9.17 (A)	$(D) / (A) =$	0.07 (E)	8.5
Weighted Root Density (G)						
Root Density as % =	30.00 (F)	$(F) \times (E) =$			2.15921 (G)	9.5
Bank Angle (H)						
Bank Angle as Degrees =	30 (H)				2.5	
Surface Protection (I)						
Surface Protection as % =	85% (I)				1.5	
Bank Material Adjustment:						
Bedrock (Overall Very Low BEHI) Boulders (Overall Low BEHI) Cobble (Subtract 10 points if uniform medium to large cobble) Gravel or Composite Matrix (Add 5–10 points depending on percentage of bank material that is composed of sand) Sand (Add 10 points) Silt/Clay (no adjustment unless primarily clay, then subtract 20 points)			Bank Material Adjustment		10

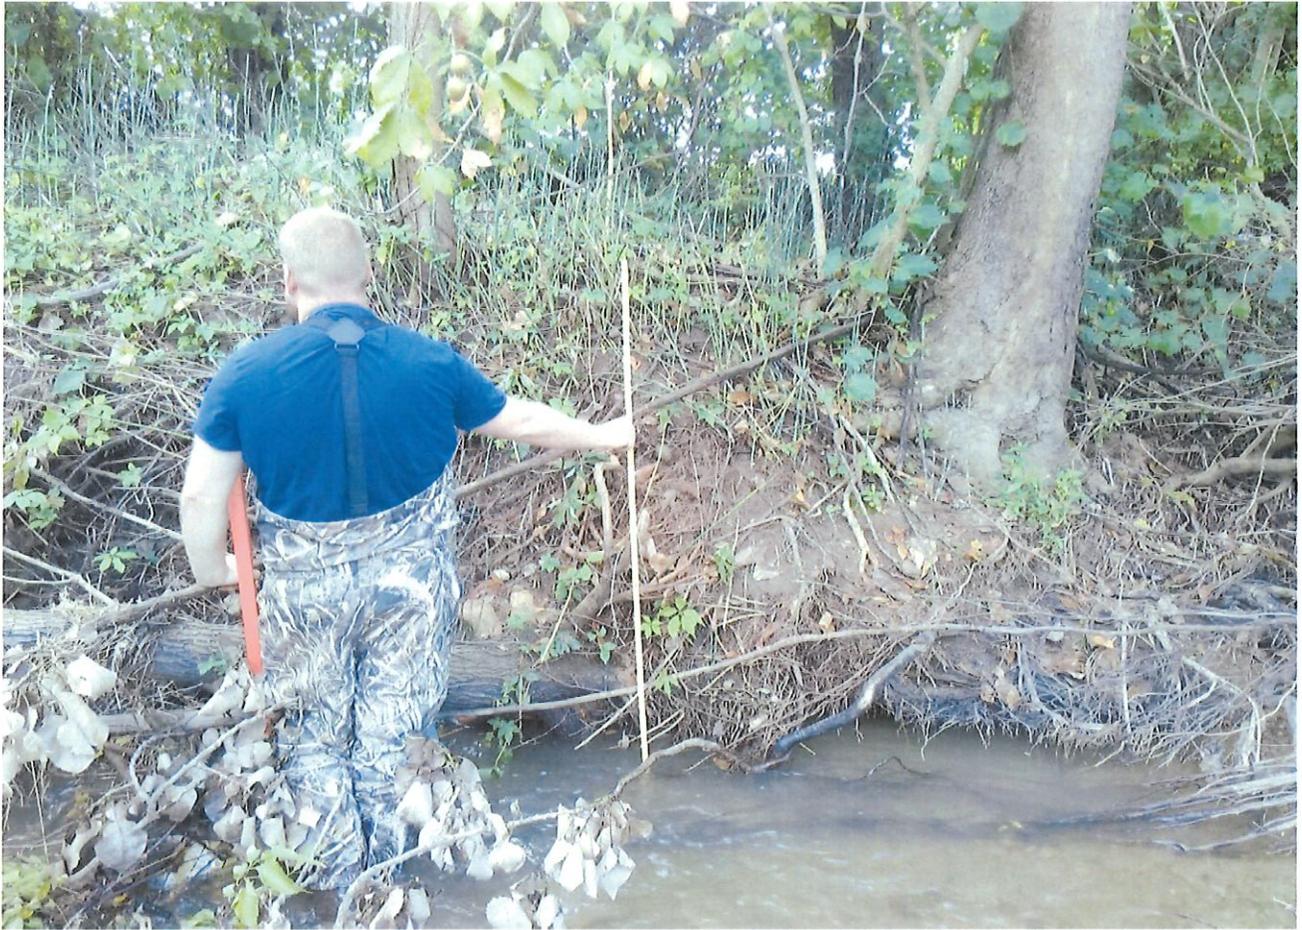
Bank Erosion Hazard Index (BEHI)							
Stream: Fetters Run				Location: Lancaster, Fairfield County, Ohio			
Station: Section 12, Right Bank				Observers: H. Hayter, B. Petru, P. Renner			
Date: 8/1/2019		Stream Type:		Valley Type:			
Study Bank Height to Bankfull Height (C)							BEHI Score (Fig. 3-7)
Study Bank Height (ft) =	6.60 (A)	Bankfull Height (ft) =	2.80 (B)	(A) / (B) =	2.36 (C)	8.5	
Root Depth to Study Bank Height (E)							
Root Depth (ft) =	2.30 (D)	Study Bank Height (ft) =	6.60 (A)	(D) / (A) =	0.35 (E)	5.0	
Weighted Root Density (G)							
Root Density as % =	25.00 (F)	(F) × (E) =			8.71212 (G)	8.5	
Bank Angle (H)							
Bank Angle as Degrees =	57 (H)					3.5	
Surface Protection (I)							
Surface Protection as % =	20% (I)					7.0	
Bank Material Adjustment:							
Bedrock (Overall Very Low BEHI) Boulders (Overall Low BEHI) Cobble (Subtract 10 points if uniform medium to large cobble) Gravel or Composite Matrix (Add 5–10 points depending on percentage of bank material that is composed of sand) Sand (Add 10 points) Silt/Clay (no adjustment unless primarily clay, then subtract 20 points)				Bank Material Adjustment		10

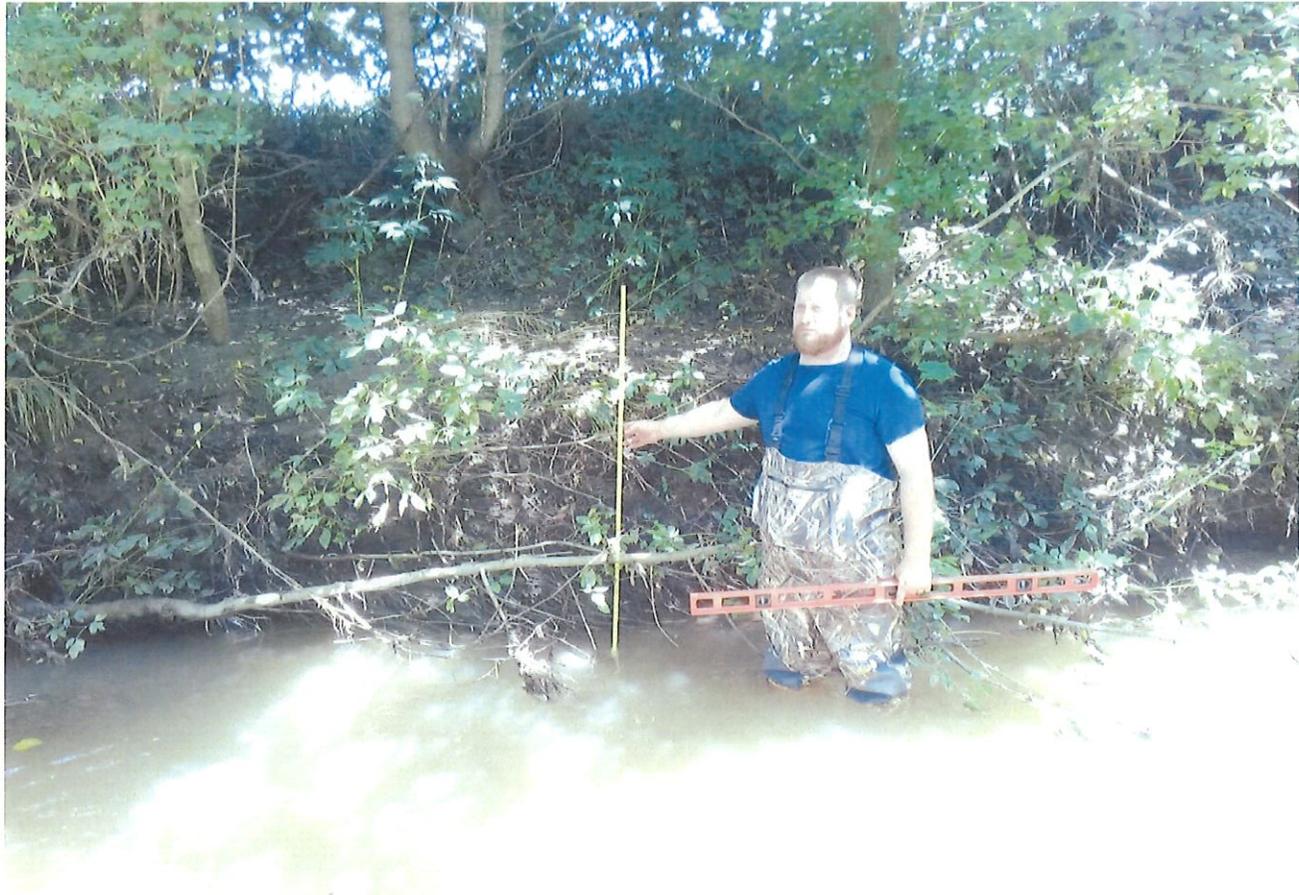
Bank Erosion Hazard Index (BEHI)						
Stream: Fetters Run			Location: Lancaster, Fairfield County, Ohio			
Station: Section 13, Left Bank			Observers: H. Hayter, B. Petru, P. Renner			
Date: 8/1/2019		Stream Type:		Valley Type:		
Study Bank Height to Bankfull Height (C)						BEHI Score (Fig. 3-7)
Study Bank Height (ft) =	8.67 (A)	Bankfull Height (ft) =	2.67 (B)	(A) / (B) =	3.25 (C)	10.0
Root Depth to Study Bank Height (E)						
Root Depth (ft) =	0.42 (D)	Study Bank Height (ft) =	8.67 (A)	(D) / (A) =	0.05 (E)	9.0
Weighted Root Density (G)						
Root Density as % =	15.00 (F)			(F) × (E) =	0.72664 (G)	10.0
Bank Angle (H)						
		Bank Angle as Degrees =	50 (H)			3.5
Surface Protection (I)						
		Surface Protection as % =	15% (I)			7.5
Bank Material Adjustment: Bedrock (Overall Very Low BEHI) Boulders (Overall Low BEHI) Cobble (Subtract 10 points if uniform medium to large cobble) Gravel or Composite Matrix (Add 5–10 points depending on percentage of bank material that is composed of sand) Sand (Add 10 points) Silt/Clay (no adjustment unless primarily clay, then subtract 20 points)			Bank Material Adjustment		10
