Fetters Run (College to Fair) Field Assessment

March 25, 2020

Hull & Associates, Inc.

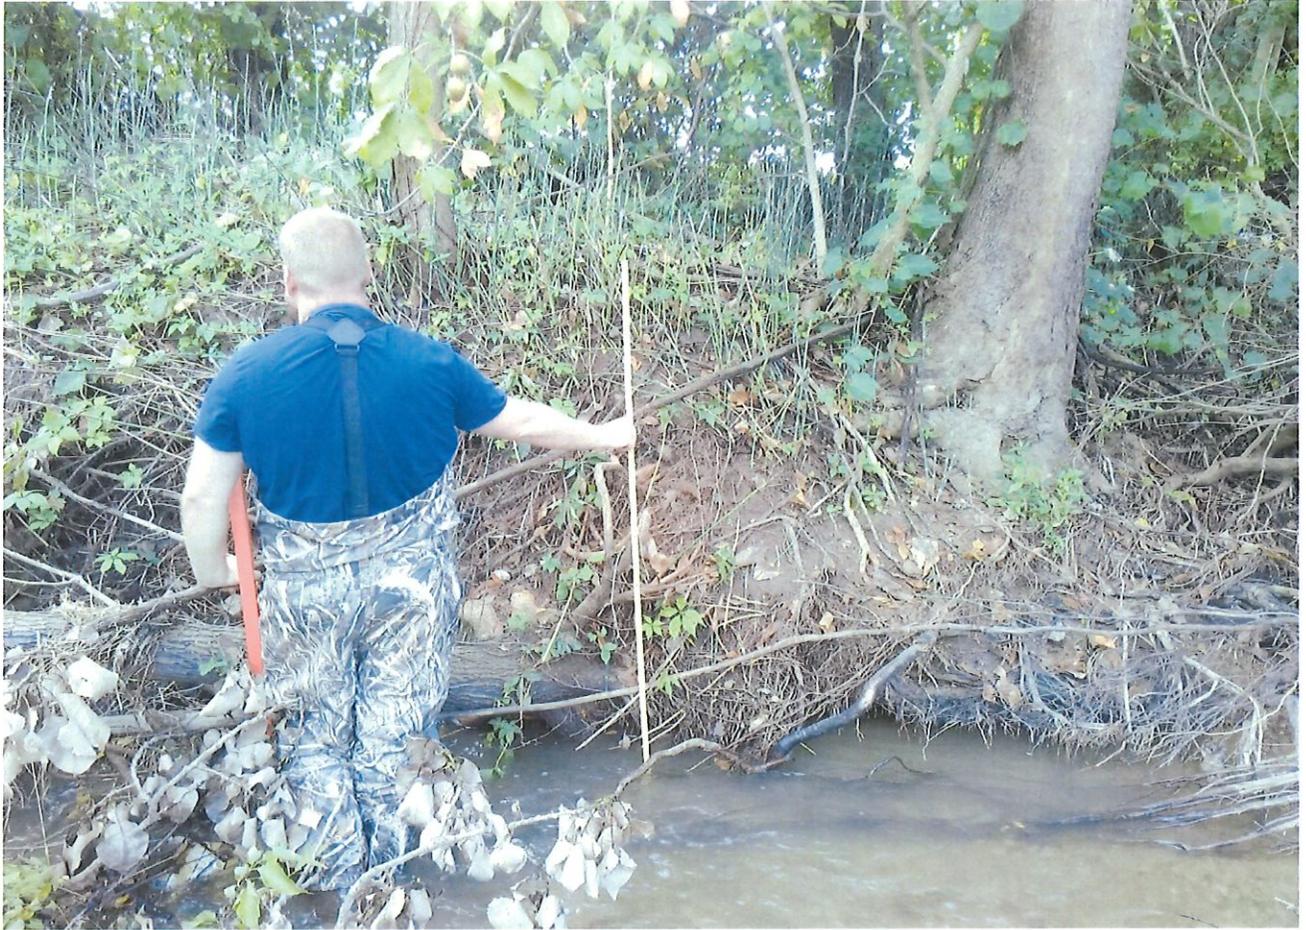
Bank Erosion Hazard Index (BEHI)																						
Stream: Fetters Run				Location: Lancaster, Fairfield County, Ohio																		
Station: Section 13, Right Bank				Observers: H. Hayter, B. Petru, P. Renner																		
Date: 8/1/2019		Stream Type:		Valley Type:																		
Study Bank Height to Bankfull Height (C)							BEHI Score (Fig. 3-7)															
Study Bank Height (ft) =	6.60 (A)	Bankfull Height (ft) =	2.80 (B)	$(A) / (B) =$		2.36 (C)	8.5															
Root Depth to Study Bank Height (E)																						
Root Depth (ft) =	2.30 (D)	Study Bank Height (ft) =	6.60 (A)	$(D) / (A) =$		0.35 (E)	5.0															
Weighted Root Density (G)																						
Root Density as % =	25.00 (F)			$(F) \times (E) =$		8.71212 (G)	8.5															
Bank Angle (H)																						
Bank Angle as Degrees =	57 (H)						3.5															
Surface Protection (I)

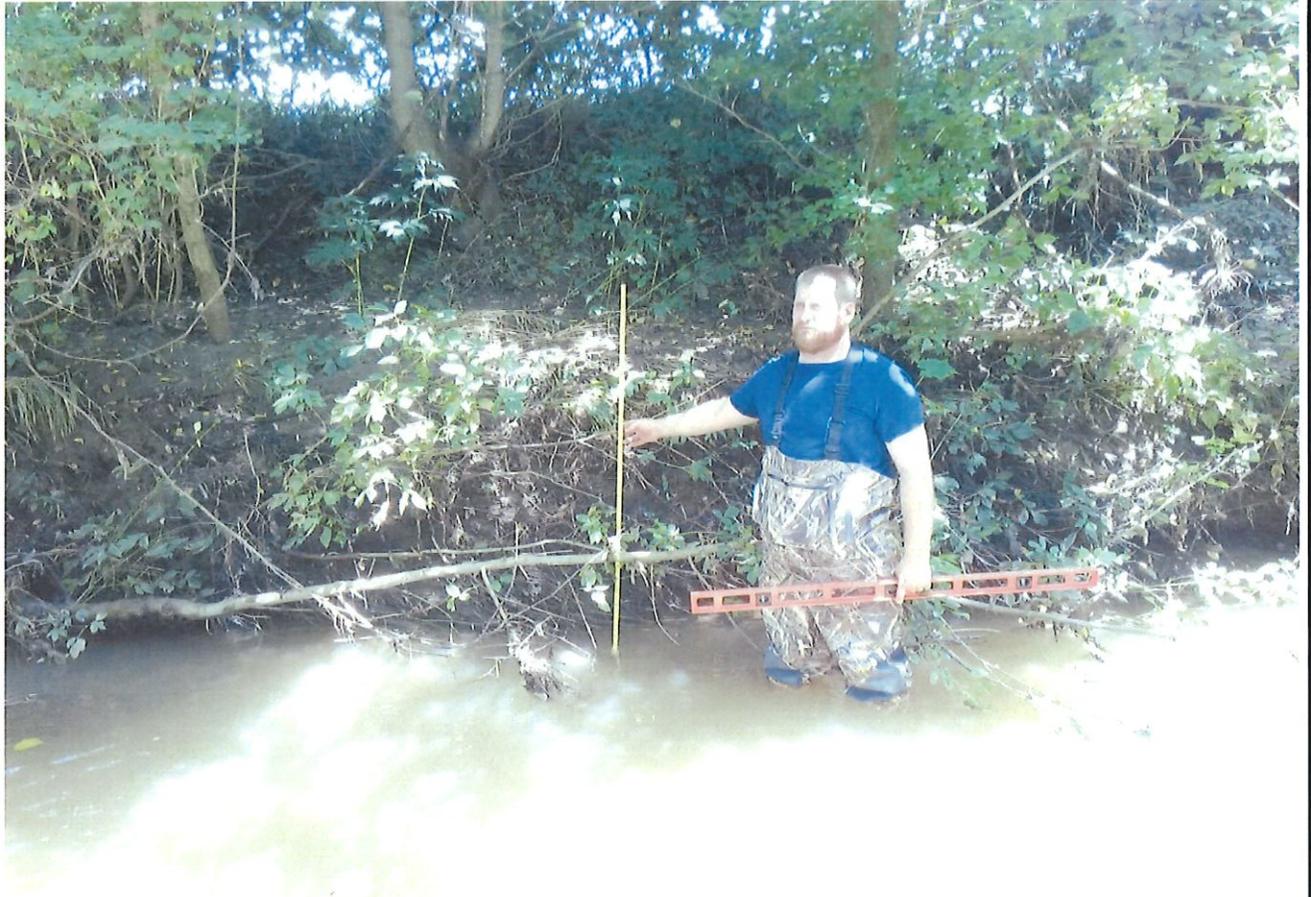
Bank Erosion Hazard Index (BEHI)							
Stream: Fetters Run				Location: Lancaster, Fairfield County, Ohio			
Station: Section 14, Left Bank				Observers: H. Hayter, B. Petru, P. Renner			
Date: 8/1/2019		Stream Type:		Valley Type:			
Study Bank Height to Bankfull Height (C)							BEHI Score (Fig. 3-7)
Study Bank Height (ft) =	8.67	(A)	Bankfull Height (ft) =	2.67	(B)	(A) / (B) =	3.25

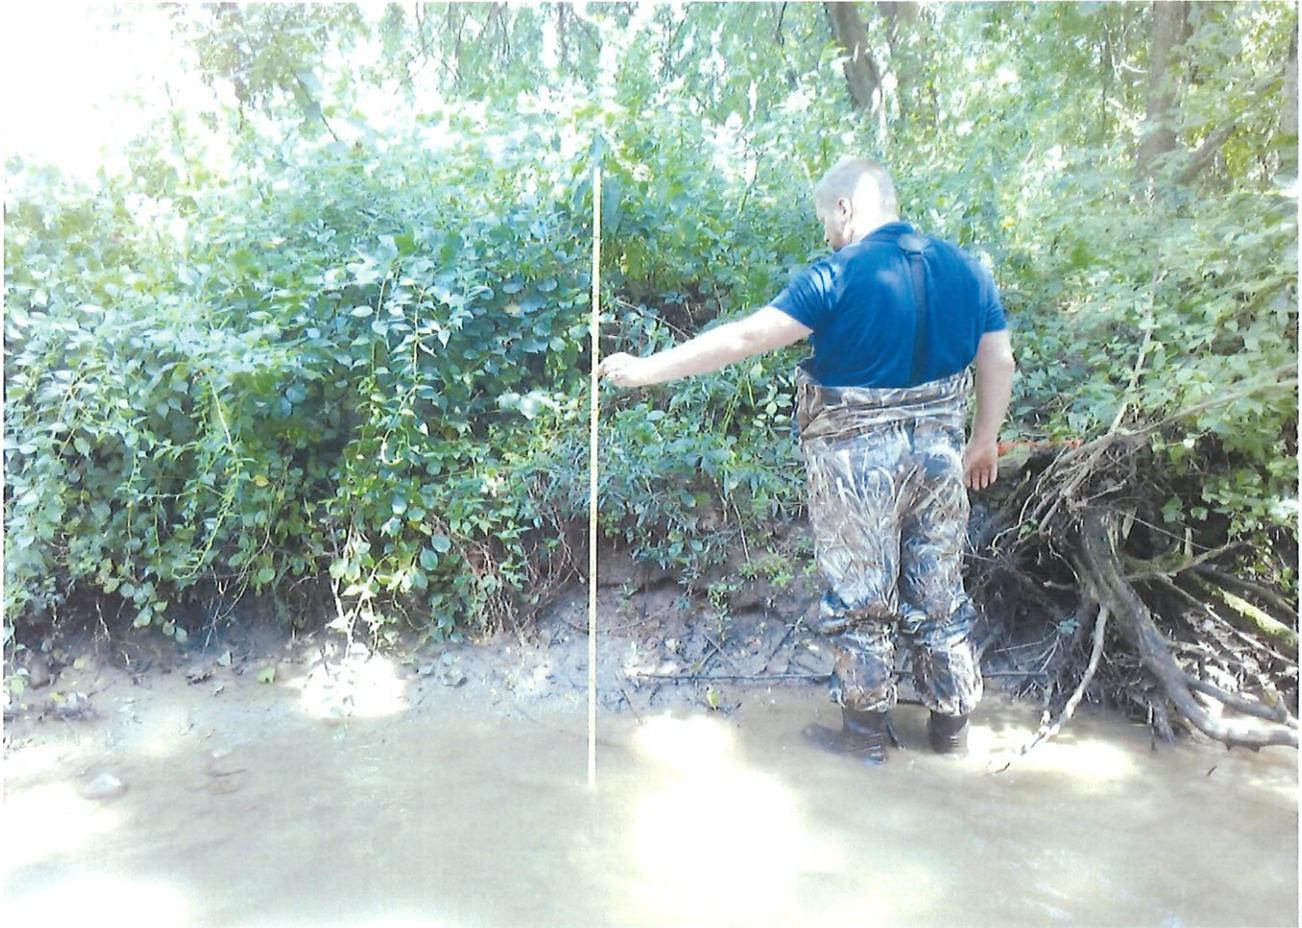
Bank Erosion Hazard Index (BEHI)						
Stream: Fetters Run			Location: Lancaster, Fairfield County, Ohio			
Station: Section 15, Left Bank			Observers: H. Hayter, B. Petru, P. Renner			
Date: 8/1/2019		Stream Type:		Valley Type:		
Study Bank Height to Bankfull Height (C)						BEHI Score (Fig. 3-7)
Study Bank Height (ft) =	5.25 (A)	Bankfull Height (ft) =	1.91 (B)	$(A) / (B) =$	2.75 (C)	8.5
Root Depth to Study Bank Height (E)						
Root Depth (ft) =	1.40 (D)	Study Bank Height (ft) =	5.25 (A)	$(D) / (A) =$	0.27 (E)	6.5
Weighted Root Density (G)						
Root Density as % =	20.00 (F)	$(F) \times (E) =$			5.33333 (G)	9.0
Bank Angle (H)						
Bank Angle as Degrees =	35 (H)				3.0	
Surface Protection (I)						
Surface Protection as % =	45% (I)				4.5	
Bank Material Adjustment:						
Bedrock (Overall Very Low BEHI) Boulders (Overall Low BEHI) Cobble (Subtract 10 points if uniform medium to large cobble) Gravel or Composite Matrix (Add 5–10 points depending on percentage of bank material that is composed of sand) Sand (Add 10 points) Silt/Clay (no adjustment unless primarily clay, then subtract 20 points)			Bank Material Adjustment		10

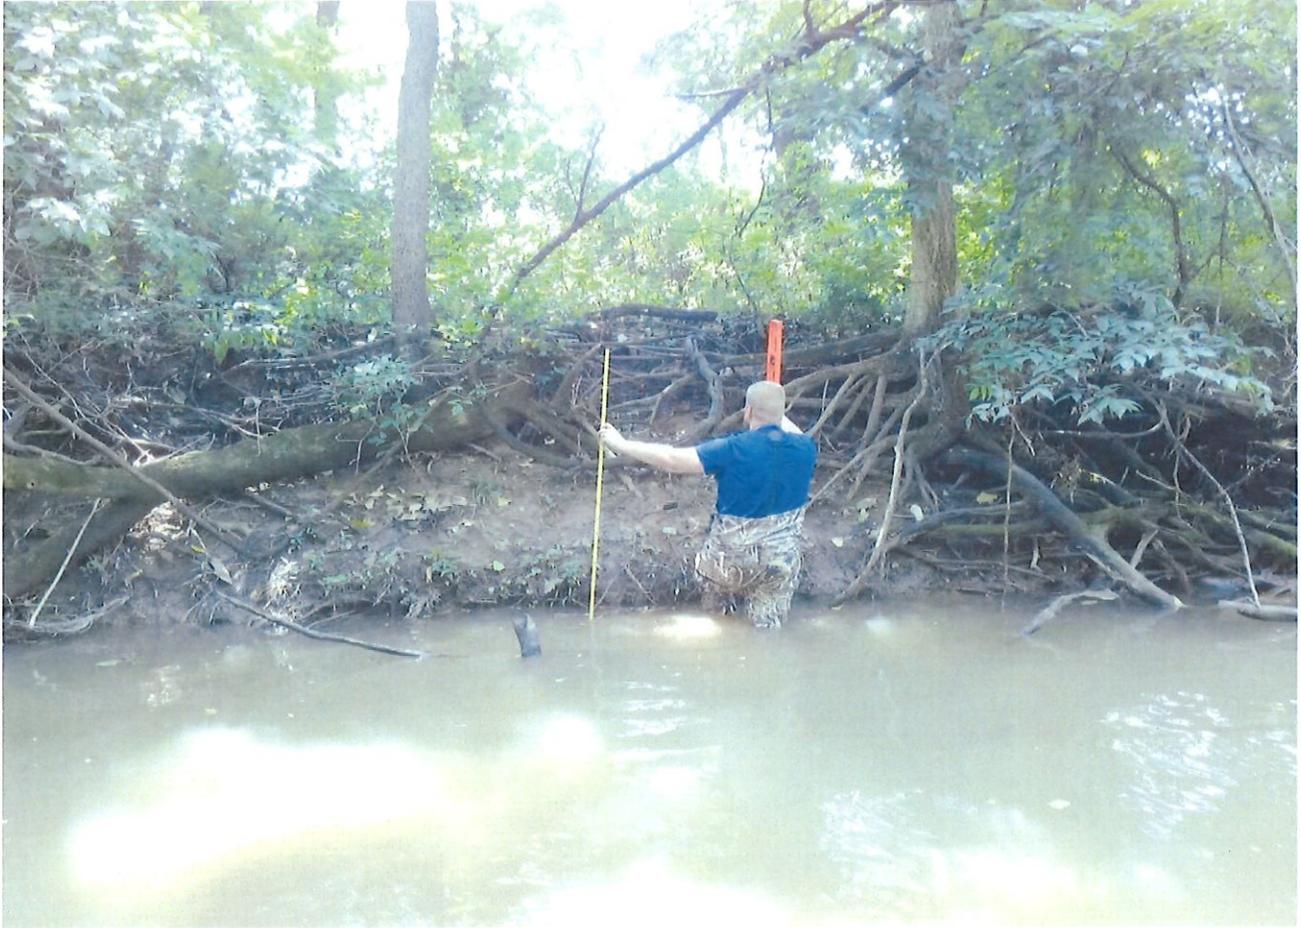
Bank Erosion Hazard Index (BEHI)																			
Stream: Fetters Run				Location: Lancaster, Fairfield County, Ohio															
Station: Section 15, Right Bank				Observers: H. Hayter, B. Petru, P. Renner															
Date: 8/1/2019		Stream Type:		Valley Type:															
Study Bank Height to Bankfull Height (C)							BEHI Score (Fig. 3-7)												
Study Bank Height (ft) =	7.08 (A)	Bankfull Height (ft) =	2.33 (B)	$(A) / (B) =$		3.04 (C)	9.0												
Root Depth to Study Bank Height (E)																			
Root Depth (ft) =	3.00 (D)	Study Bank Height (ft) =	7.08 (A)	$(D) / (A) =$		0.42 (E)	4.5												
Weighted Root Density (G)																			
Root Density as % =	10.00 (F)			$(F) \times (E) =$		4.23729 (G)	9.0												
Bank Angle (H)																			
		Bank Angle as Degrees =	35 (H)				3.0												
Surface Protection (I)																			
		Surface Protection as % =	5% (I)				10.0												
Bank Material Adjustment:																			
<ul style="list-style-type: none"> Bedrock (Overall Very Low BEHI) Boulders (Overall Low BEHI) Cobble (Subtract 10 points if uniform medium to large cobble) Gravel or Composite Matrix (Add 5–10 points depending on percentage of bank material that is composed of sand) Sand (Add 10 points) Silt/Clay (no adjustment unless primarily clay, then subtract 20 points) 				Bank Material Adjustment		10													
				Stratification Adjustment		10													
				Add 5–10 points, depending on position of unstable layers in relation to bankfull stage															
<table border="1" style="width: 100%; border-collapse: collapse; text-align: center;"> <tr> <td style="padding: 2px;">Very Low</td> <td style="padding: 2px;">Low</td> <td style="padding: 2px;">Moderate</td> <td style="padding: 2px;">High</td> <td style="padding: 2px;">Very High</td> <td style="padding: 2px;">Extreme</td> </tr> <tr> <td style="padding: 2px;">5 – 9.5</td> <td style="padding: 2px;">10 – 19.5</td> <td style="padding: 2px;">20 – 29.5</td> <td style="padding: 2px;">30 – 39.5</td> <td style="padding: 2px;">40 – 45</td> <td style="padding: 2px;">46 – 50</td> </tr> </table>						Very Low	Low	Moderate	High	Very High	Extreme	5 – 9.5	10 – 19.5	20 – 29.5	30 – 39.5	40 – 45	46 – 50	Adjective Rating and Total Score	Extreme 55.5
Very Low	Low	Moderate	High	Very High	Extreme														
5 – 9.5	10 – 19.5	20 – 29.5	30 – 39.5	40 – 45	46 – 50

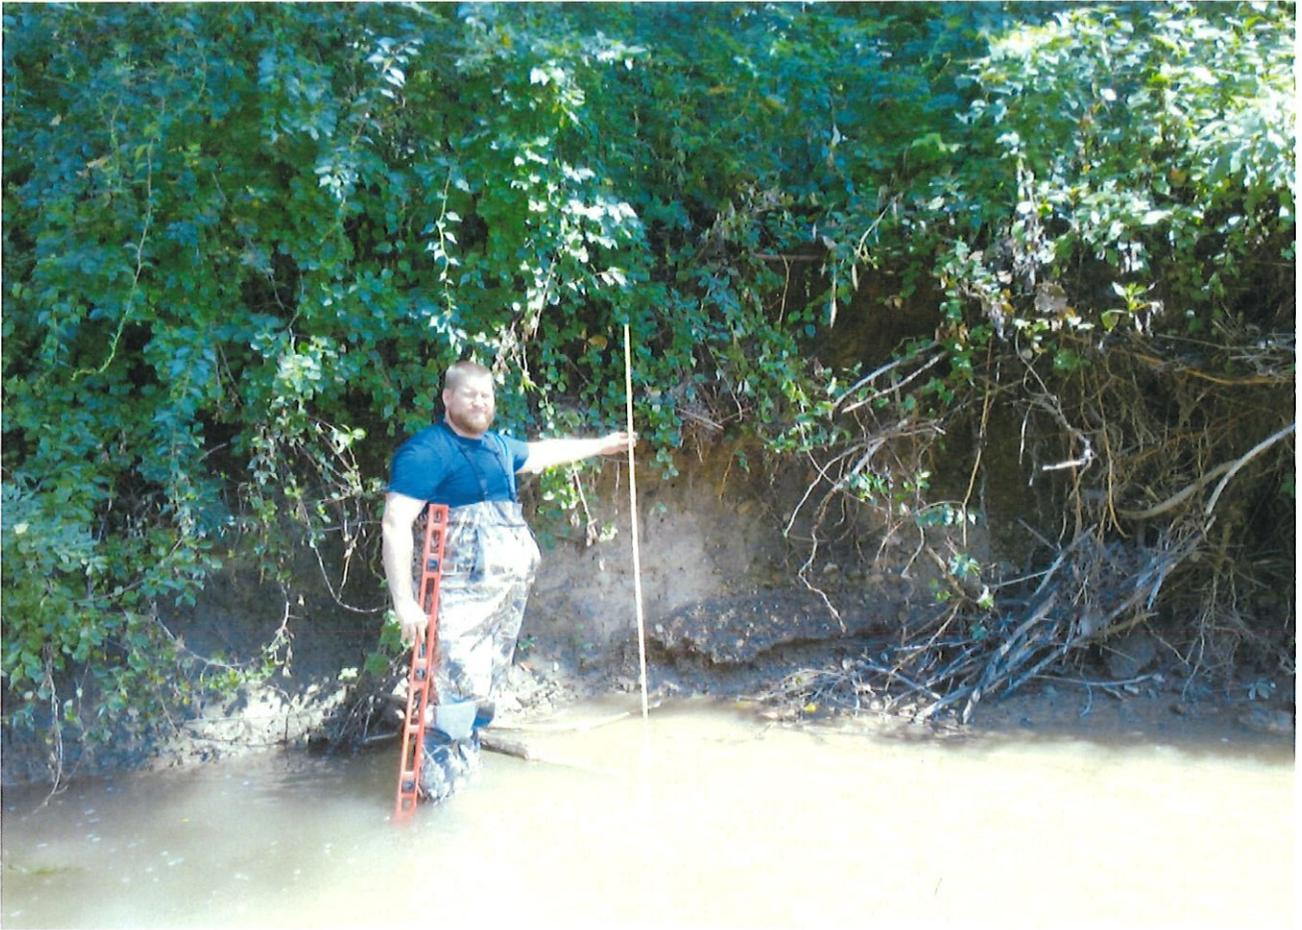
Bank Erosion Hazard Index (BEHI)							
Stream: Fetters Run				Location: Lancaster, Fairfield County, Ohio			
Station: Section 16, Left Bank				Observers: H. Hayter, B. Petru, P. Renner			
Date: 8/1/2019		Stream Type:		Valley Type:			
Study Bank Height to Bankfull Height (C)							BEHI Score (Fig. 3-7)
Study Bank Height (ft) =	9.83 (A)	Bankfull Height (ft) =	2.42 (B)	$(A) / (B) =$	4.06 (C)	10.0	
Root Depth to Study Bank Height (E)							
Root Depth (ft) =	1.00 (D)	Study Bank Height (ft) =	9.83 (A)	$(D) / (A) =$	0.10 (E)	8.5	
Weighted Root Density (G)							
Root Density as % =	10.00 (F)	$(F) \times (E) =$			1.01729 (G)	10.0	
Bank Angle (H)							
Bank Angle as Degrees =	95 (H)					8.0	
Surface Protection (I)							
Surface Protection as % =	5% (I)					10.0	
Bank Material Adjustment:							
Bedrock (Overall Very Low BEHI) Boulders (Overall Low BEHI) Cobble (Subtract 10 points if uniform medium to large cobble) Gravel or Composite Matrix (Add 5–10 points depending on percentage of bank material that is composed of sand) Sand (Add 10 points) Silt/Clay (no adjustment unless primarily clay, then subtract 20 points)				Bank Material Adjustment		10

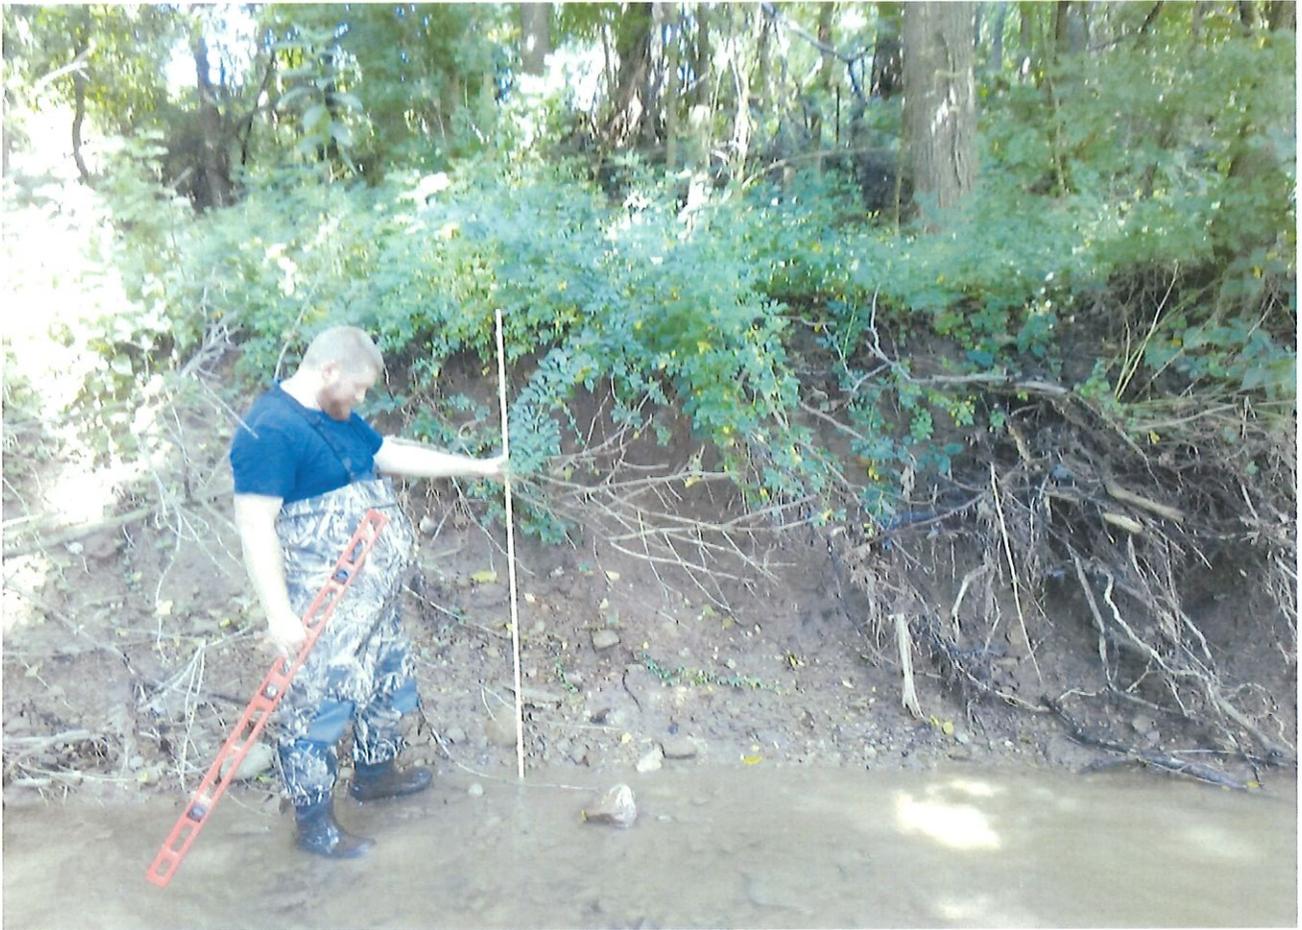
Bank Erosion Hazard Index (BEHI)							
Stream: Fetters Run				Location: Lancaster, Fairfield County, Ohio			
Station: Section 18, Left Bank				Observers: H. Hayter, B. Petru, P. Renner			
Date: 8/1/2019		Stream Type:		Valley Type:			
Study Bank Height to Bankfull Height (C)							BEHI Score (Fig. 3-7)
Study Bank Height (ft) =	6.58 (A)	Bankfull Height (ft) =	1.67 (B)	$(A) / (B) =$	3.94 (C)	10.0	
Root Depth to Study Bank Height (E)							
Root Depth (ft) =	0.80 (D)	Study Bank Height (ft) =	6.58 (A)	$(D) / (A) =$	0.12 (E)	8.5	
Weighted Root Density (G)							
Root Density as % =	15.00 (F)	$(F) \times (E) =$	1.82371 (G)		10.0		
Bank Angle (H)							
Bank Angle as Degrees =	75 (H)					5.5	
Surface Protection (I)							
Surface Protection as % =	10% (I)					9.0	
Bank Material Adjustment:							
Bedrock (Overall Very Low BEHI) Boulders (Overall Low BEHI) Cobble (Subtract 10 points if uniform medium to large cobble) Gravel or Composite Matrix (Add 5–10 points depending on percentage of bank material that is composed of sand) Sand (Add 10 points) Silt/Clay (no adjustment unless primarily clay, then subtract 20 points)				Bank Material Adjustment		10

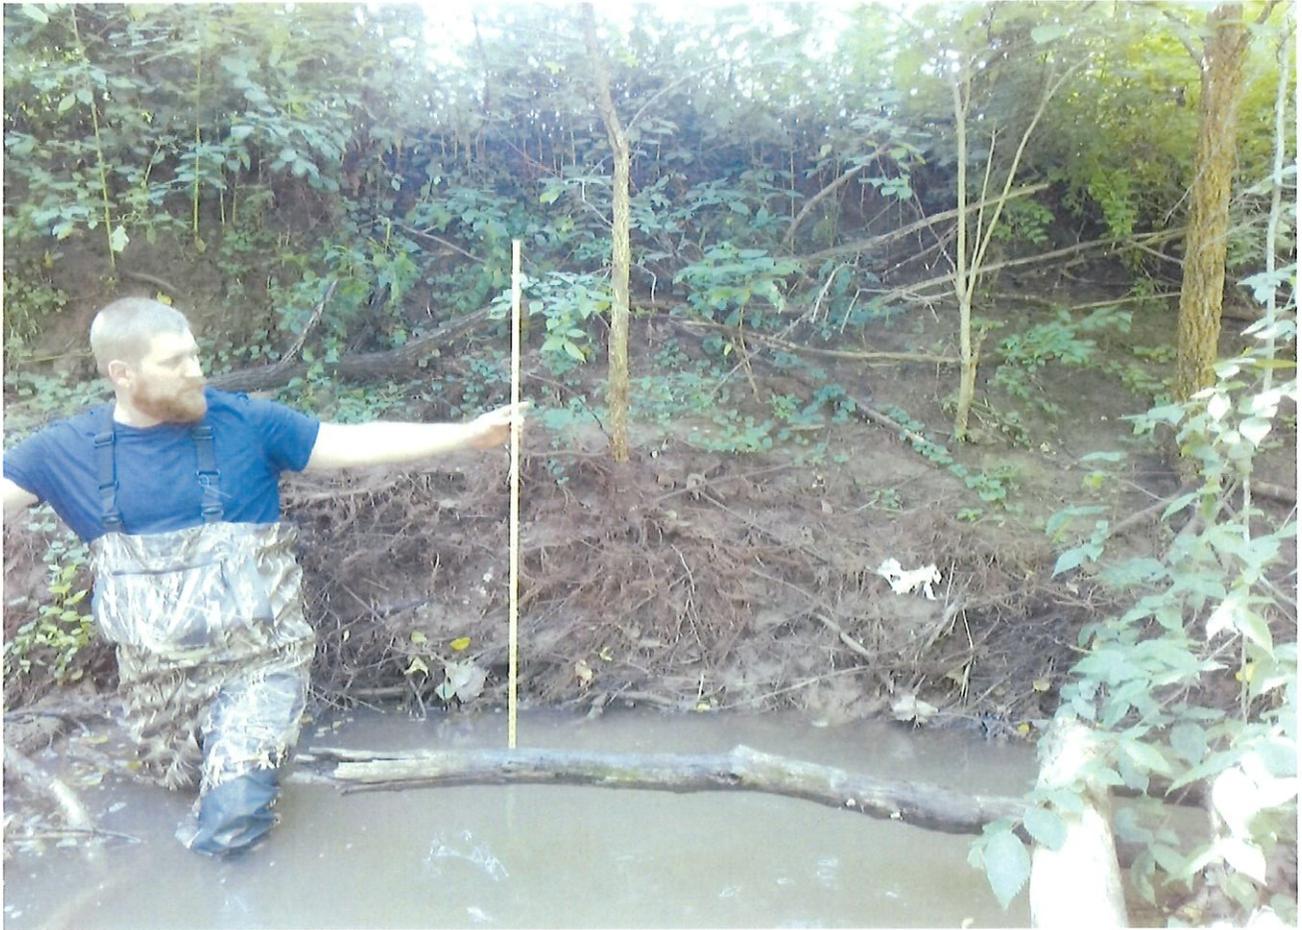
Bank Erosion Hazard Index (BEHI)						
Stream:	Fetters Run	Location:	Lancaster, Fairfield County, Ohio			
Station:	Section 19, Right Bank	Observers:	H. Hayter, B. Petru, P. Renner			
Date:	8/1/2019	Stream Type:	Valley Type:			
Study Bank Height to Bankfull Height (C)						BEHI Score (Fig. 3-7)
Study Bank Height (ft) =	8.75 (A)	Bankfull Height (ft) =	3.09 (B)	$(A) / (B) =$	2.83 (C)	9.0
Root Depth to Study Bank Height (E)						
Root Depth (ft) =	0.60 (D)	Study Bank Height (ft) =	8.75 (A)	$(D) / (A) =$	0.07 (E)	8.5
Weighted Root Density (G)						
Root Density as % =	20.00 (F)	$(F) \times (E) =$	1.37143 (G)			10.0
Bank Angle (H)						
Bank Angle as Degrees =	30 (H)				2.5	
Surface Protection (I)						
Surface Protection as % =	15% (I)				8.0	
Bank Material Adjustment:						
Bedrock (Overall Very Low BEHI) Boulders (Overall Low BEHI) Cobble (Subtract 10 points if uniform medium to large cobble) Gravel or Composite Matrix (Add 5-10 points depending on percentage of bank material that is composed of sand) Sand (Add 10 points) Silt/Clay (no adjustment unless primarily clay, then subtract 20 points)						Bank Material Adjustment

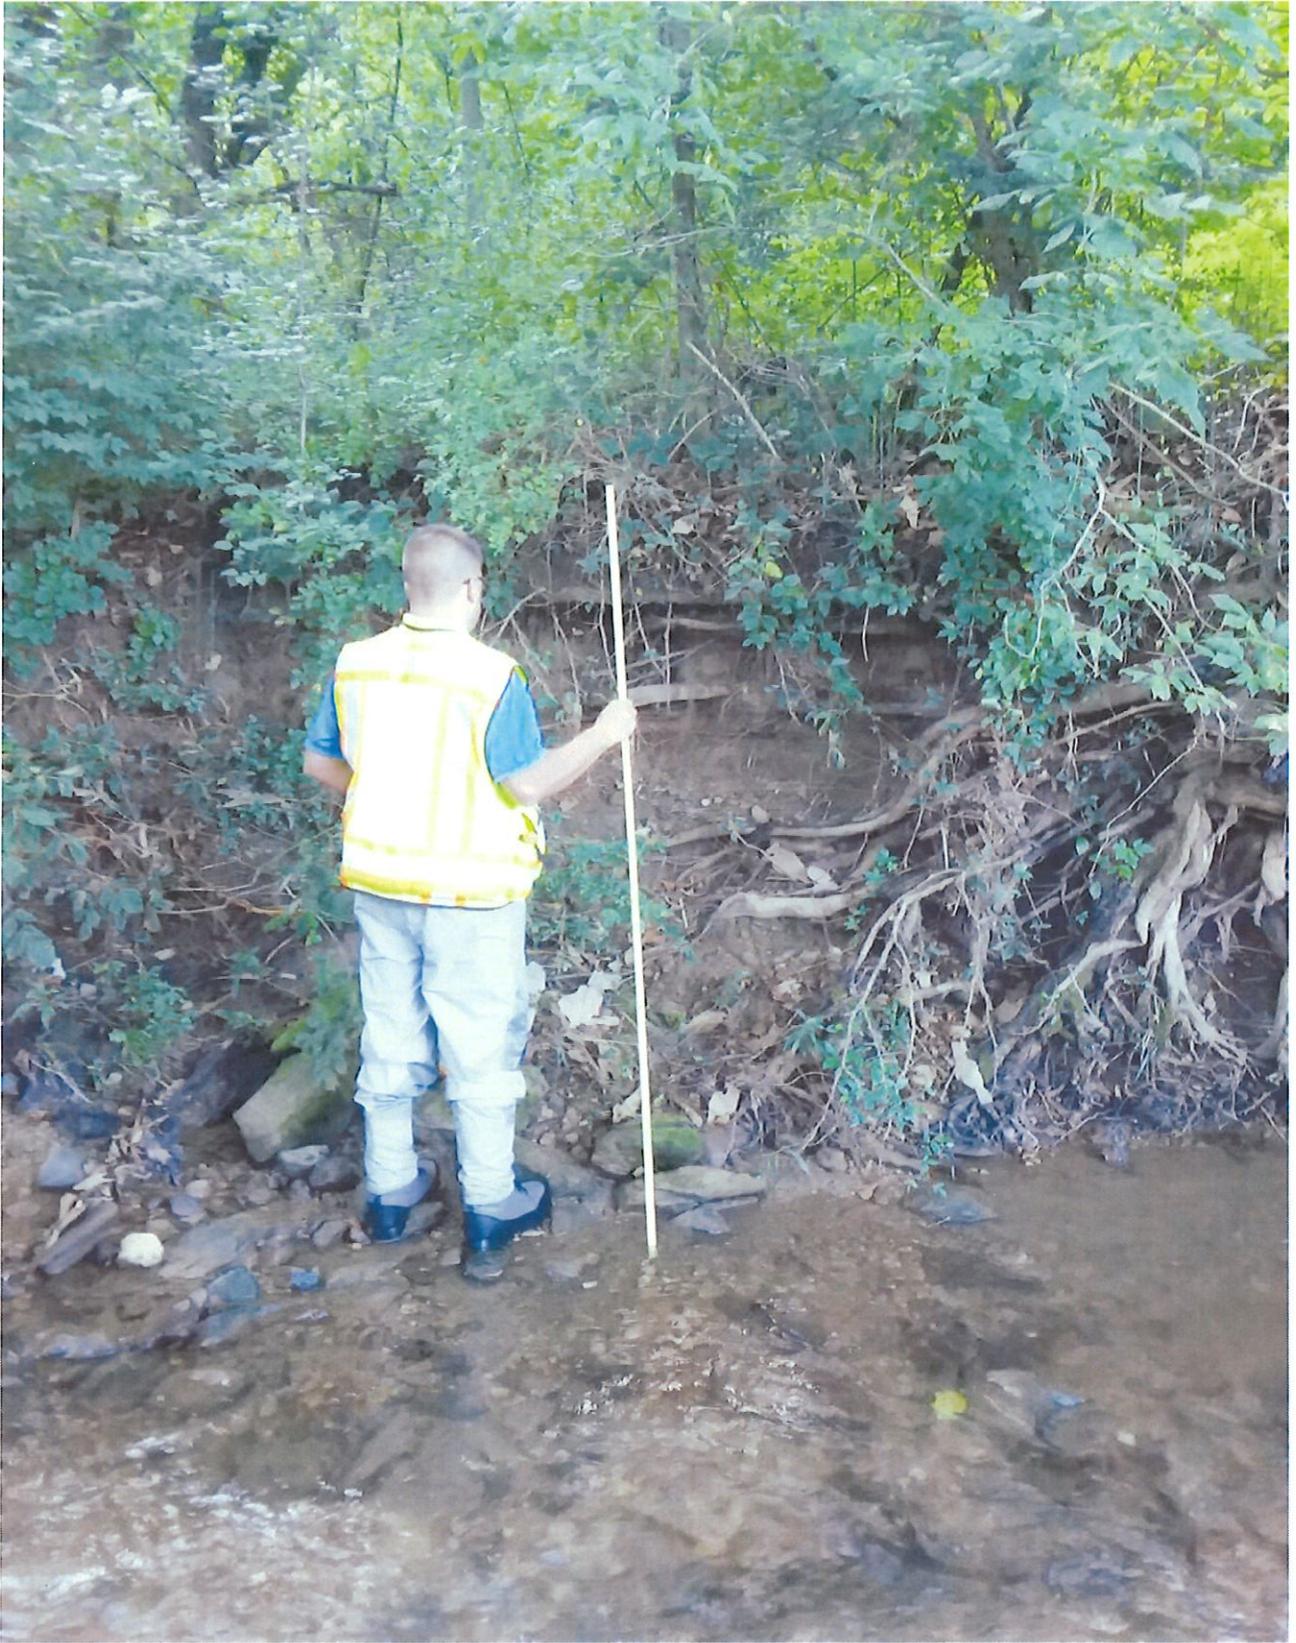
Bank Erosion Hazard Index (BEHI)							
Stream: Fetters Run			Location: Lancaster, Fairfield County, Ohio				
Station: Section 20, Left Bank			Observers: H. Hayter, B. Petru, P. Renner				
Date: 8/1/2019		Stream Type:		Valley Type:			
Study Bank Height to Bankfull Height (C)						BEHI Score (Fig. 3-7)	
Study Bank Height (ft) =	7.75 (A)	Bankfull Height (ft) =	2.67 (B)	(A) / (B) =	2.90 (C)	9.0	
Root Depth to Study Bank Height (E)							
Root Depth (ft) =	2.16 (D)	Study Bank Height (ft) =	7.75 (A)	(D) / (A) =	0.28 (E)	6.0	
Weighted Root Density (G)							
Root Density as % =	20.00 (F)	(F) × (E) =			5.57419 (G)	9.0	
Bank Angle (H)							
Bank Angle as Degrees =	112 (H)				9.0		
Surface Protection (I)							
Surface Protection as % =	25% (I)				6.5		
Bank Material Adjustment:							
<ul style="list-style-type: none"> Bedrock (Overall Very Low BEHI) Boulders (Overall Low BEHI) Cobble (Subtract 10 points if uniform medium to large cobble) Gravel or Composite Matrix (Add 5–10 points depending on percentage of bank material that is composed of sand) Sand (Add 10 points) Silt/Clay (no adjustment unless primarily clay, then subtract 20 points) 						Bank Material Adjustment	10

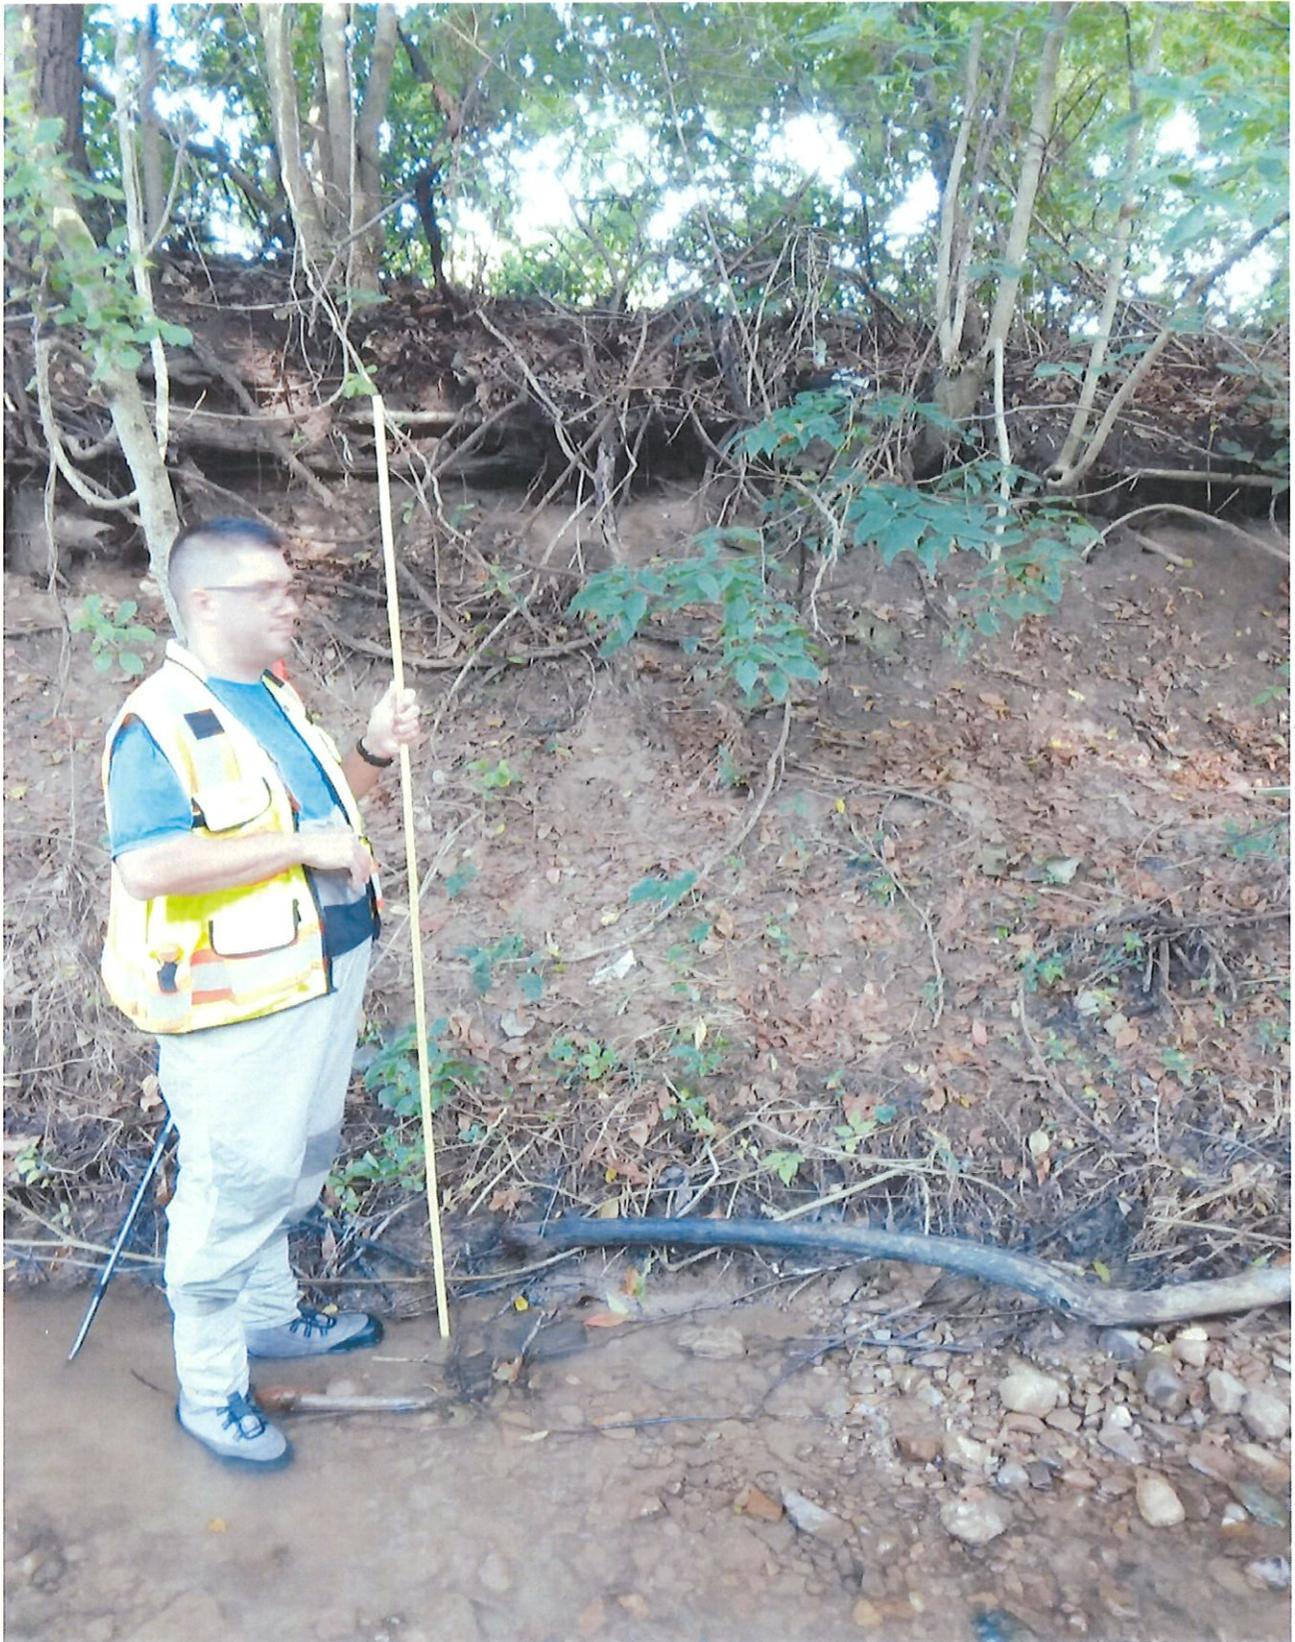
Bank Erosion Hazard Index (BEHI)							
Stream: Fetters Run			Location: Lancaster, Fairfield County, Ohio				
Station: Section 21, Right Bank			Observers: H. Hayter, B. Petru, P. Renner				
Date: 8/1/2019		Stream Type:			Valley Type:		
Study Bank Height to Bankfull Height (C)							BEHI Score (Fig. 3-7)
Study Bank Height (ft) =	9.60 (A)	Bankfull Height (ft) =	2.75 (B)	(A) / (B) =	3.49 (C)	10.0	
Root Depth to Study Bank Height (E)							
Root Depth (ft) =	1.50 (D)	Study Bank Height (ft) =	9.60 (A)	(D) / (A) =	0.16 (E)	7.5	
Weighted Root Density (G)							
Root Density as % =	15.00 (F)	(F) × (E) =	2.34375 (G)			9.5	
Bank Angle (H)							
Bank Angle as Degrees =	40 (H)					5.0	
Surface Protection (I)							
Surface Protection as % =	5% (I)					10.0	
Bank Material Adjustment: Bedrock (Overall Very Low BEHI) Boulders (Overall Low BEHI) Cobble (Subtract 10 points if uniform medium to large cobble) Gravel or Composite Matrix (Add 5–10 points depending on percentage of bank material that is composed of sand) Sand (Add 10 points) Silt/Clay (no adjustment unless primarily clay, then subtract 20 points)			→		Bank Material Adjustment 10

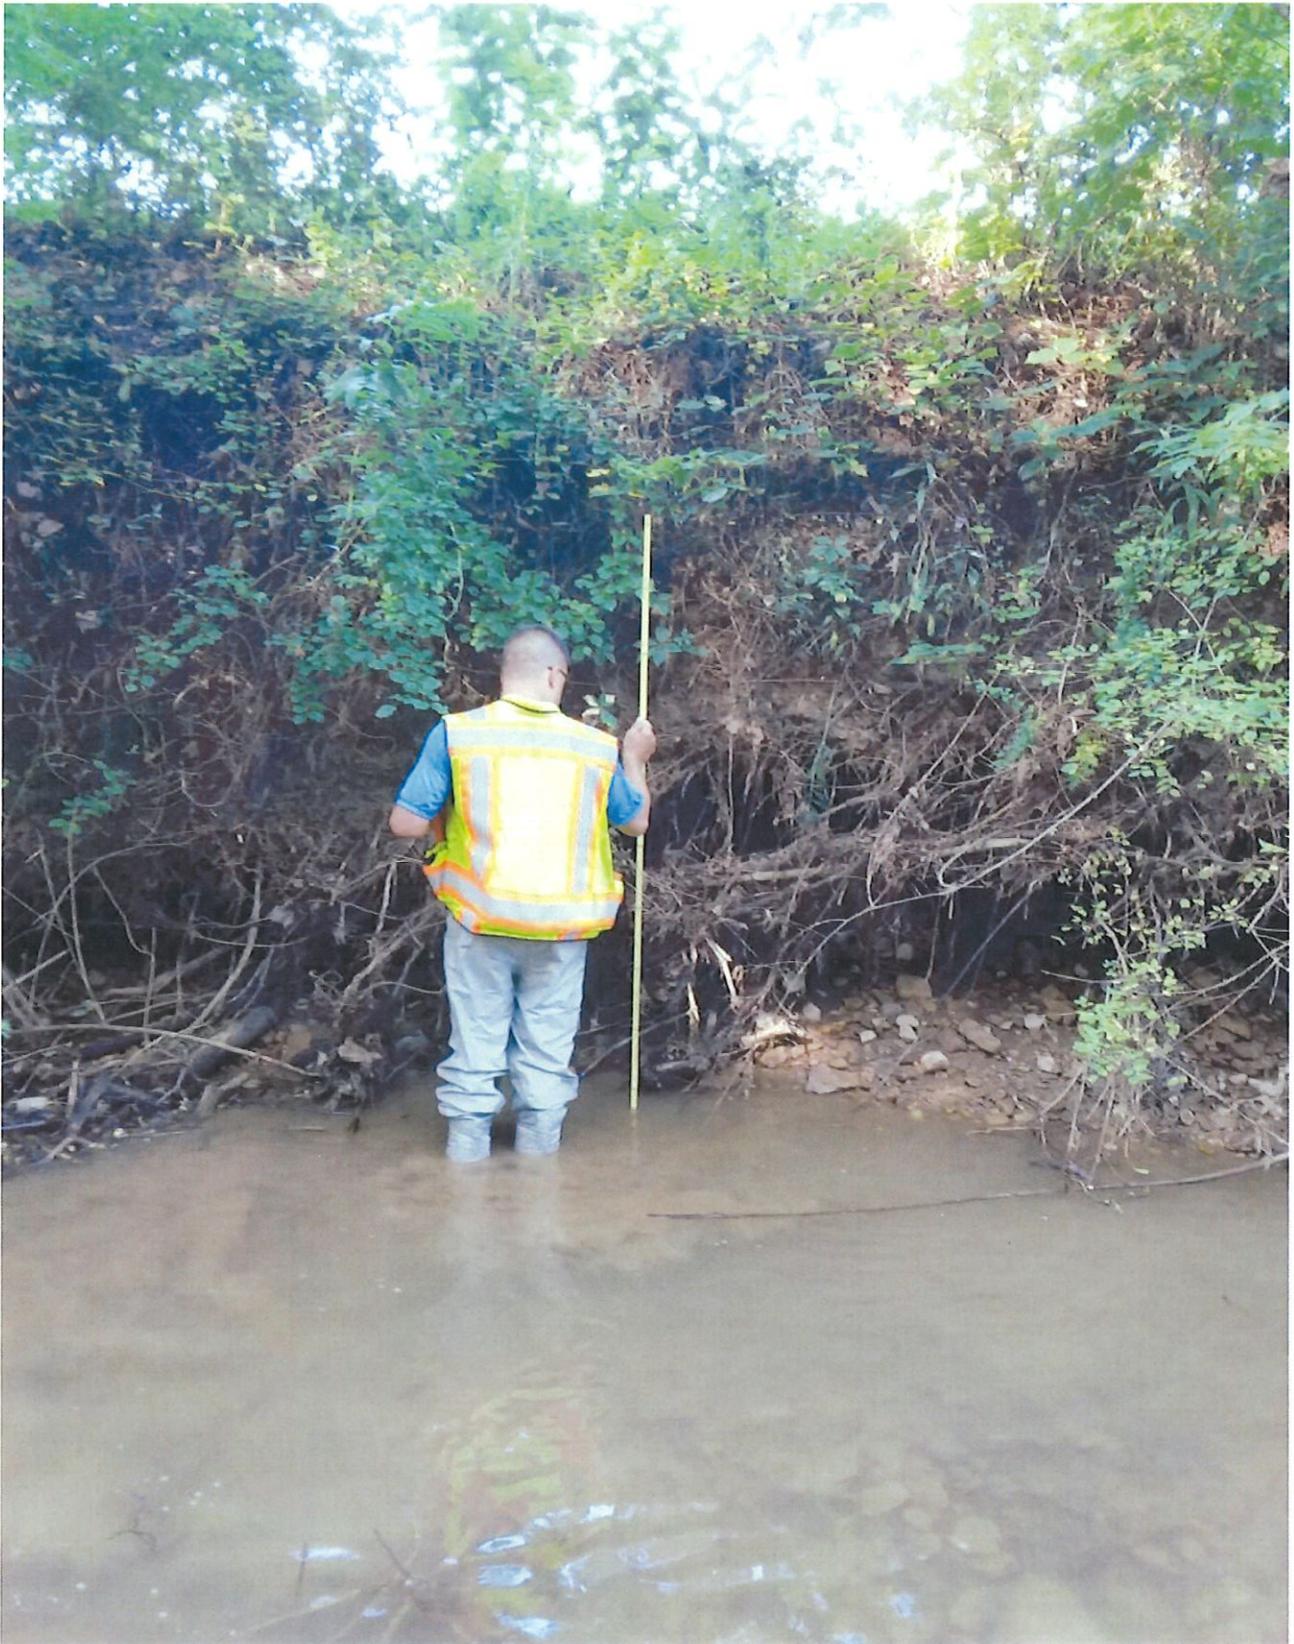
Station: **Section 23, Right Bank**

Bank Erosion Hazard Index (BEHI)						
Stream: Fetters Run			Location: Lancaster, Fairfield County, Ohio			
Station: Section 23, Right Bank			Observers: B. Petru, P. Renner			
Date: 8/2/2019		Stream Type:		Valley Type:		
Study Bank Height to Bankfull Height (C)						BEHI Score (Fig. 3-7)
Study Bank Height (ft) =	11.00 (A)	Bankfull Height (ft) =	3.00 (B)	(A) / (B) =	3.67 (C)	10.0
Root Depth to Study Bank Height (E)						
Root Depth (ft) =	3.50 (D)	Study Bank Height (ft) =	11.00 (A)	(D) / (A) =	0.32 (E)	5.5
Weighted Root Density (G)						
Root Density as % =	25.00 (F)	(F) × (E) =			7.95455 (G)	8.5
Bank Angle (H)						
Bank Angle as Degrees =	150 (H)				10.0	
Surface Protection (I)						
Surface Protection as % =	20% (I)				7.0	
Bank Material Adjustment:						
<ul style="list-style-type: none"> Bedrock (Overall Very Low BEHI) Boulders (Overall Low BEHI) Cobble (Subtract 10 points if uniform medium to large cobble) Gravel or Composite Matrix (Add 5–10 points depending on percentage of bank material that is composed of sand) Sand (Add 10 points) Silt/Clay (no adjustment unless primarily clay, then subtract 20 points) 						Bank Material Adjustment

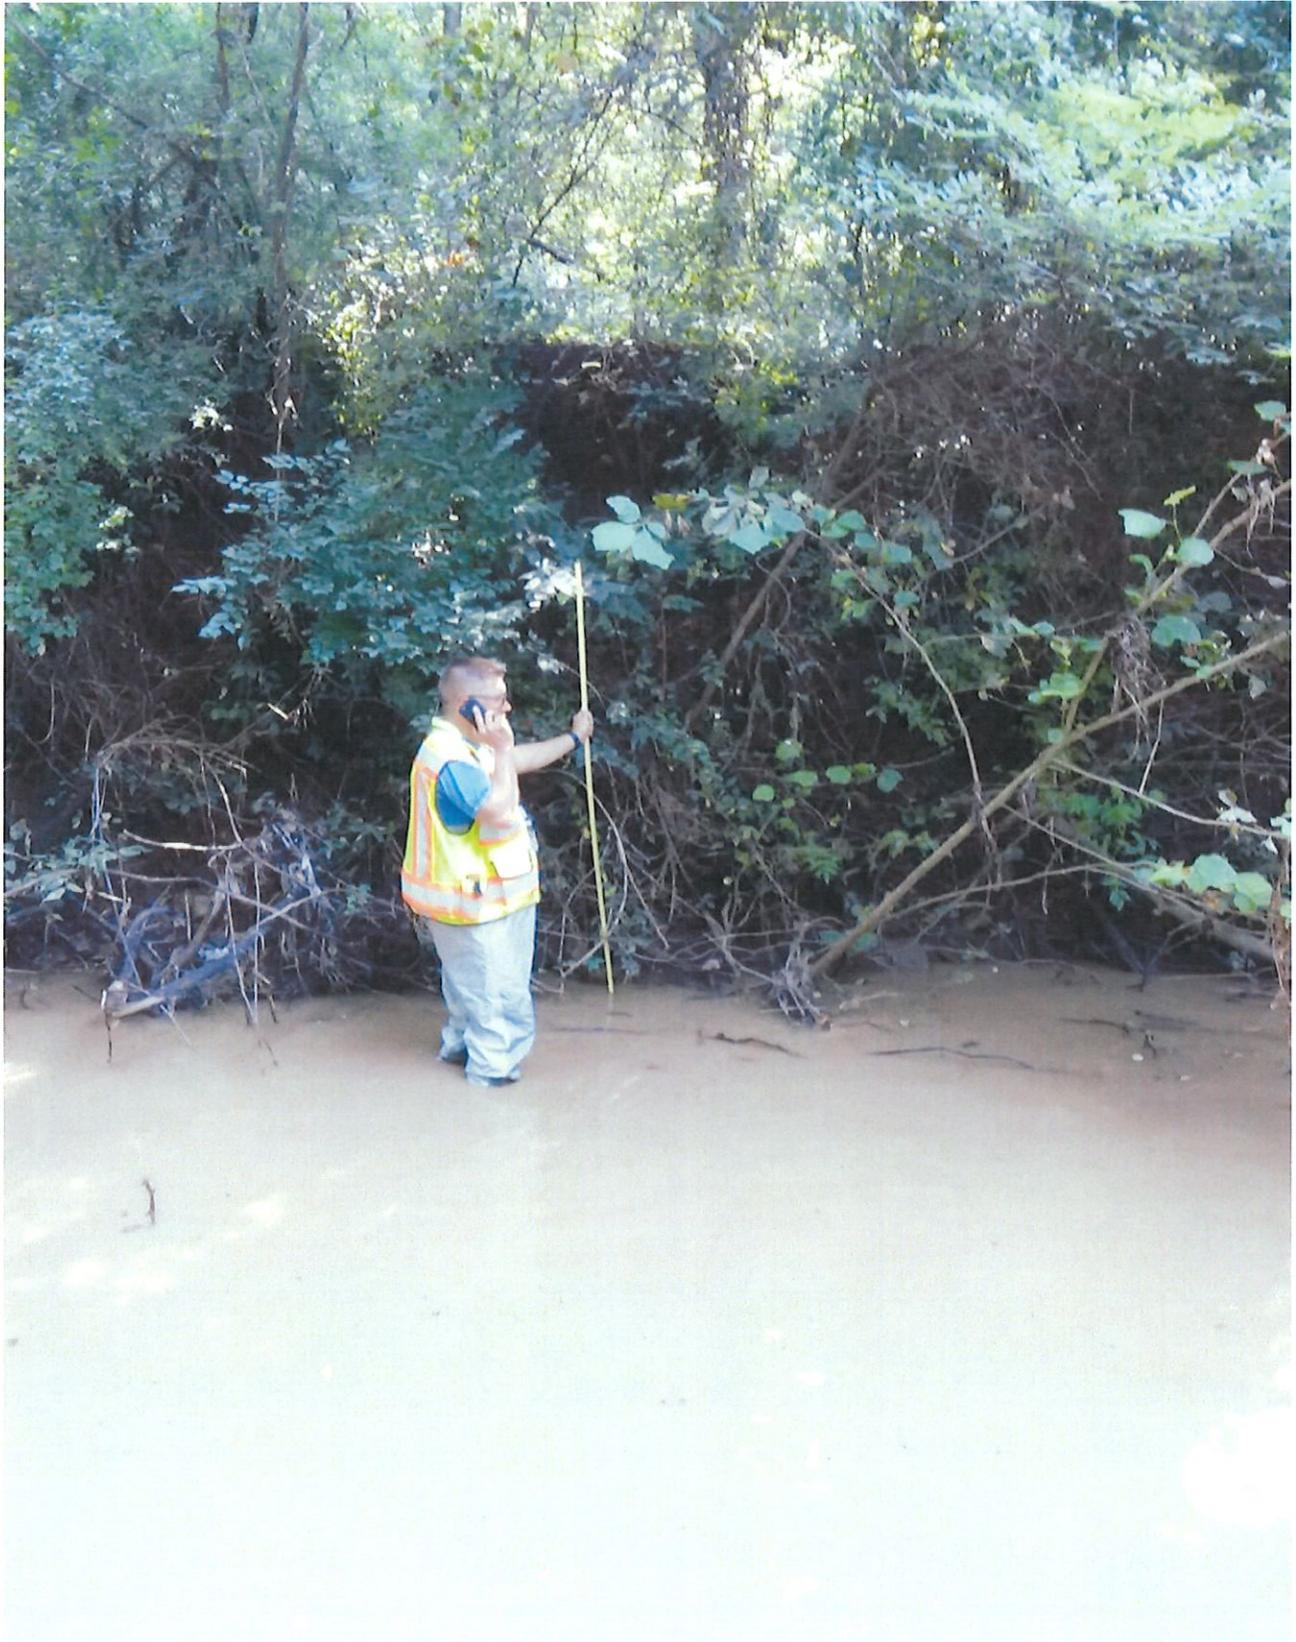
Station: **Section 24, Left Bank**

Bank Erosion Hazard Index (BEHI)																											
Stream:	Fetters Run			Location:	Lancaster, Fairfield County, Ohio																						
Station:	Section 24, Left Bank			Observers:	B. Petru, P. Renner																						
Date:	8/2/2019		Stream Type:	Valley Type:																							
BEHI Score (Fig. 3-7)																											
Study Bank Height to Bankfull Height (C)																											
Study Bank Height (ft) =	9.30 (A)	Bankfull Height (ft) =	3.70 (B)	$(A) / (B) =$	2.51 (C)	8.5																					
Root Depth to Study Bank Height (E)																											
Root Depth (ft) =	1.20 (D)	Study Bank Height (ft) =	9.30 (A)	$(D) / (A) =$	0.13 (E)	8.0																					
Weighted Root Density (G)																											
Root Density as % =	20.00 (F)	$(F) \times (E) =$			2.58065 (G)	9.5																					
Bank Angle (H)																											
Bank Angle as Degrees =	70 (H)				4.5

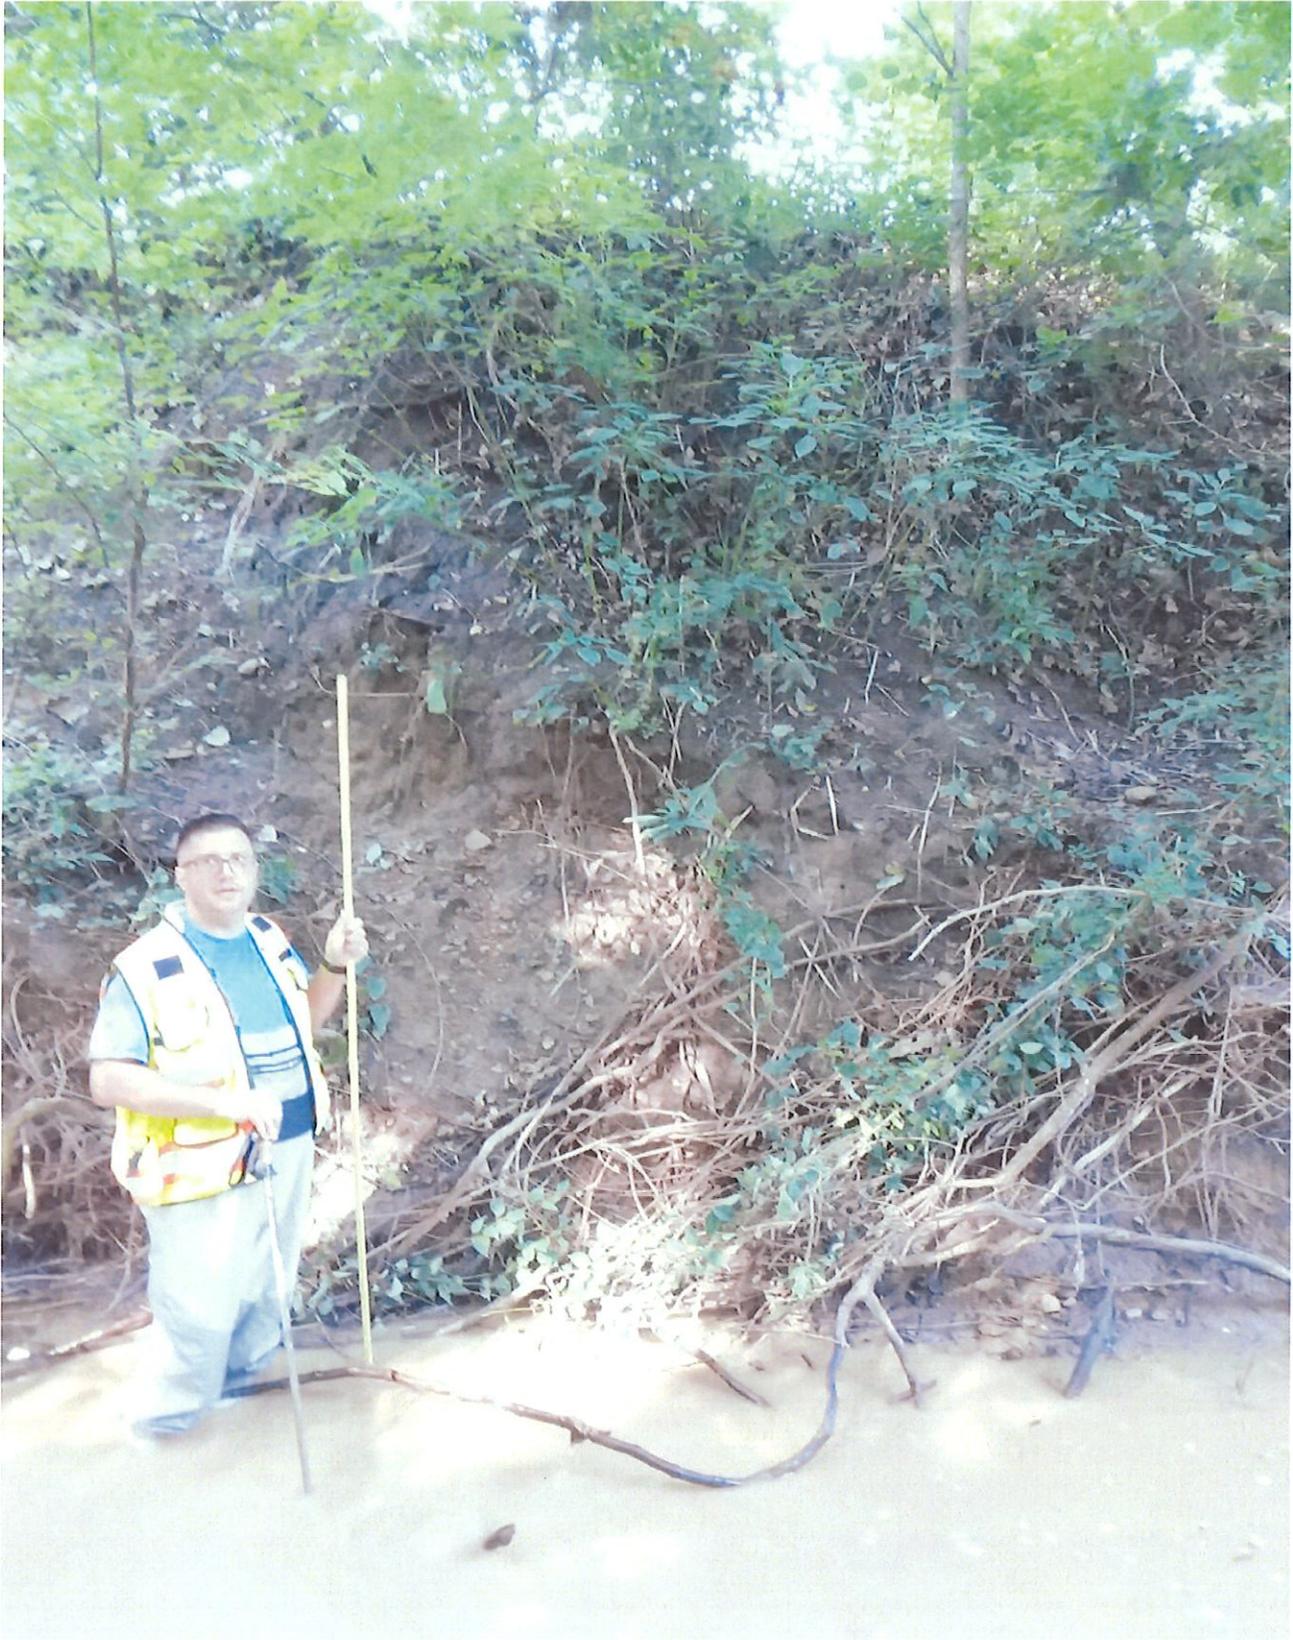
Station: **Section 25, Right Bank**

Bank Erosion Hazard Index (BEHI)							
Stream: Fetters Run				Location: Lancaster, Fairfield County, Ohio			
Station: Section 25, Right Bank				Observers: B. Petru, P. Renner			
Date: 8/2/2019		Stream Type:		Valley Type:			
Study Bank Height to Bankfull Height (C)							BEHI Score (Fig. 3-7)
Study Bank Height (ft) =	12.90 (A)	Bankfull Height (ft) =	3.60 (B)	$(A) / (B) =$	3.58 (C)	10.0	
Root Depth to Study Bank Height (E)							
Root Depth (ft) =	1.30 (D)	Study Bank Height (ft) =	12.90 (A)	$(D) / (A) =$	0.10 (E)	8.5	
Weighted Root Density (G)							
Root Density as % =	15.00 (F)	$(F) \times (E) =$	1.51163 (G)				10.0
Bank Angle (H)							
Bank Angle as Degrees =	65 (H)						4.5
Surface Protection (I)							
Surface Protection as % =	20% (I)						7.0
Bank Material Adjustment:							
Bedrock (Overall Very Low BEHI) Boulders (Overall Low BEHI) Cobble (Subtract 10 points if uniform medium to large cobble) Gravel or Composite Matrix (Add 5-10 points depending on percentage of bank material that is composed of sand) Sand (Add 10 points) Silt/Clay (no adjustment unless primarily clay, then subtract 20 points)				Bank Material Adjustment		10
