Fetters Run (College to Fair) Field Assessment

March 25, 2020

Hull & Associates, Inc.

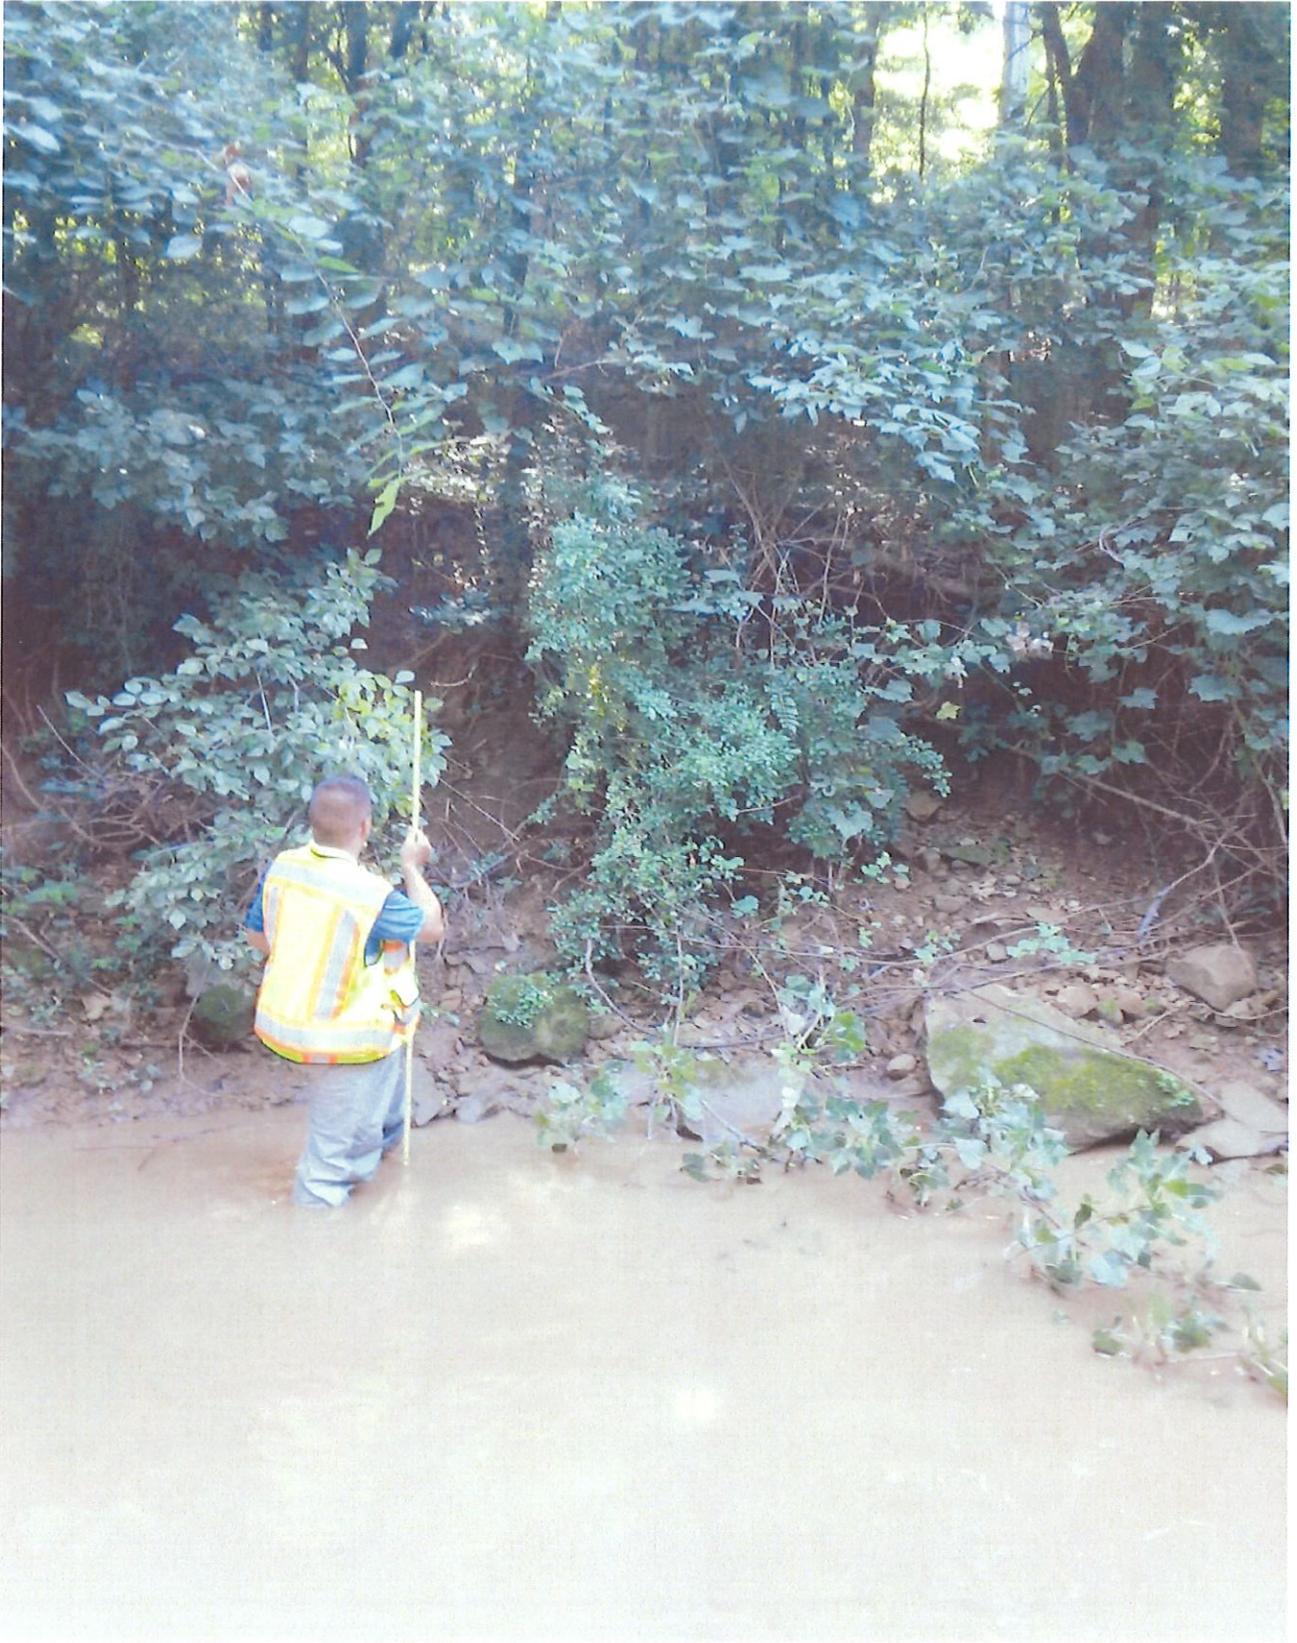
Section 26, Left Bank

Stratification Adjustment	9	
				Adjective Rating and Total Score		9	
Very Low	Low	Moderate	High	Very High	Extreme	Extreme	
5 – 9.5	10 – 19.5	20 – 29.5	30 – 39.5	40 – 45	46 – 50	58.0

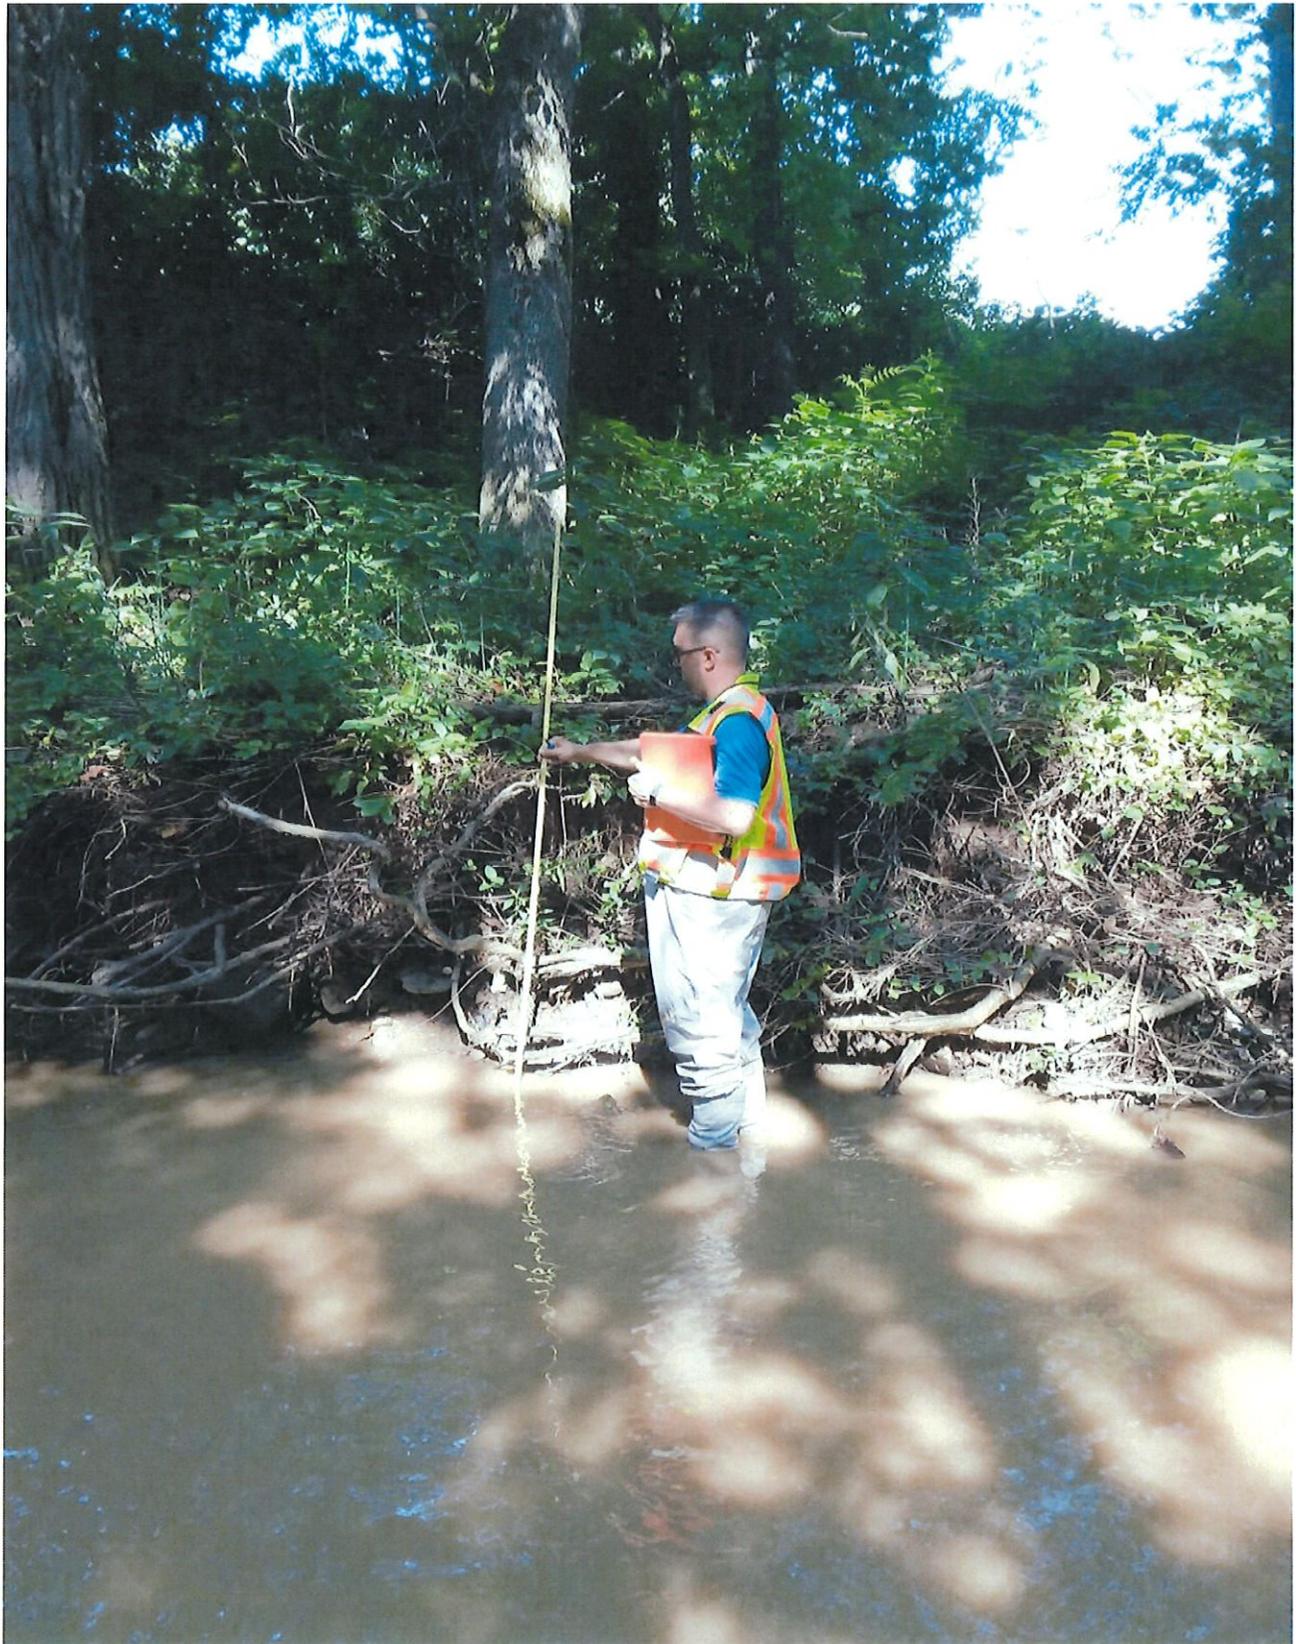
Bank Erosion Hazard Index (BEHI)						
Stream: Fetters Run			Location: Lancaster, Fairfield County, Ohio			
Station: Section 27, Right Bank			Observers: B. Petru, P. Renner			
Date: 8/2/2019		Stream Type:		Valley Type:		
Study Bank Height to Bankfull Height (C)						BEHI Score (Fig. 3-7)
Study Bank Height (ft) =	4.00 (A)	Bankfull Height (ft) =	2.50 (B)	$(A) / (B) =$	1.60 (C)	6.5
Root Depth to Study Bank Height (E)						
Root Depth (ft) =	2.60 (D)	Study Bank Height (ft) =	4.00 (A)	$(D) / (A) =$	0.65 (E)	3.0
Weighted Root Density (G)						
Root Density as % =	25.00 (F)			$(F) \times (E) =$	16.25 (G)	8.0
Bank Angle (H)						
		Bank Angle as Degrees =	55 (H)			3.5
Surface Protection (I)						
		Surface Protection as % =	30% (I)			6.0
Bank Material Adjustment:						
Bedrock (Overall Very Low BEHI) Boulders (Overall Low BEHI) Cobble (Subtract 10 points if uniform medium to large cobble) Gravel or Composite Matrix (Add 5–10 points depending on percentage of bank material that is composed of sand) Sand (Add 10 points) Silt/Clay (no adjustment unless primarily clay, then subtract 20 points)

Bank Material Adjustment						10
Stratification Adjustment						
Add 5–10 points, depending on position of unstable layers in relation to bankfull stage						6
Very Low	Low	Moderate	High	Very High	Extreme	Adjective Rating and Total Score
5 – 9.5	10 – 19.5	20 – 29.5	30 – 39.5	40 – 45	46 – 50	Very High 43.0

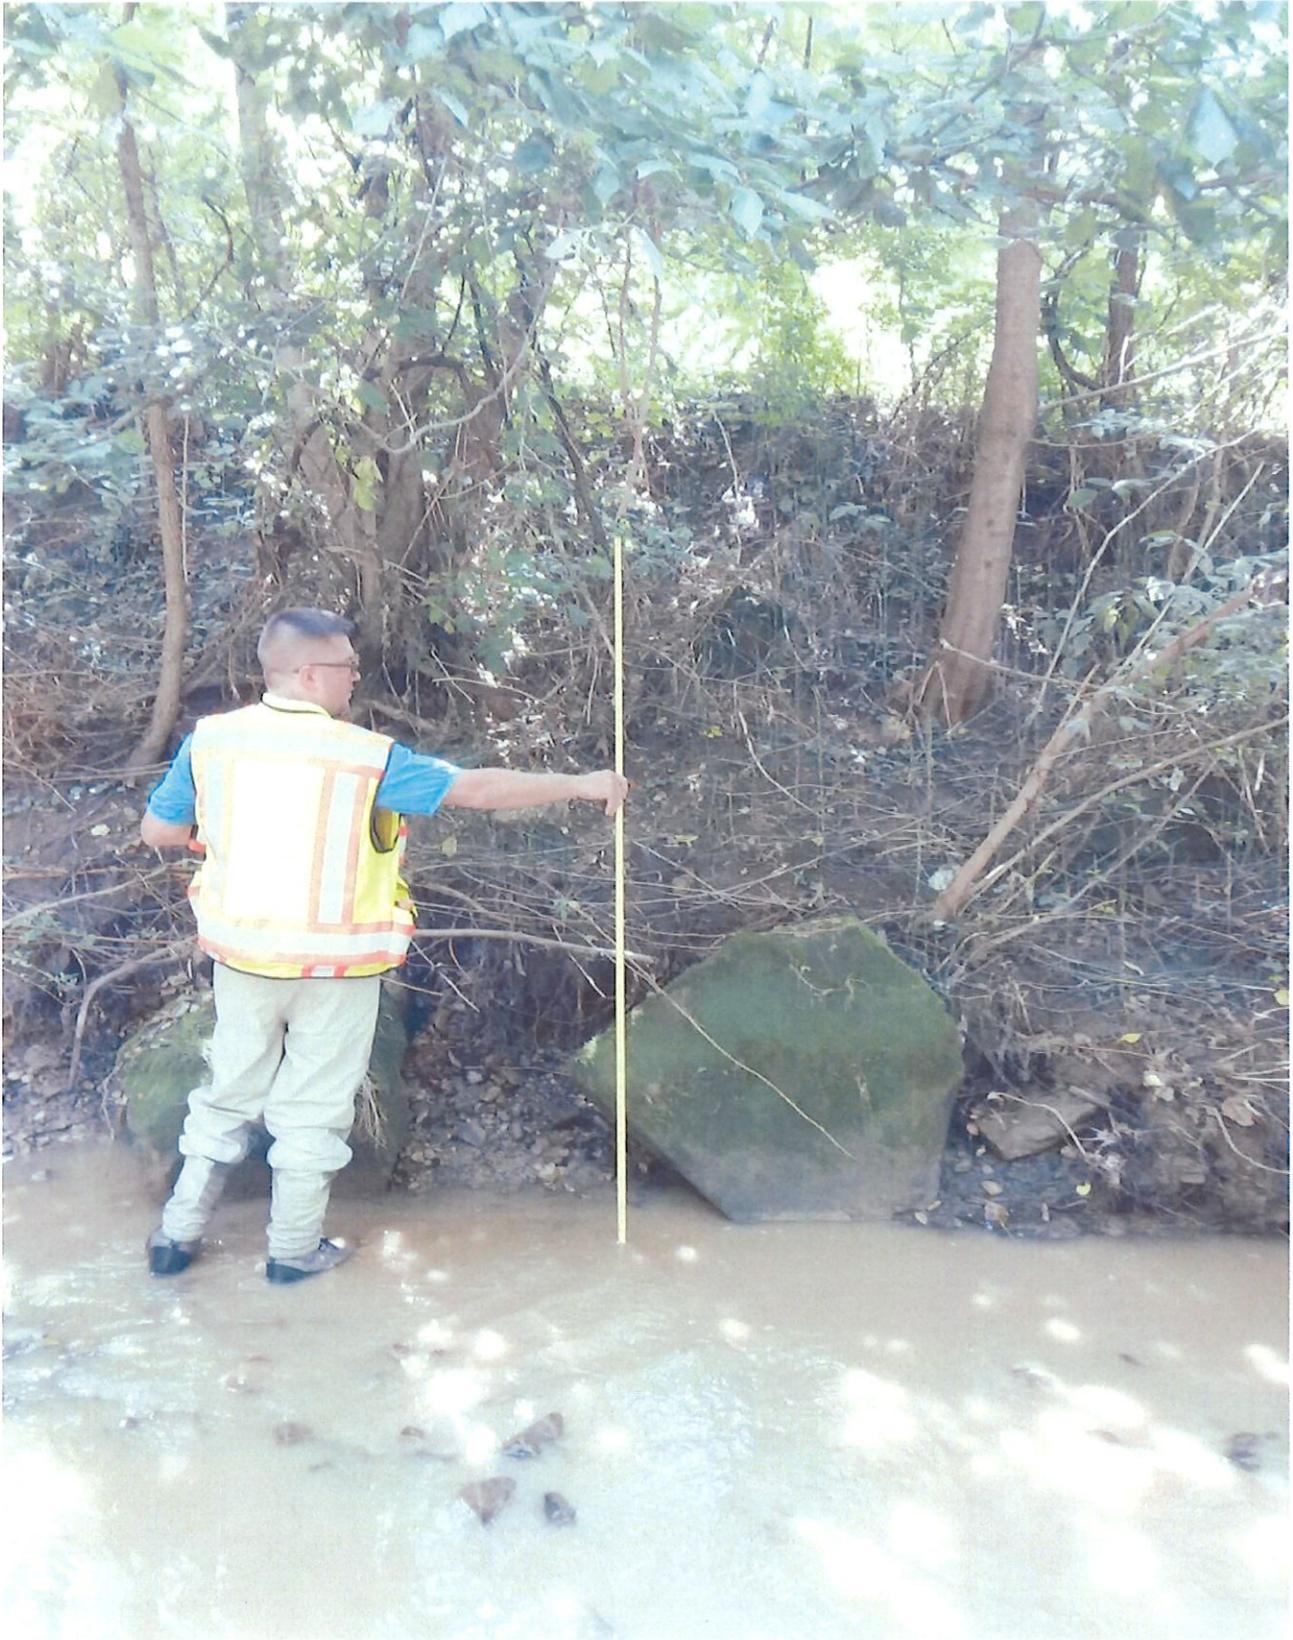
Bank Erosion Hazard Index (BEHI)																						
Stream: Fetters Run			Location: Lancaster, Fairfield County, Ohio																			
Station: Section 28, Left Bank			Observers: B. Petru, P. Renner																			
Date: 8/2/2019		Stream Type:		Valley Type:																		
Study Bank Height to Bankfull Height (C)						BEHI Score (Fig. 3-7)																
Study Bank Height (ft) =	10.50 (A)	Bankfull Height (ft) =	3.60 (B)	$(A) / (B) =$	2.92 (C)	9.0																
Root Depth to Study Bank Height (E)																						
Root Depth (ft) =	0.80 (D)	Study Bank Height (ft) =	10.50 (A)	$(D) / (A) =$	0.08 (E)	8.5																
Weighted Root Density (G)																						
Root Density as % =	15.00 (F)			$(F) \times (E) =$	1.14286 (G)	10.0																
Bank Angle (H)																						
Bank Angle as Degrees =	50 (H)					3.5																
Surface Protection (I)																						
Surface Protection as % =	25% (I)					6.5

Very Low	Low	Moderate	High	Very High	Extreme	Adjective Rating and Total Score	Extreme															
5 – 9.5	10 – 19.5	20 – 29.5	30 – 39.5	40 – 45	46 – 50	57.5

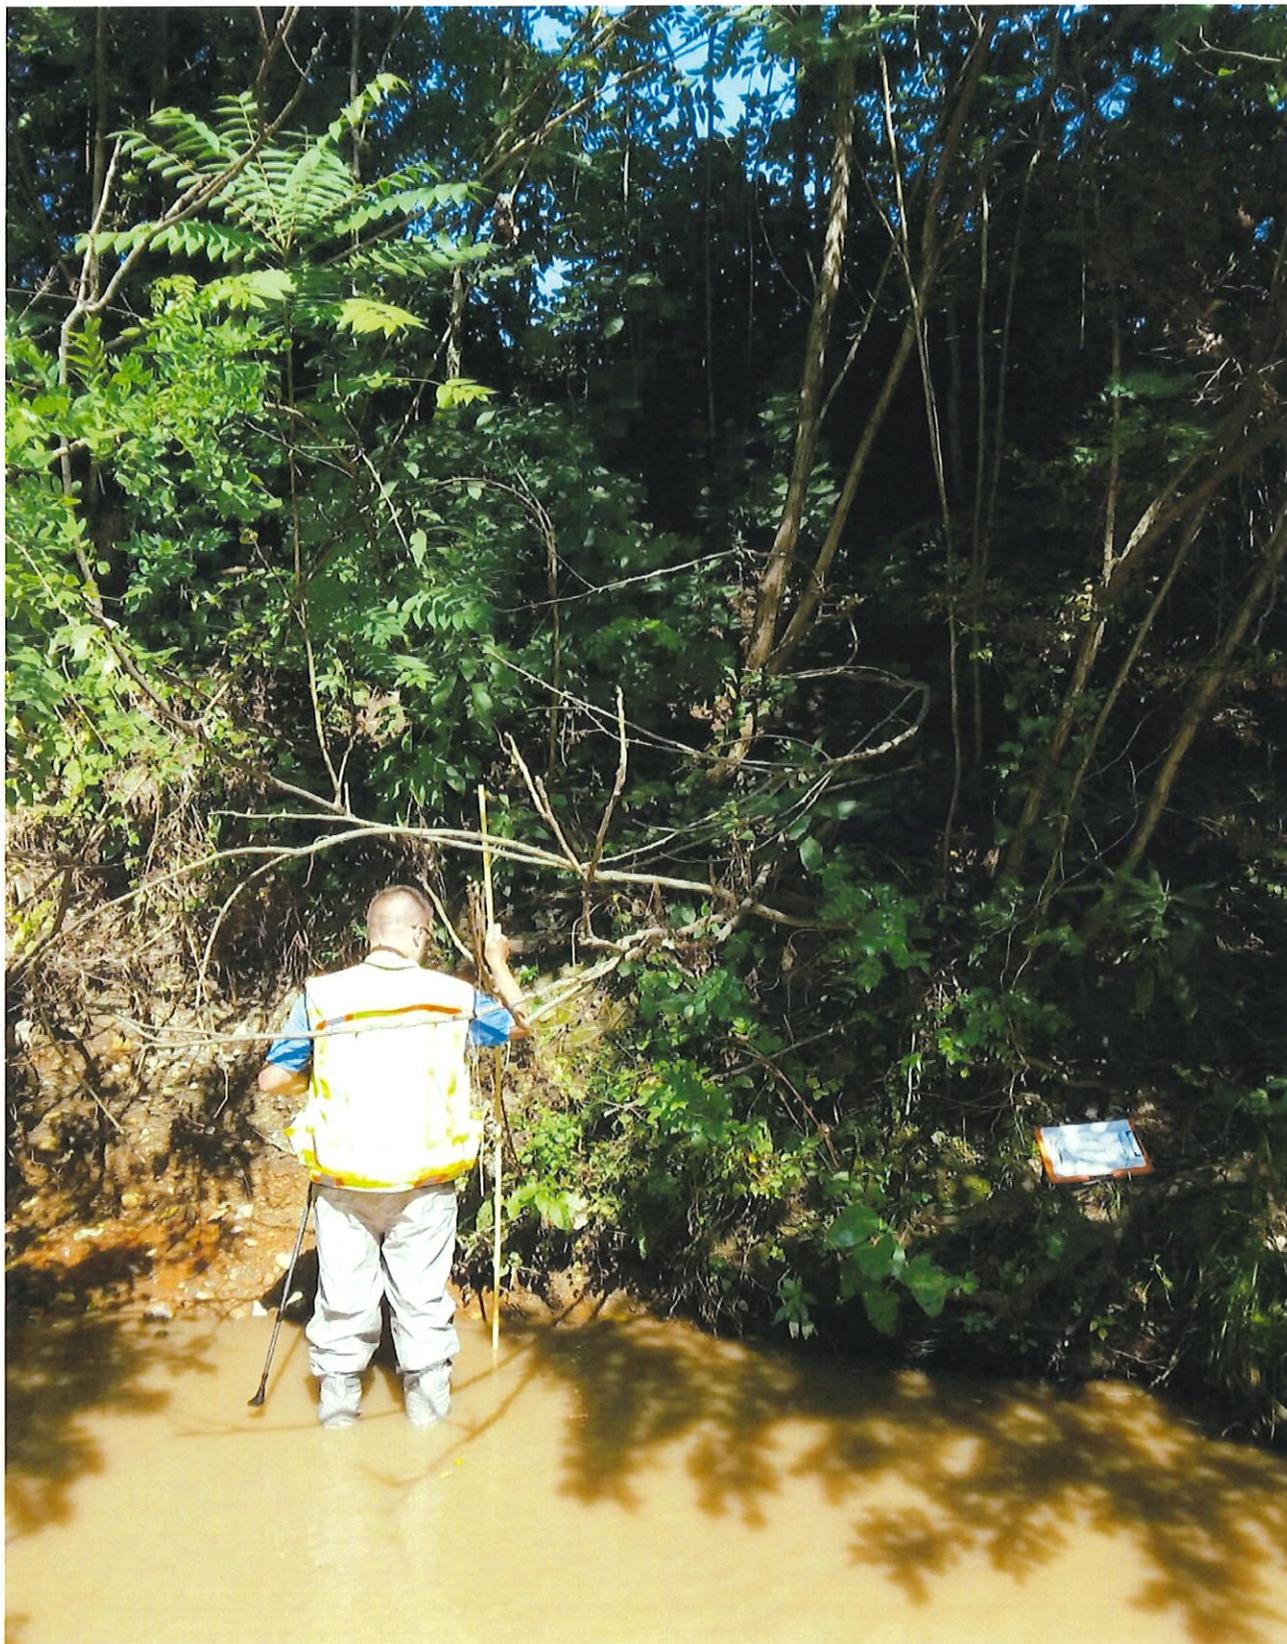
Bank Erosion Hazard Index (BEHI)								
Stream: Fetters Run				Location: Lancaster, Fairfield County, Ohio				
Station: Section 29, Right Bank				Observers: B. Petru, P. Renner				
Date: 8/2/2019		Stream Type:		Valley Type:				
Study Bank Height to Bankfull Height (C)							BEHI Score (Fig. 3-7)	
Study Bank Height (ft) =	14.00 (A)	Bankfull Height (ft) =	3.40 (B)	$(A) / (B) =$	4.12 (C)	10.0		
Root Depth to Study Bank Height (E)								
Root Depth (ft) =	2.00 (D)	Study Bank Height (ft) =	14.00 (A)	$(D) / (A) =$	0.14 (E)	8.0		
Weighted Root Density (G)								
Root Density as % =	20.00 (F)	$(F) \times (E) =$				2.85714 (G)	9.5	
Bank Angle (H)								
Bank Angle as Degrees =	85 (H)					7.0		
Surface Protection (I)								
Surface Protection as % =	25% (I)					6.5		
Bank Material Adjustment:								
Bedrock (Overall Very Low BEHI) Boulders (Overall Low BEHI) Cobble (Subtract 10 points if uniform medium to large cobble) Gravel or Composite Matrix (Add 5–10 points depending on percentage of bank material that is composed of sand) Sand (Add 10 points) Silt/Clay (no adjustment unless primarily clay, then subtract 20 points)							Bank Material Adjustment	10

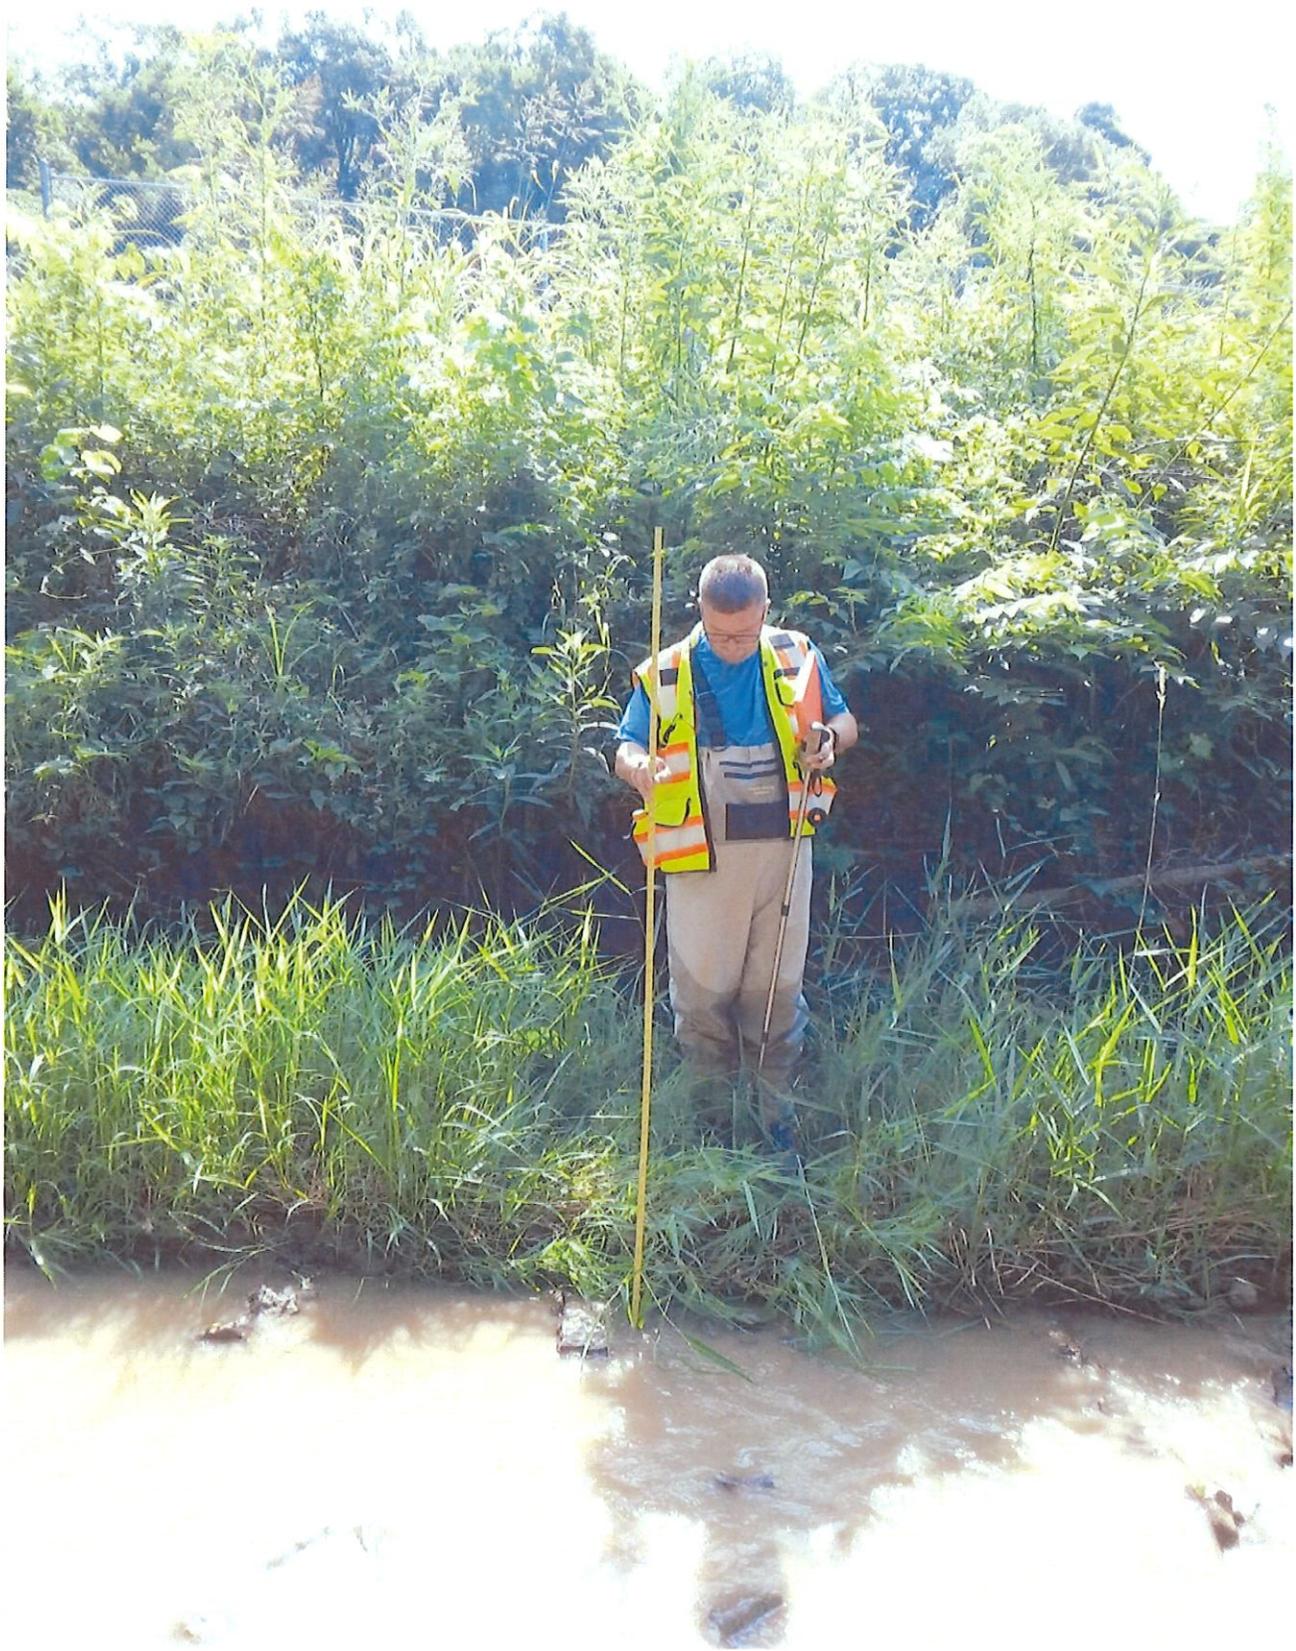
Bank Erosion Hazard Index (BEHI)						
Stream: Fetters Run			Location: Lancaster, Fairfield County, Ohio			
Station: Section 30, Left Bank			Observers: B. Petru, P. Renner			
Date: 8/2/2019		Stream Type:		Valley Type:		
Study Bank Height to Bankfull Height (C)						BEHI Score (Fig. 3-7)
Study Bank Height (ft) =	5.80 (A)	Bankfull Height (ft) =	3.50 (B)	$(A) / (B) =$	1.66 (C)	6.5
Root Depth to Study Bank Height (E)						
Root Depth (ft) =	1.80 (D)	Study Bank Height (ft) =	5.80 (A)	$(D) / (A) =$	0.31 (E)	5.5
Weighted Root Density (G)						
Root Density as % =	25.00 (F)	$(F) \times (E) =$			7.75862 (G)	9.0
Bank Angle (H)						
Bank Angle as Degrees =	70 (H)				4.5	
Surface Protection (I)						
Surface Protection as % =	60% (I)				3.5	
Bank Material Adjustment:						
Bedrock (Overall Very Low BEHI) Boulders (Overall Low BEHI) Cobble (Subtract 10 points if uniform medium to large cobble) Gravel or Composite Matrix (Add 5–10 points depending on percentage of bank material that is composed of sand) Sand (Add 10 points) Silt/Clay (no adjustment unless primarily clay, then subtract 20 points)				Bank Material Adjustment		8

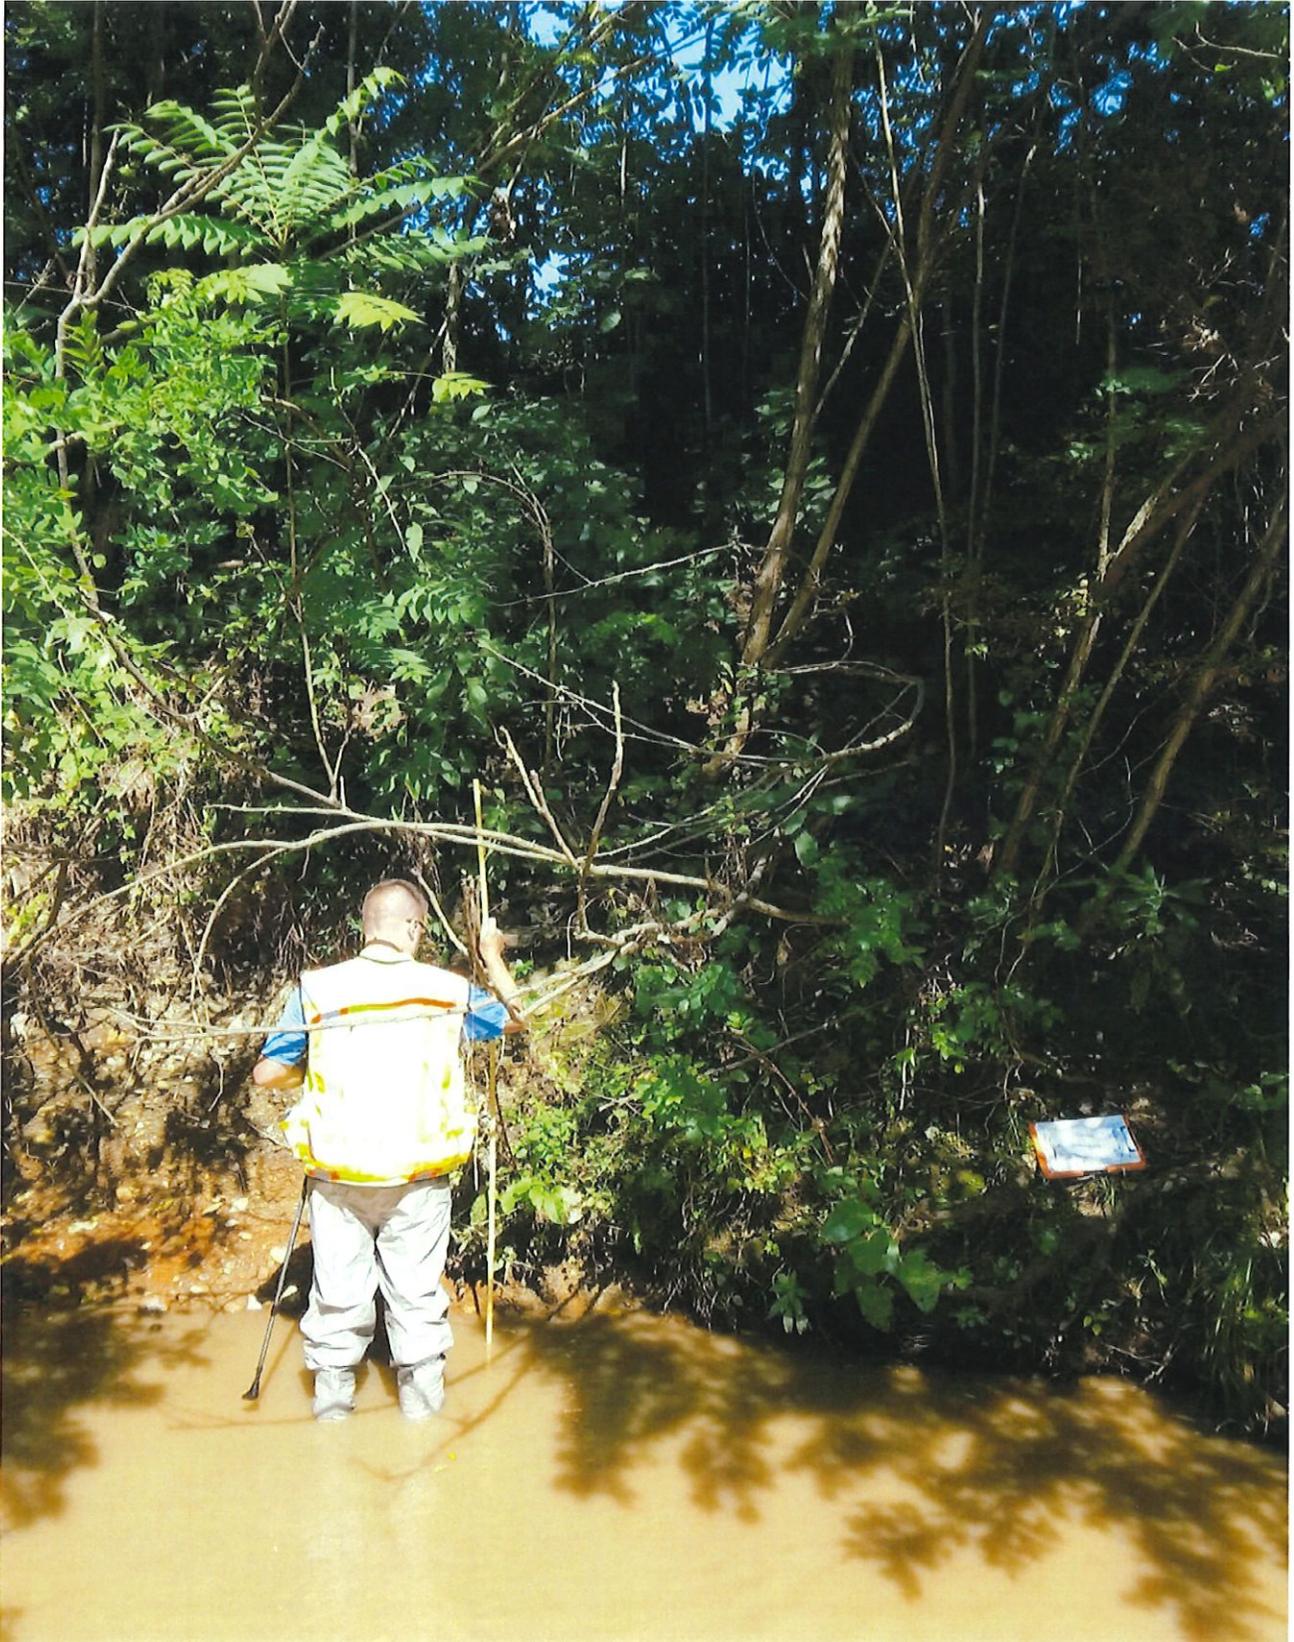
Bank Erosion Hazard Index (BEHI)						
Stream: Fetters Run			Location: Lancaster, Fairfield County, Ohio			
Station: Section 30, Right Bank			Observers: B. Petru, P. Renner			
Date: 8/2/2019		Stream Type:		Valley Type:		
Study Bank Height to Bankfull Height (C)						BEHI Score (Fig. 3-7)
Study Bank Height (ft) =	14.00 (A)	Bankfull Height (ft) =	3.40 (B)	$(A) / (B) =$	4.12 (C)	10.0
Root Depth to Study Bank Height (E)						
Root Depth (ft) =	2.00 (D)	Study Bank Height (ft) =	14.00 (A)	$(D) / (A) =$	0.14 (E)	8.0
Weighted Root Density (G)						
Root Density as % =	20.00 (F)	$(F) \times (E) =$			2.85714 (G)	9.5
Bank Angle (H)						
Bank Angle as Degrees =	85 (H)				7.0	
Surface Protection (I)						
Surface Protection as % =	25% (I)				6.5	
Bank Material Adjustment:						
Bedrock (Overall Very Low BEHI) Boulders (Overall Low BEHI) Cobble (Subtract 10 points if uniform medium to large cobble) Gravel or Composite Matrix (Add 5–10 points depending on percentage of bank material that is composed of sand) Sand (Add 10 points) Silt/Clay (no adjustment unless primarily clay, then subtract 20 points)					Bank Material Adjustment	10

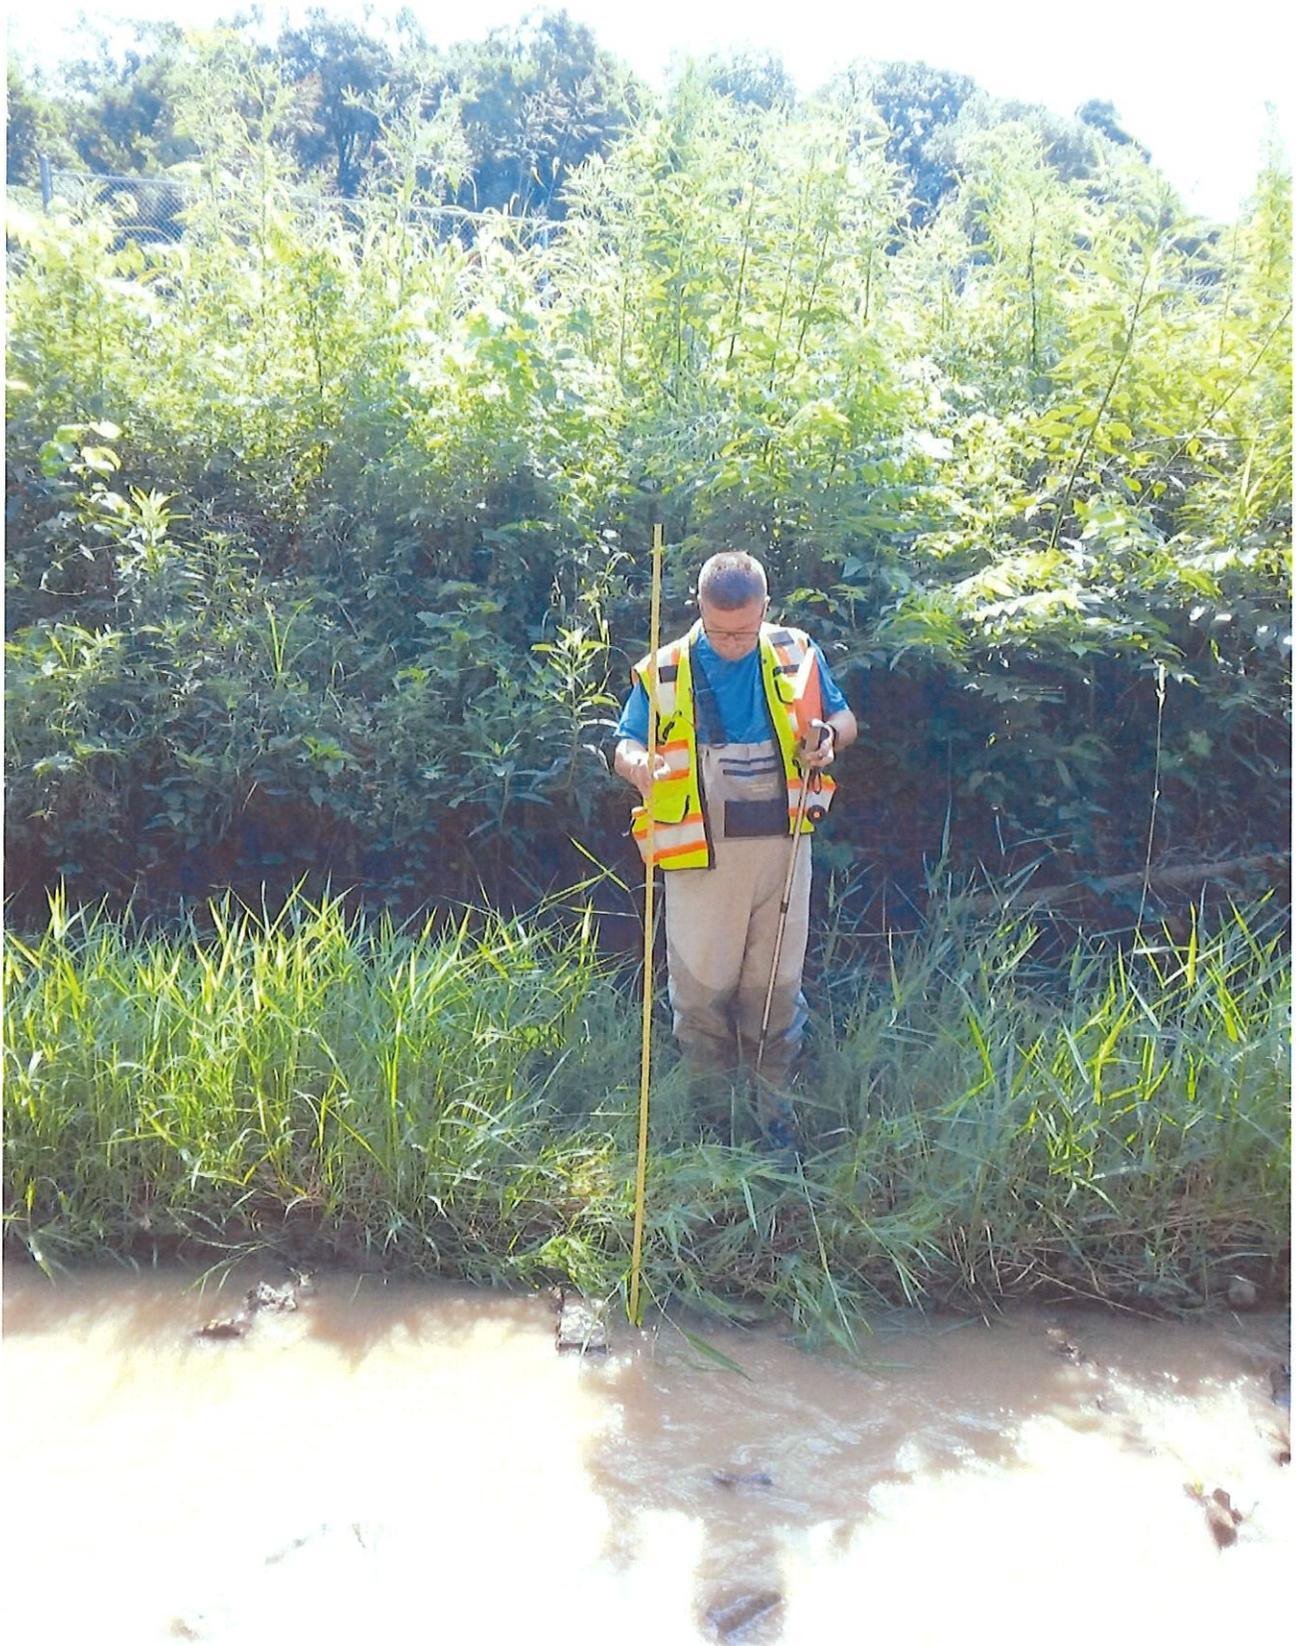
Bank Erosion Hazard Index (BEHI)									
Stream: Fetters Run					Location: Lancaster, Fairfield County, Ohio				
Station: Section 31, Left Bank					Observers: B. Petru, P. Renner				
Date: 8/2/2019			Stream Type:			Valley Type:			
Study Bank Height to Bankfull Height (C)								BEHI Score (Fig. 3-7)	
Study Bank Height (ft) =	5.80 (A)	Bankfull Height (ft) =	3.50 (B)	(A) / (B) =		1.66 (C)	6.5		
Root Depth to Study Bank Height (E)									
Root Depth (ft) =	1.80 (D)	Study Bank Height (ft) =	5.80 (A)	(D) / (A) =		0.31 (E)	5.5		
Weighted Root Density (G)									
Root Density as % =	25.00 (F)			(F) × (E) =		7.75862 (G)	9.0		
Bank Angle (H)									
		Bank Angle as Degrees =	70 (H)				4.5		
Surface Protection (I)									
		Surface Protection as % =	60% (I)				3.5		
Bank Material Adjustment:					Bank Material Adjustment				
Bedrock (Overall Very Low BEHI)					<div style="border: 1px solid black; padding: 5px; width: fit-content; margin: auto;"> Stratification Adjustment Add 5–10 points, depending on position of unstable layers in relation to bankfull stage </div>

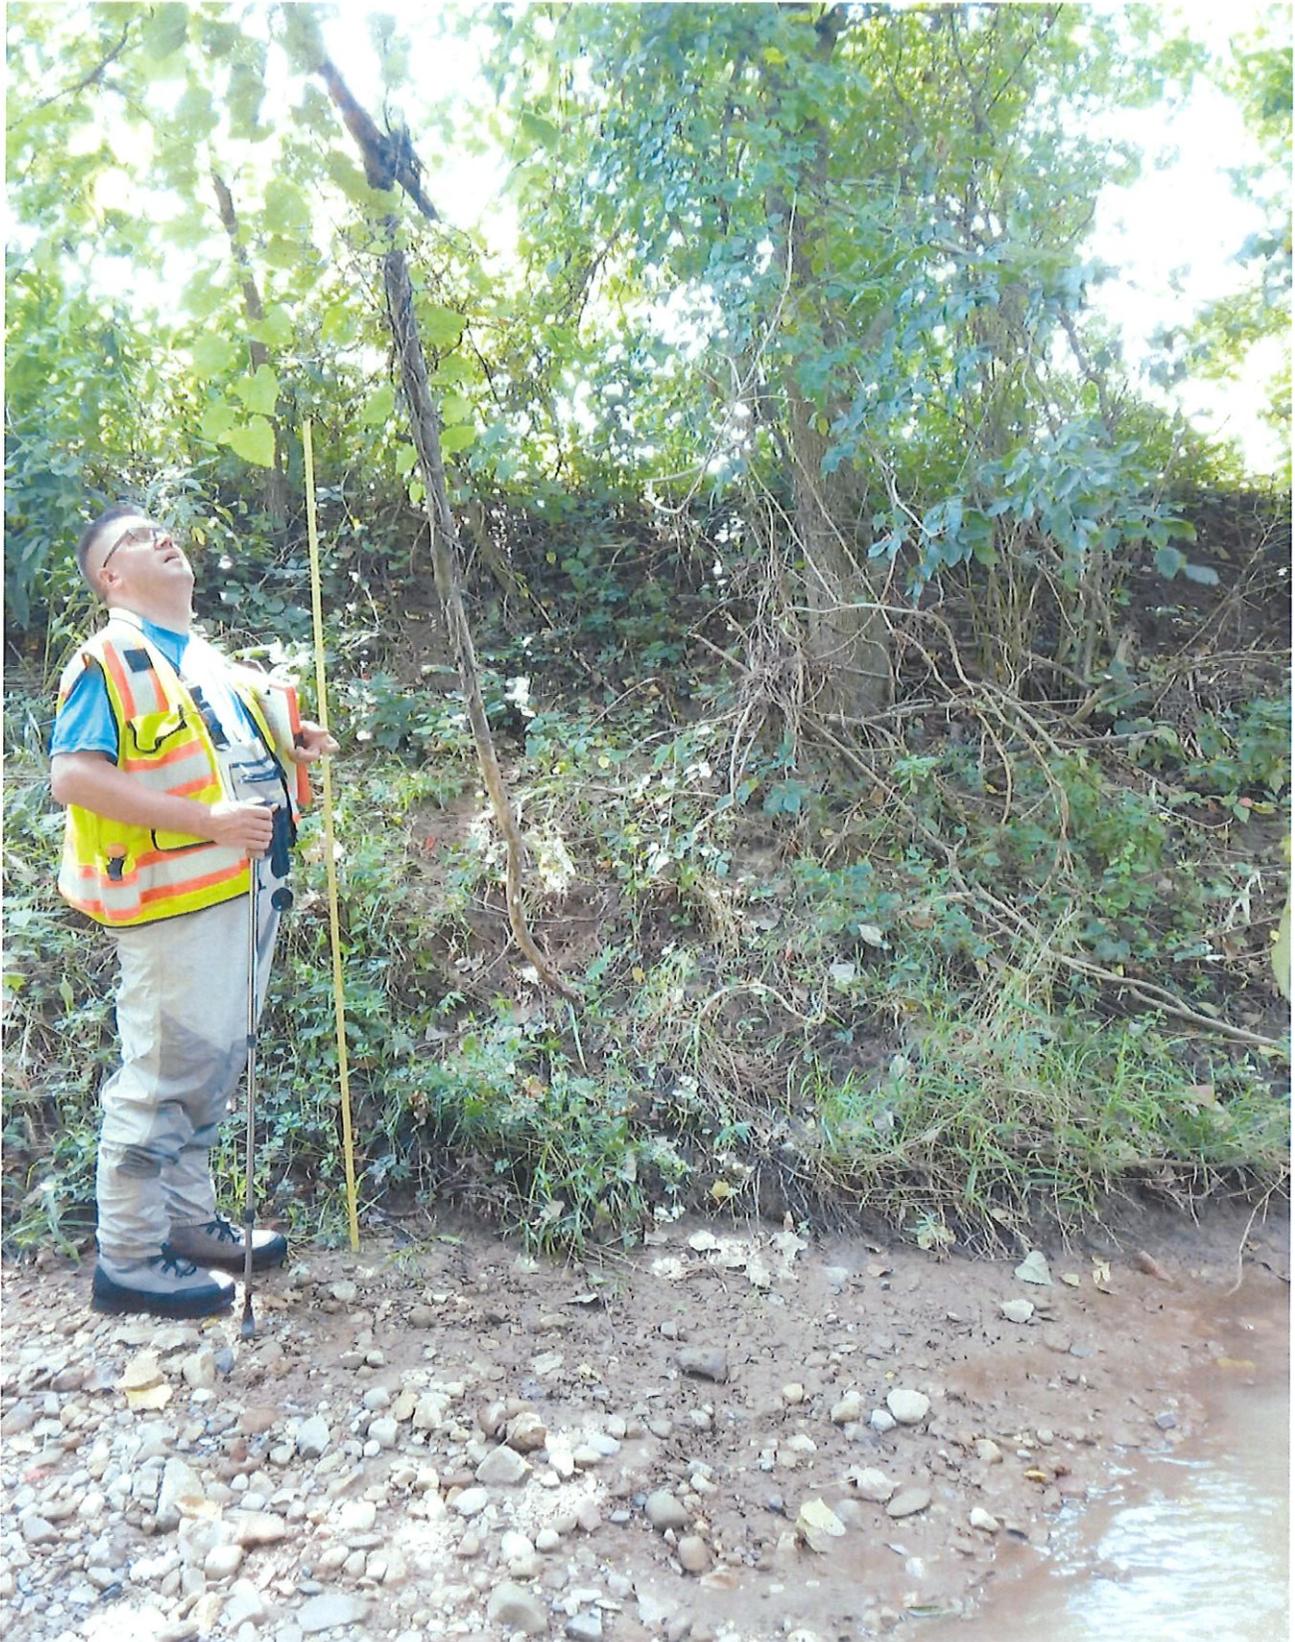
Bank Erosion Hazard Index (BEHI)							
Stream: Fetters Run			Location: Lancaster, Fairfield County, Ohio				
Station: Section 32, Left Bank			Observers: B. Petru, P. Renner				
Date: 8/2/2019		Stream Type:		Valley Type:			
Study Bank Height to Bankfull Height (C)						BEHI Score (Fig. 3-7)	
Study Bank Height (ft) =	8.60 (A)	Bankfull Height (ft) =	3.10 (B)	(A) / (B) =	2.77 (C)	9.0	
Root Depth to Study Bank Height (E)							
Root Depth (ft) =	0.60 (D)	Study Bank Height (ft) =	8.60 (A)	(D) / (A) =	0.07 (E)	8.5	
Weighted Root Density (G)							
Root Density as % =	10.00 (F)	(F) × (E) =			0.69767 (G)	10.0	
Bank Angle (H)							
Bank Angle as Degrees =	50 (H)				3.5		
Surface Protection (I)							
Surface Protection as % =	40% (I)				5.0		
Bank Material Adjustment:							
<ul style="list-style-type: none"> Bedrock (Overall Very Low BEHI) Boulders (Overall Low BEHI) Cobble (Subtract 10 points if uniform medium to large cobble) Gravel or Composite Matrix (Add 5–10 points depending on percentage of bank material that is composed of sand) Sand (Add 10 points) Silt/Clay (no adjustment unless primarily clay, then subtract 20 points) 						Bank Material Adjustment	10

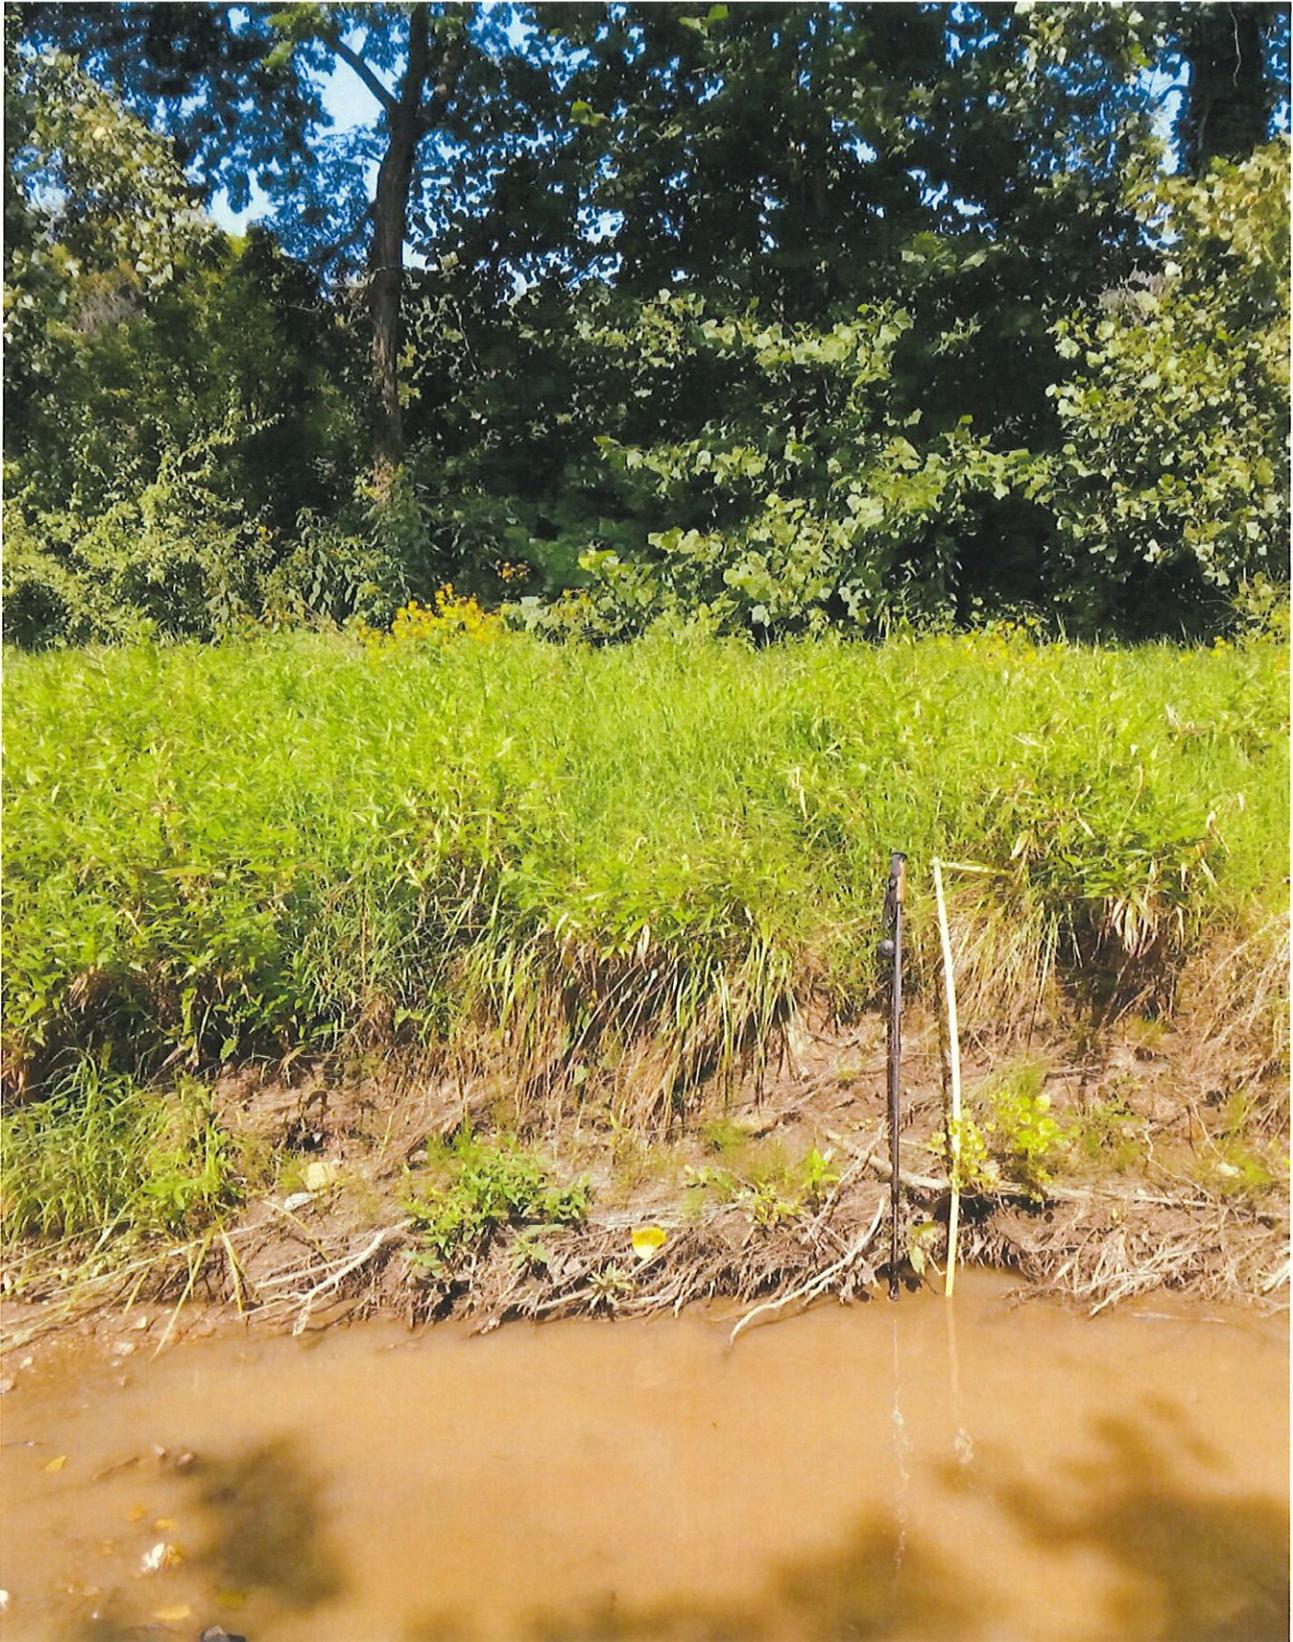
Bank Erosion Hazard Index (BEHI)							
Stream: Fetters Run			Location: Lancaster, Fairfield County, Ohio				
Station: Section 32, Right Bank			Observers: B. Petru, P. Renner				
Date: 8/2/2019		Stream Type:			Valley Type:		
Study Bank Height to Bankfull Height (C)							BEHI Score (Fig. 3-7)
Study Bank Height (ft) =	4.00 (A)	Bankfull Height (ft) =	3.00 (B)	$(A) / (B) =$	1.33 (C)	5.0	
Root Depth to Study Bank Height (E)							
Root Depth (ft) =	0.70 (D)	Study Bank Height (ft) =	4.00 (A)	$(D) / (A) =$	0.18 (E)	7.5	
Weighted Root Density (G)							
Root Density as % =	15.00 (F)	$(F) \times (E) =$			2.625 (G)	9.5	
Bank Angle (H)							
Bank Angle as Degrees =	90 (H)					8.0	
Surface Protection (I)							
Surface Protection as % =	25% (I)					6.5	
Bank Material Adjustment:							
<ul style="list-style-type: none"> Bedrock (Overall Very Low BEHI) Boulders (Overall Low BEHI) Cobble (Subtract 10 points if uniform medium to large cobble) Gravel or Composite Matrix (Add 5–10 points depending on percentage of bank material that is composed of sand) Sand (Add 10 points) Silt/Clay (no adjustment unless primarily clay, then subtract 20 points)
