Fetters Run (College to Fair) Field Assessment

March 25, 2020

Hull & Associates, Inc.

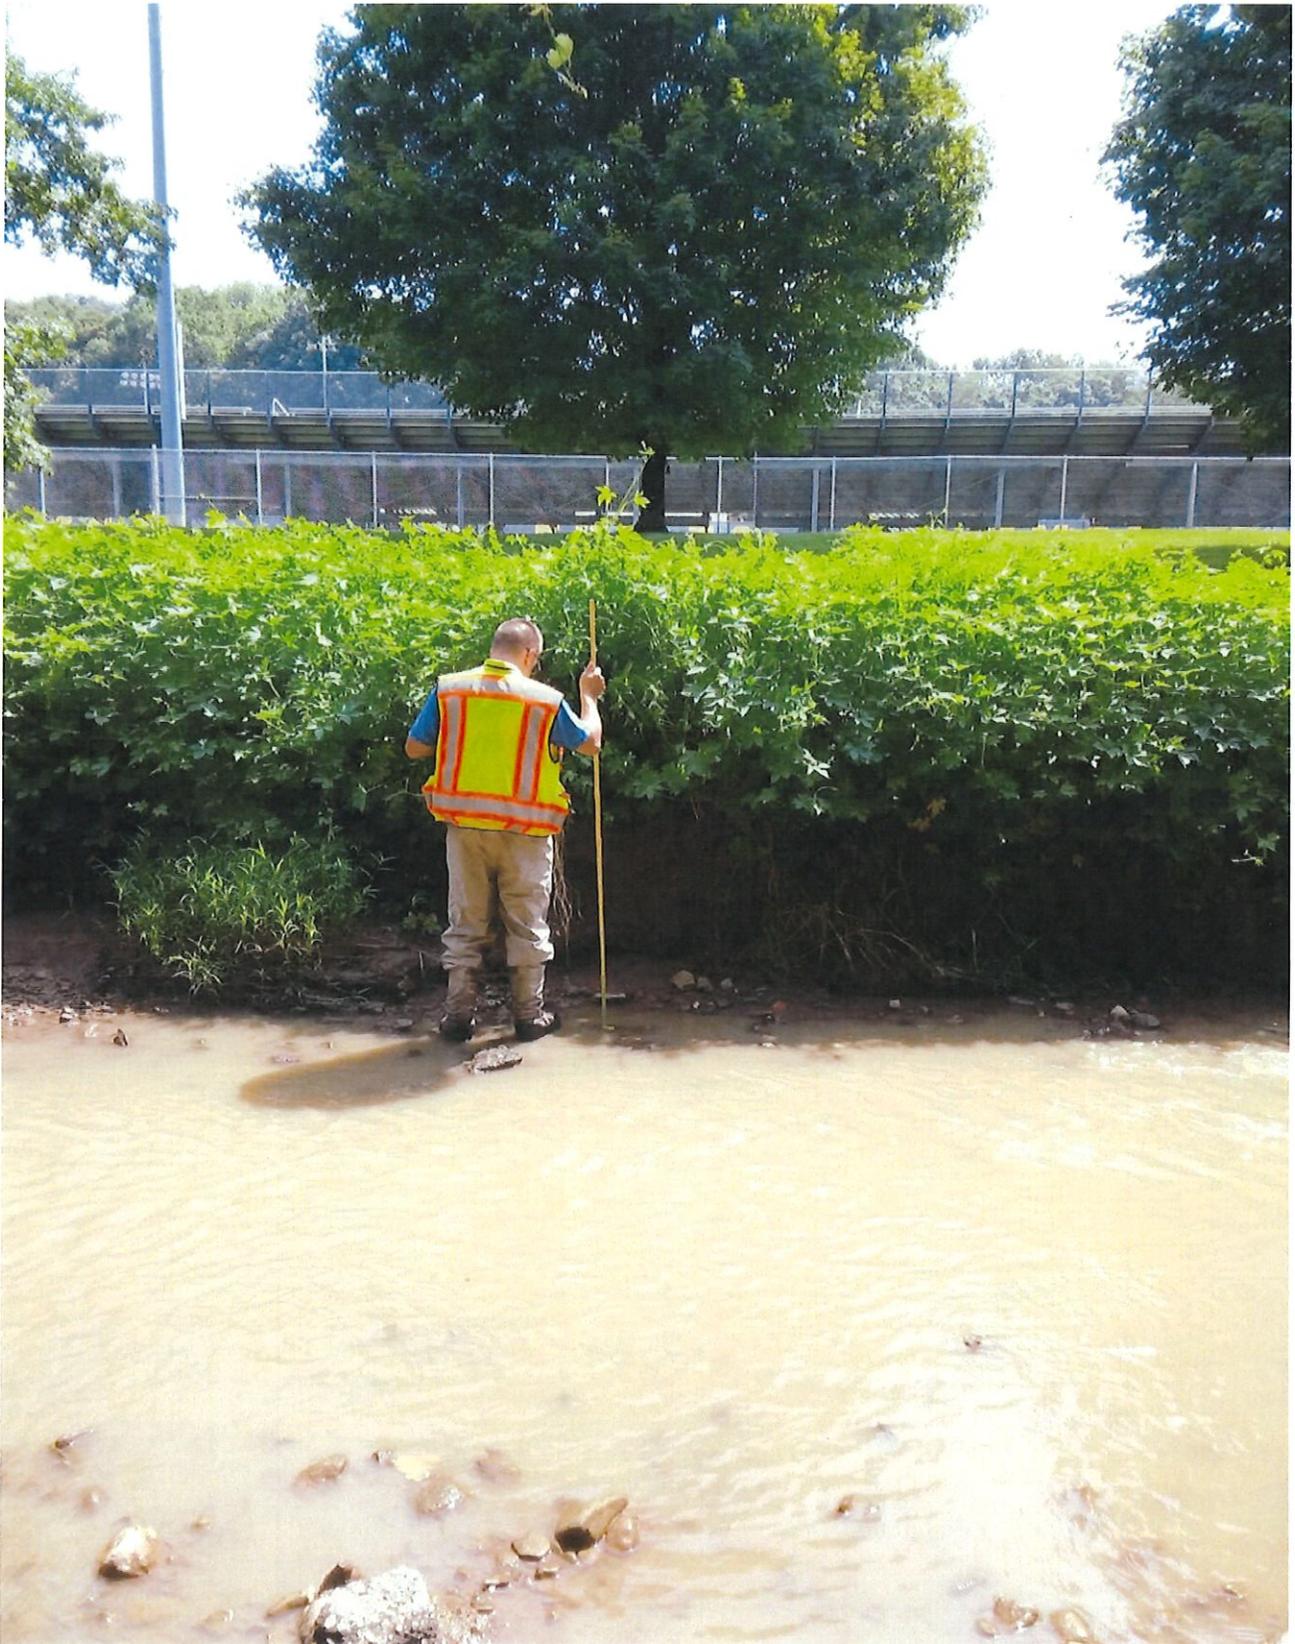
Bank Erosion Hazard Index (BEHI)							
Stream: Fetters Run				Location: Lancaster, Fairfield County, Ohio			
Station: Section 33, Left Bank				Observers: B. Petru, P. Renner			
Date: 8/2/2019		Stream Type:		Valley Type:			
Study Bank Height to Bankfull Height (C)							BEHI Score (Fig. 3-7)
Study Bank Height (ft) =	4.50 (A)	Bankfull Height (ft) =	2.90 (B)	$(A) / (B) =$		1.55 (C)	6.0
Root Depth to Study Bank Height (E)							
Root Depth (ft) =	2.00 (D)	Study Bank Height (ft) =	4.50 (A)	$(D) / (A) =$		0.44 (E)	4.5
Weighted Root Density (G)							
Root Density as % =	5.00 (F)	$(F) \times (E) =$				2.22222 (G)	9.5
Bank Angle (H)							
Bank Angle as Degrees =	90 (H)					8.0	
Surface Protection (I)							
Surface Protection as % =	5% (I)					10.0	
Bank Material Adjustment:							
<ul style="list-style-type: none"> Bedrock (Overall Very Low BEHI) Boulders (Overall Low BEHI) Cobble (Subtract 10 points if uniform medium to large cobble) Gravel or Composite Matrix (Add 5–10 points depending on percentage of bank material that is composed of sand) Sand (Add 10 points) Silt/Clay (no adjustment unless primarily clay, then subtract 20 points)

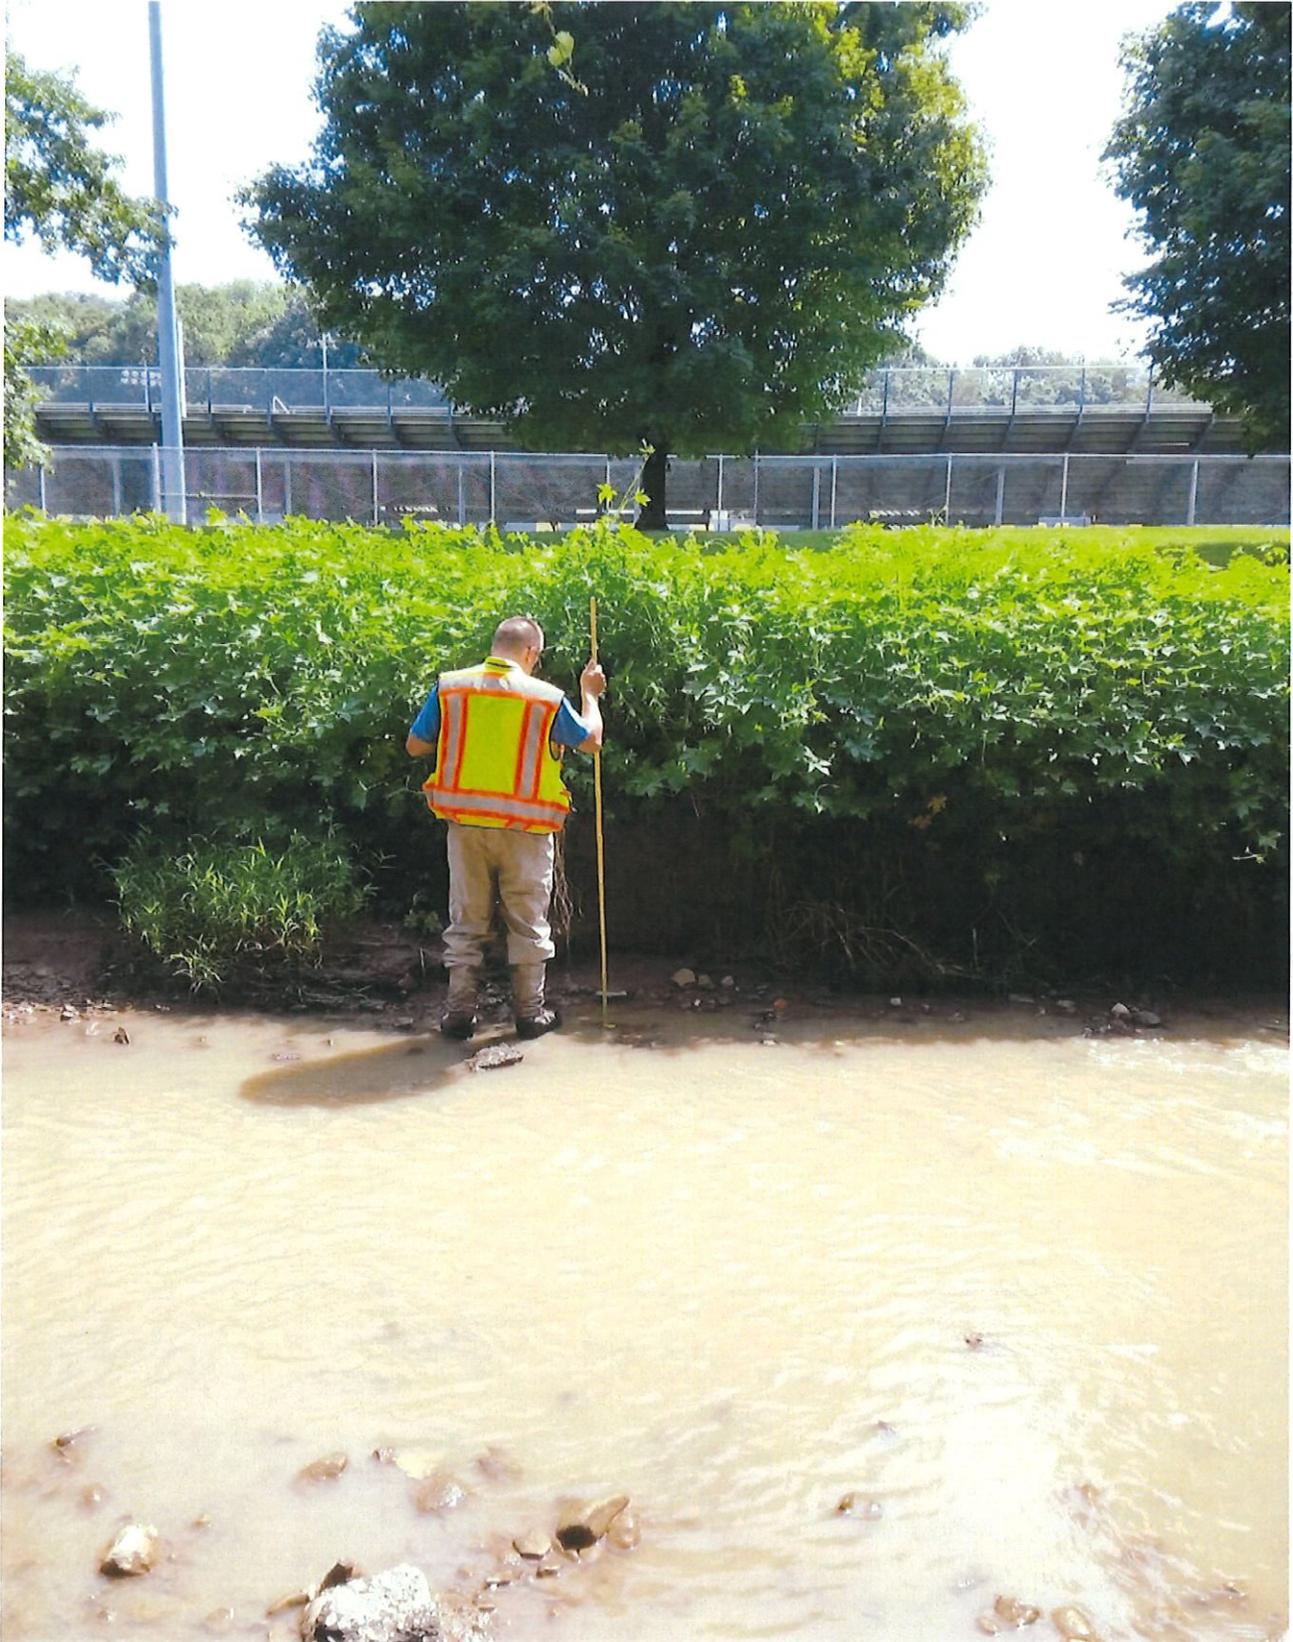
Bank Erosion Hazard Index (BEHI)								
Stream: Fetters Run				Location: Lancaster, Fairfield County, Ohio				
Station: Section 34, Left Bank				Observers: B. Petru, P. Renner				
Date: 8/2/2019		Stream Type:		Valley Type:				
Study Bank Height to Bankfull Height (C)							BEHI Score (Fig. 3-7)	
Study Bank Height (ft) =	4.50 (A)	Bankfull Height (ft) =	2.90 (B)	$(A) / (B) =$	1.55 (C)	6.0		
Root Depth to Study Bank Height (E)								
Root Depth (ft) =	2.00 (D)	Study Bank Height (ft) =	4.50 (A)	$(D) / (A) =$	0.44 (E)	4.5		
Weighted Root Density (G)								
Root Density as % =	5.00 (F)	$(F) \times (E) =$			2.22222 (G)	9.5		
Bank Angle (H)								
Bank Angle as Degrees =	90 (H)				8.0			
Surface Protection (I)								
Surface Protection as % =	5% (I)				10.0			
Bank Material Adjustment:								
<ul style="list-style-type: none"> Bedrock (Overall Very Low BEHI) Boulders (Overall Low BEHI) Cobble (Subtract 10 points if uniform medium to large cobble) Gravel or Composite Matrix (Add 5–10 points depending on percentage of bank material that is composed of sand) Sand (Add 10 points) Silt/Clay (no adjustment unless primarily clay, then subtract 20 points) 							Bank Material Adjustment	10

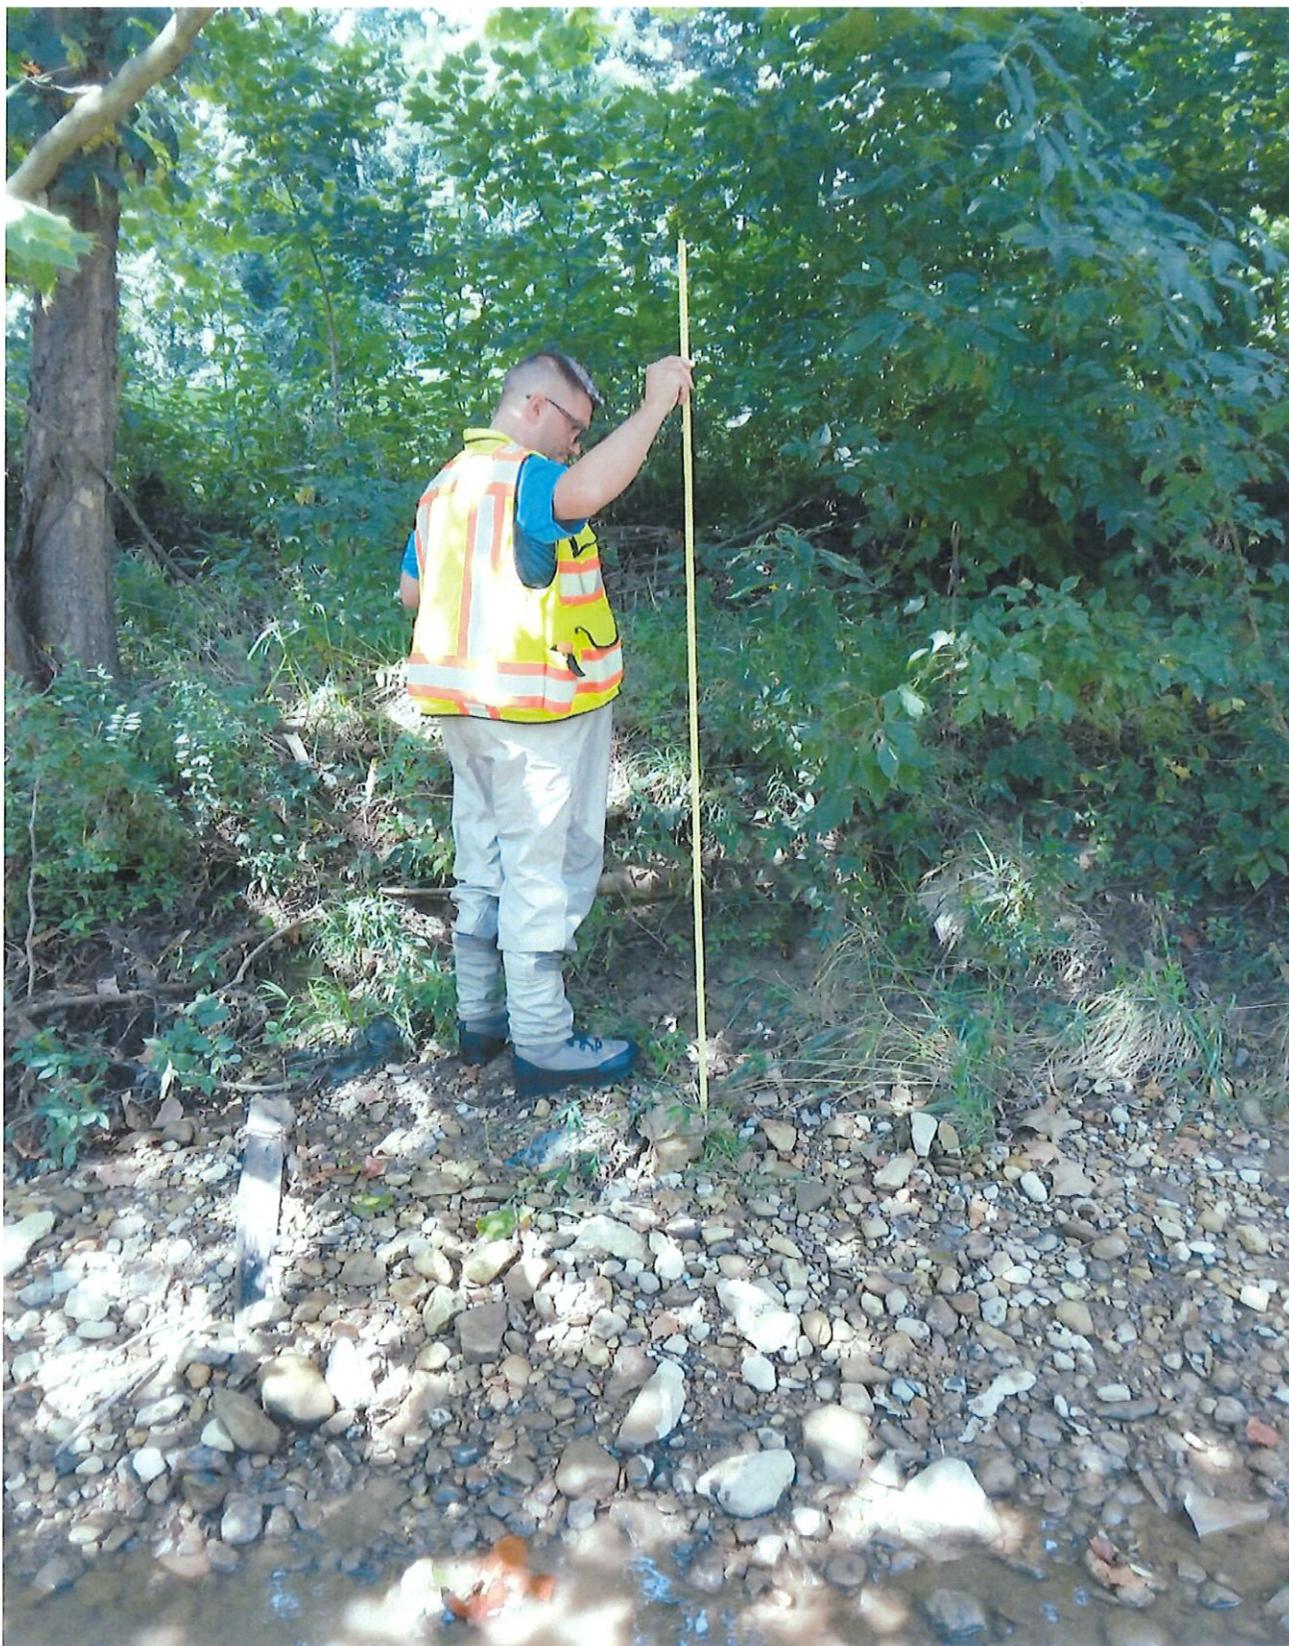
Bank Erosion Hazard Index (BEHI)							
Stream: Fetters Run				Location: Lancaster, Fairfield County, Ohio			
Station: Section 34, Right Bank				Observers: B. Petru, P. Renner			
Date: 8/2/2019		Stream Type:		Valley Type:			
Study Bank Height to Bankfull Height (C)							BEHI Score (Fig. 3-7)
Study Bank Height (ft) =	3.50 (A)	Bankfull Height (ft) =	2.30 (B)	$(A) / (B) =$	1.52 (C)	6.0	
Root Depth to Study Bank Height (E)							
Root Depth (ft) =	0.90 (D)	Study Bank Height (ft) =	3.50 (A)	$(D) / (A) =$	0.26 (E)	6.5	
Weighted Root Density (G)							
Root Density as % =	15.00 (F)	$(F) \times (E) =$			3.85714 (G)	9.5	
Bank Angle (H)							
Bank Angle as Degrees =	60 (H)					4.0	
Surface Protection (I)							
Surface Protection as % =	20% (I)					7.0	
Bank Material Adjustment:							
<ul style="list-style-type: none"> Bedrock (Overall Very Low BEHI) Boulders (Overall Low BEHI) Cobble (Subtract 10 points if uniform medium to large cobble) Gravel or Composite Matrix (Add 5–10 points depending on percentage of bank material that is composed of sand) Sand (Add 10 points) Silt/Clay (no adjustment unless primarily clay, then subtract 20 points) 				Bank Material Adjustment		10

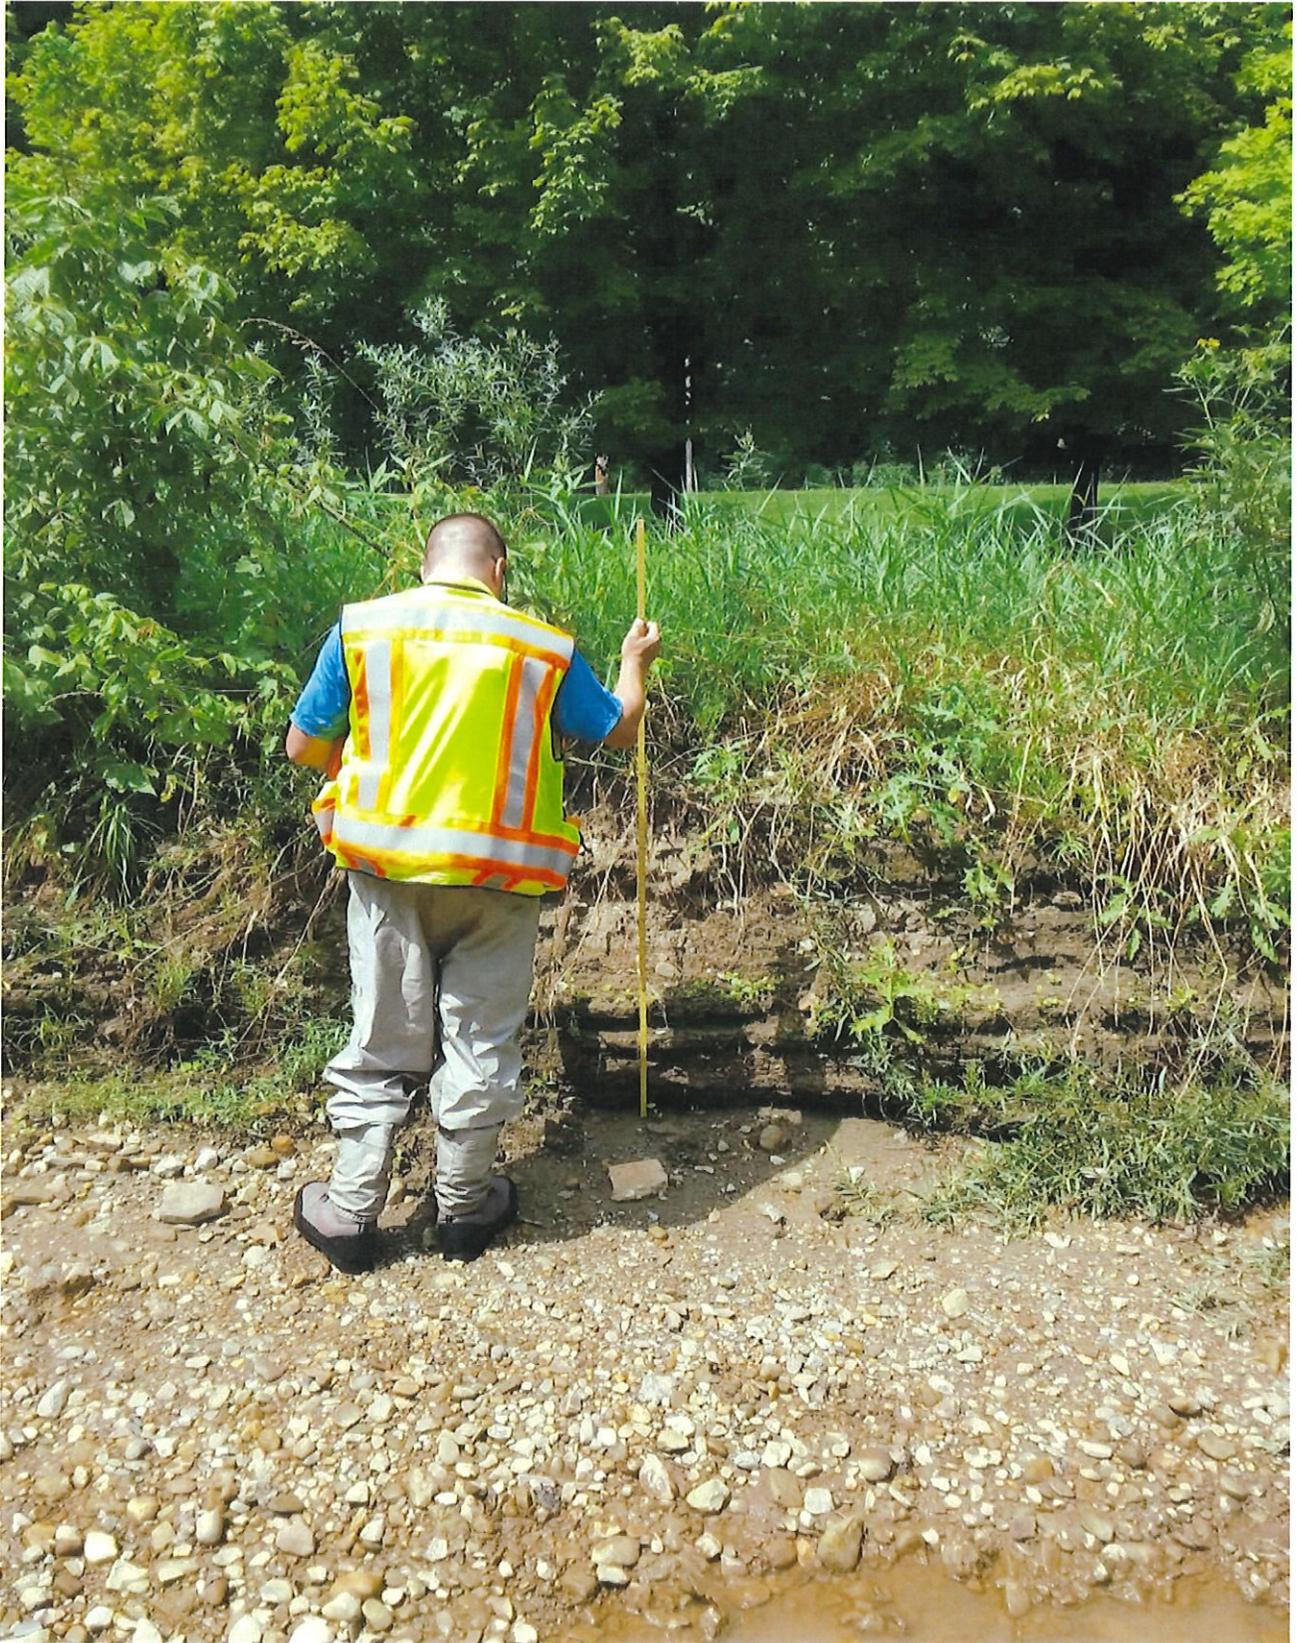
Bank Erosion Hazard Index (BEHI)						
Stream: Fetters Run			Location: Lancaster, Fairfield County, Ohio			
Station: Section 36, Right Bank			Observers: B. Petru, P. Renner			
Date: 8/2/2019		Stream Type:		Valley Type:		
Study Bank Height to Bankfull Height (C)						BEHI Score (Fig. 3-7)
Study Bank Height (ft) =	4.00 (A)	Bankfull Height (ft) =	3.20 (B)	$(A) / (B) =$	1.25 (C)	4.5
Root Depth to Study Bank Height (E)						
Root Depth (ft) =	0.80 (D)	Study Bank Height (ft) =	4.00 (A)	$(D) / (A) =$	0.20 (E)	7.0
Weighted Root Density (G)						
Root Density as % =	15.00 (F)			$(F) \times (E) =$	3 (G)	9.5
Bank Angle (H)						
Bank Angle as Degrees =	75 (H)					5.0
Surface Protection (I)						
Surface Protection as % =	10% (I)					9.0
Bank Material Adjustment:						
<ul style="list-style-type: none"> Bedrock (Overall Very Low BEHI) Boulders (Overall Low BEHI) Cobble (Subtract 10 points if uniform medium to large cobble) Gravel or Composite Matrix (Add 5–10 points depending on percentage of bank material that is composed of sand) Sand (Add 10 points) Silt/Clay (no adjustment unless primarily clay, then subtract 20 points) 						10

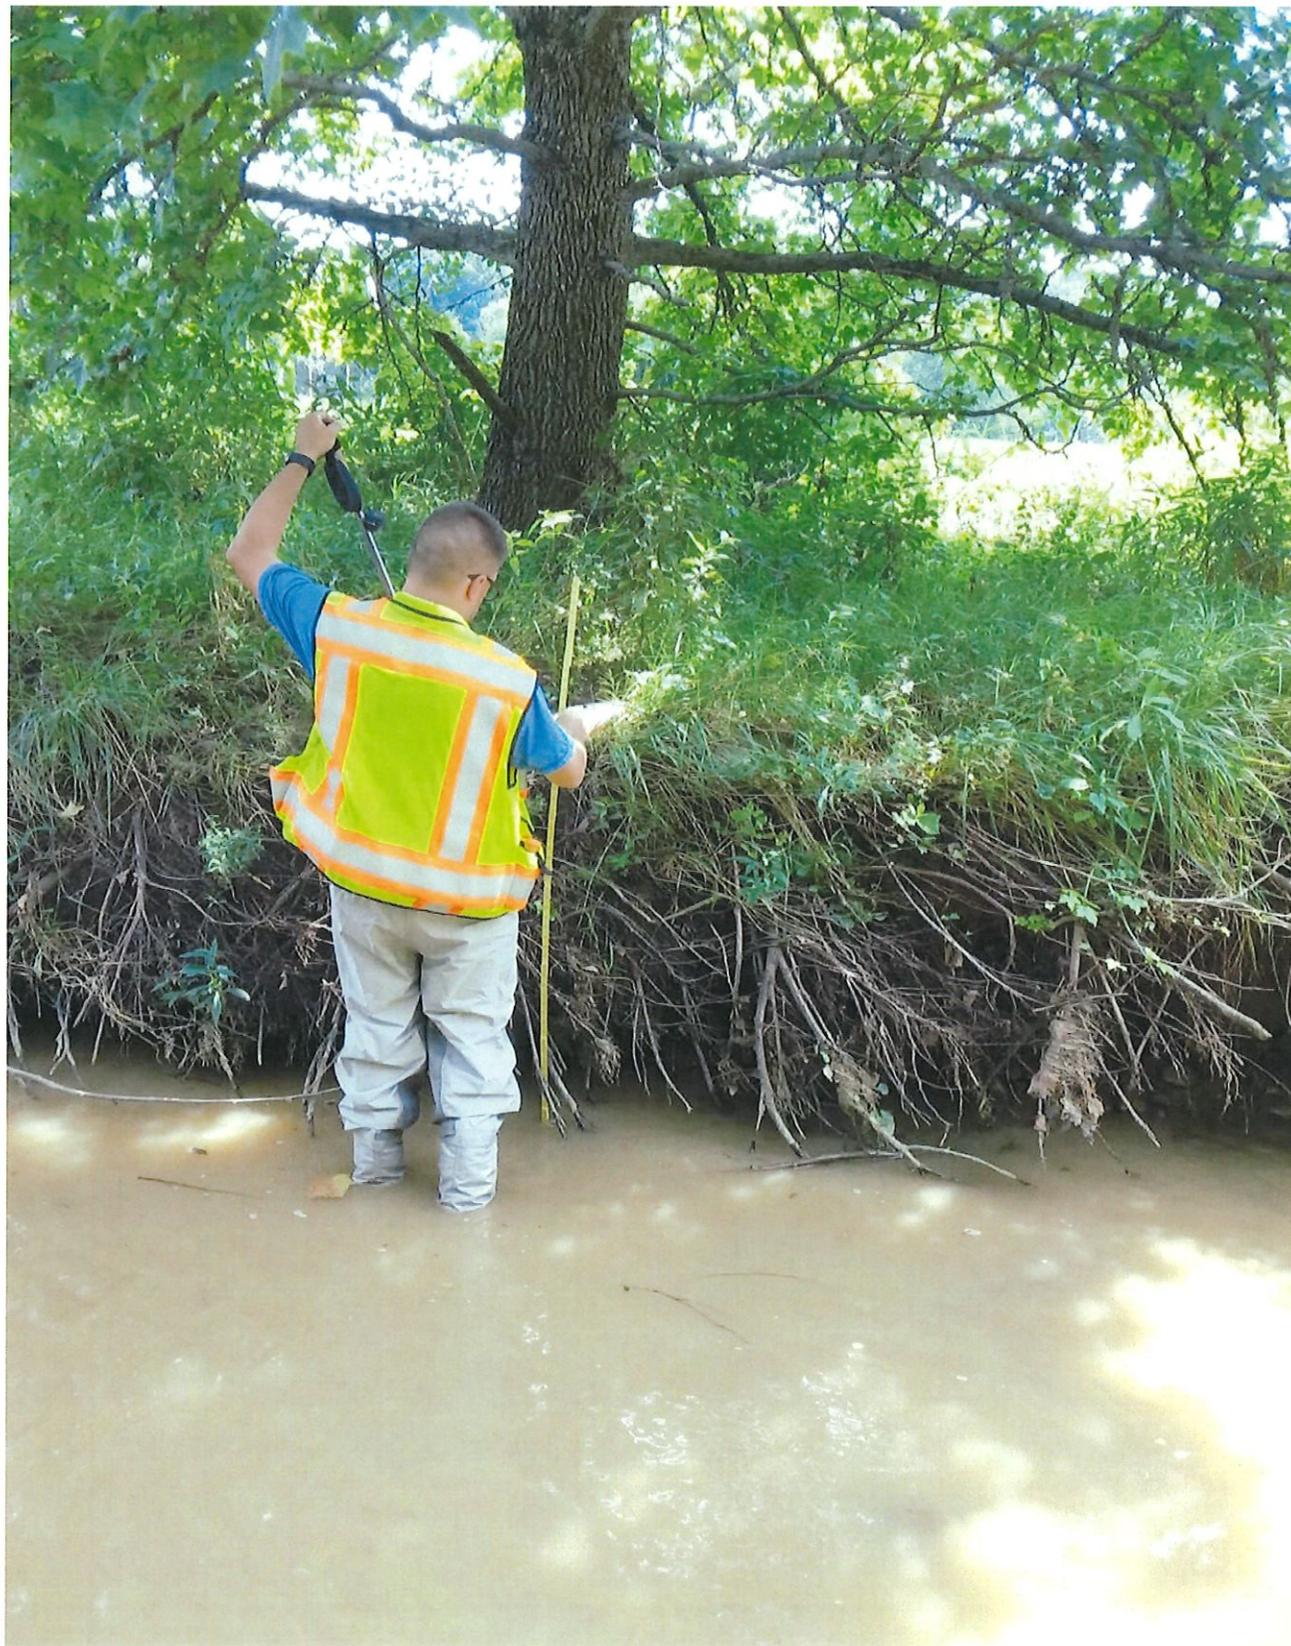
Bank Erosion Hazard Index (BEHI)							
Stream: Fetters Run			Location: Lancaster, Fairfield County, Ohio				
Station: Section 38, Left Bank			Observers: B. Petru, P. Renner				
Date: 8/2/2019		Stream Type:			Valley Type:		
Study Bank Height to Bankfull Height (C)							BEHI Score (Fig. 3-7)
Study Bank Height (ft) =	4.20 (A)	Bankfull Height (ft) =	3.20 (B)	(A) / (B) =	1.31 (C)	5.0	
Root Depth to Study Bank Height (E)							
Root Depth (ft) =	2.40 (D)	Study Bank Height (ft) =	4.20 (A)	(D) / (A) =	0.57 (E)	3.5	
Weighted Root Density (G)							
Root Density as % =	25.00 (F)	(F) × (E) =			14.2857 (G)	8.0	
Bank Angle (H)							
Bank Angle as Degrees =	110 (H)					8.5	
Surface Protection (I)							
Surface Protection as % =	2% (I)					10.0	
Bank Material Adjustment: Bedrock (Overall Very Low BEHI) Boulders (Overall Low BEHI) Cobble (Subtract 10 points if uniform medium to large cobble) Gravel or Composite Matrix (Add 5–10 points depending on percentage of bank material that is composed of sand) Sand (Add 10 points) Silt/Clay (no adjustment unless primarily clay, then subtract 20 points)					Bank Material Adjustment	10

Stratification Adjustment Add 5–10 points, depending on position of unstable layers in relation to bankfull stage							8
<i>Very Low</i>	<i>Low</i>	<i>Moderate</i>	<i>High</i>	<i>Very High</i>	<i>Extreme</i>	Adjective Rating and Total Score	Extreme
5 – 9.5	10 – 19.5	20 – 29.5	30 – 39.5	40 – 45	46 – 50	53.0

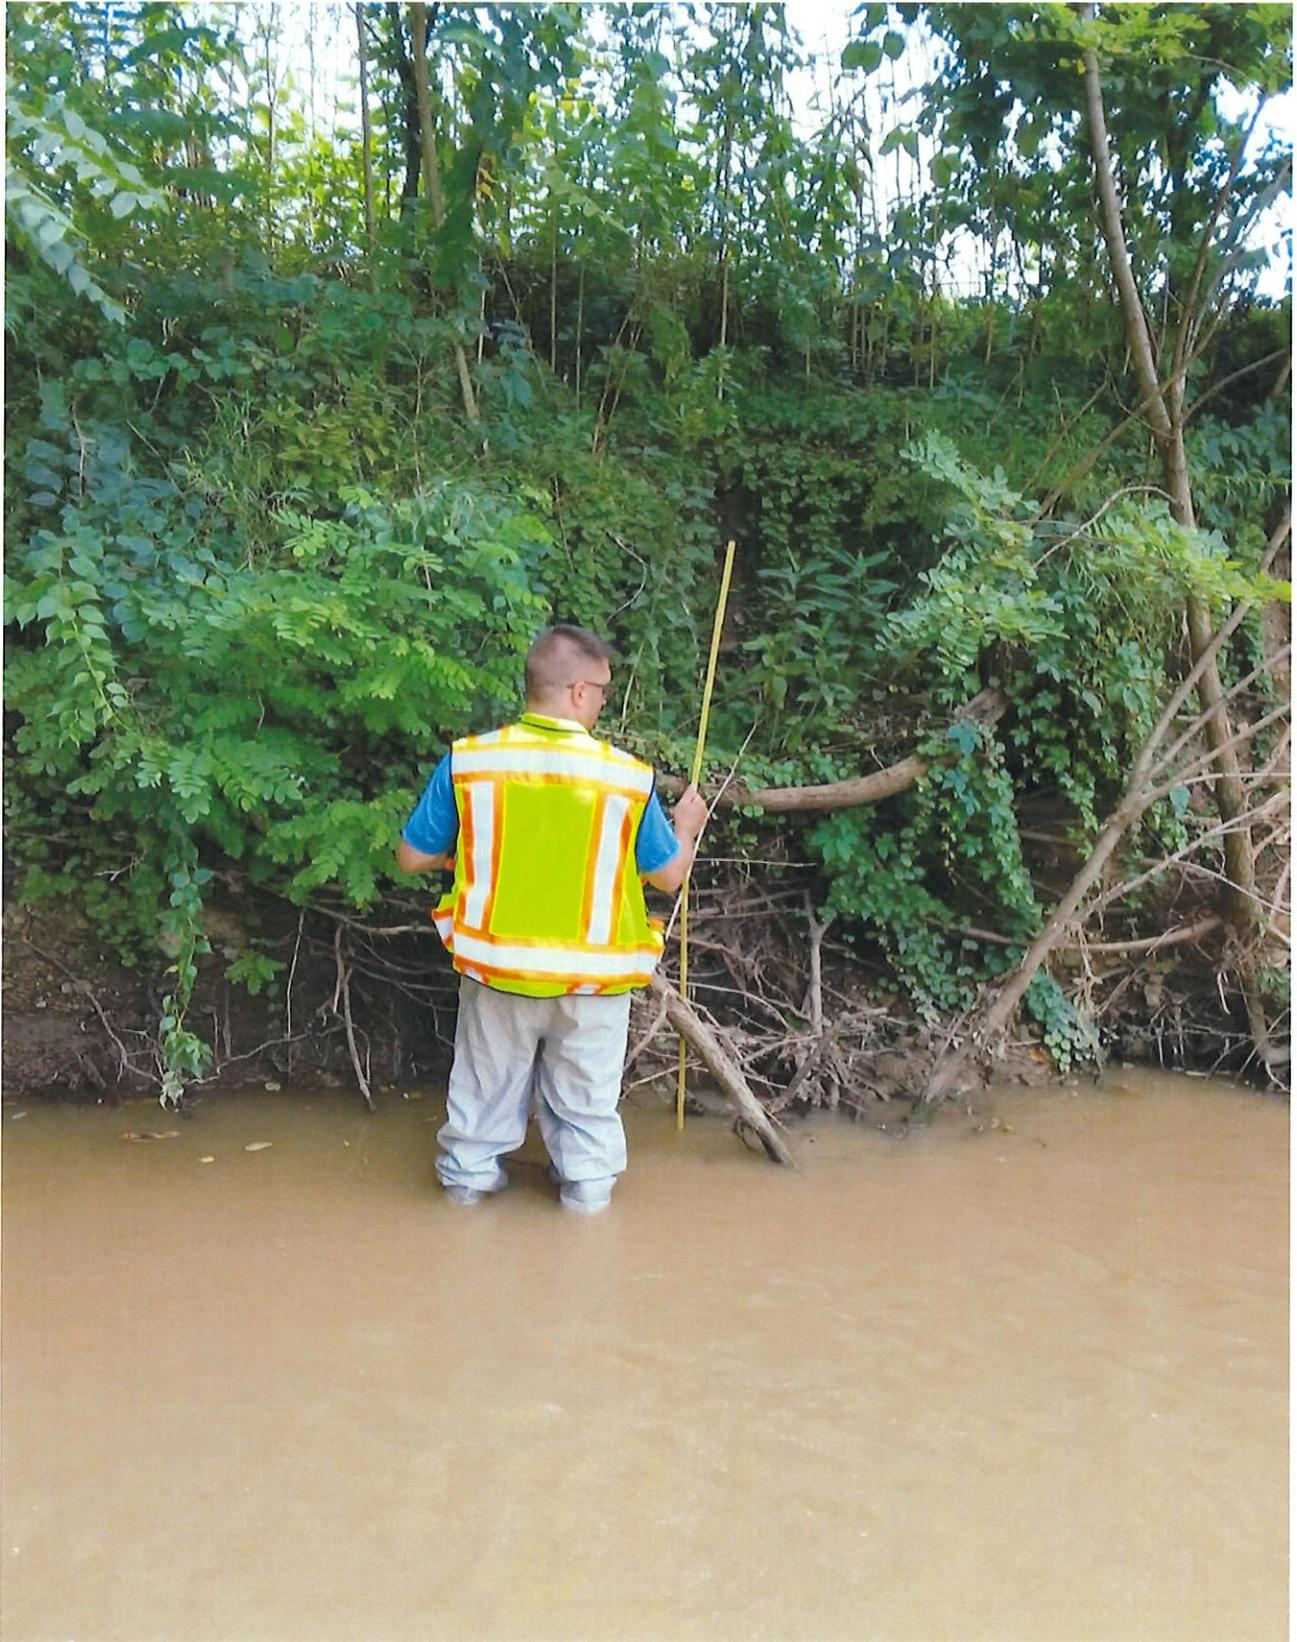
Bank Erosion Hazard Index (BEHI)							
Stream: Fetters Run				Location: Lancaster, Fairfield County, Ohio			
Station: Section 39, Left Bank				Observers: B. Petru, P. Renner			
Date: 8/2/2019		Stream Type:		Valley Type:			
Study Bank Height to Bankfull Height (C)							BEHI Score (Fig. 3-7)
Study Bank Height (ft) =	9.80 (A)	Bankfull Height (ft) =	4.00 (B)	$(A) / (B) =$	2.45 (C)	8.5	
Root Depth to Study Bank Height (E)							
Root Depth (ft) =	1.20 (D)	Study Bank Height (ft) =	9.80 (A)	$(D) / (A) =$	0.12 (E)	8.0	
Weighted Root Density (G)							
Root Density as % =	5.00 (F)	$(F) \times (E) =$			0.61224 (G)	10.0	
Bank Angle (H)							
Bank Angle as Degrees =	90 (H)					8.0	
Surface Protection (I)							
Surface Protection as % =	10% (I)					8.5	
Bank Material Adjustment:							
Bedrock (Overall Very Low BEHI) Boulders (Overall Low BEHI) Cobble (Subtract 10 points if uniform medium to large cobble) Gravel or Composite Matrix (Add 5–10 points depending on percentage of bank material that is composed of sand) Sand (Add 10 points) Silt/Clay (no adjustment unless primarily clay, then subtract 20 points)				Bank Material Adjustment		10

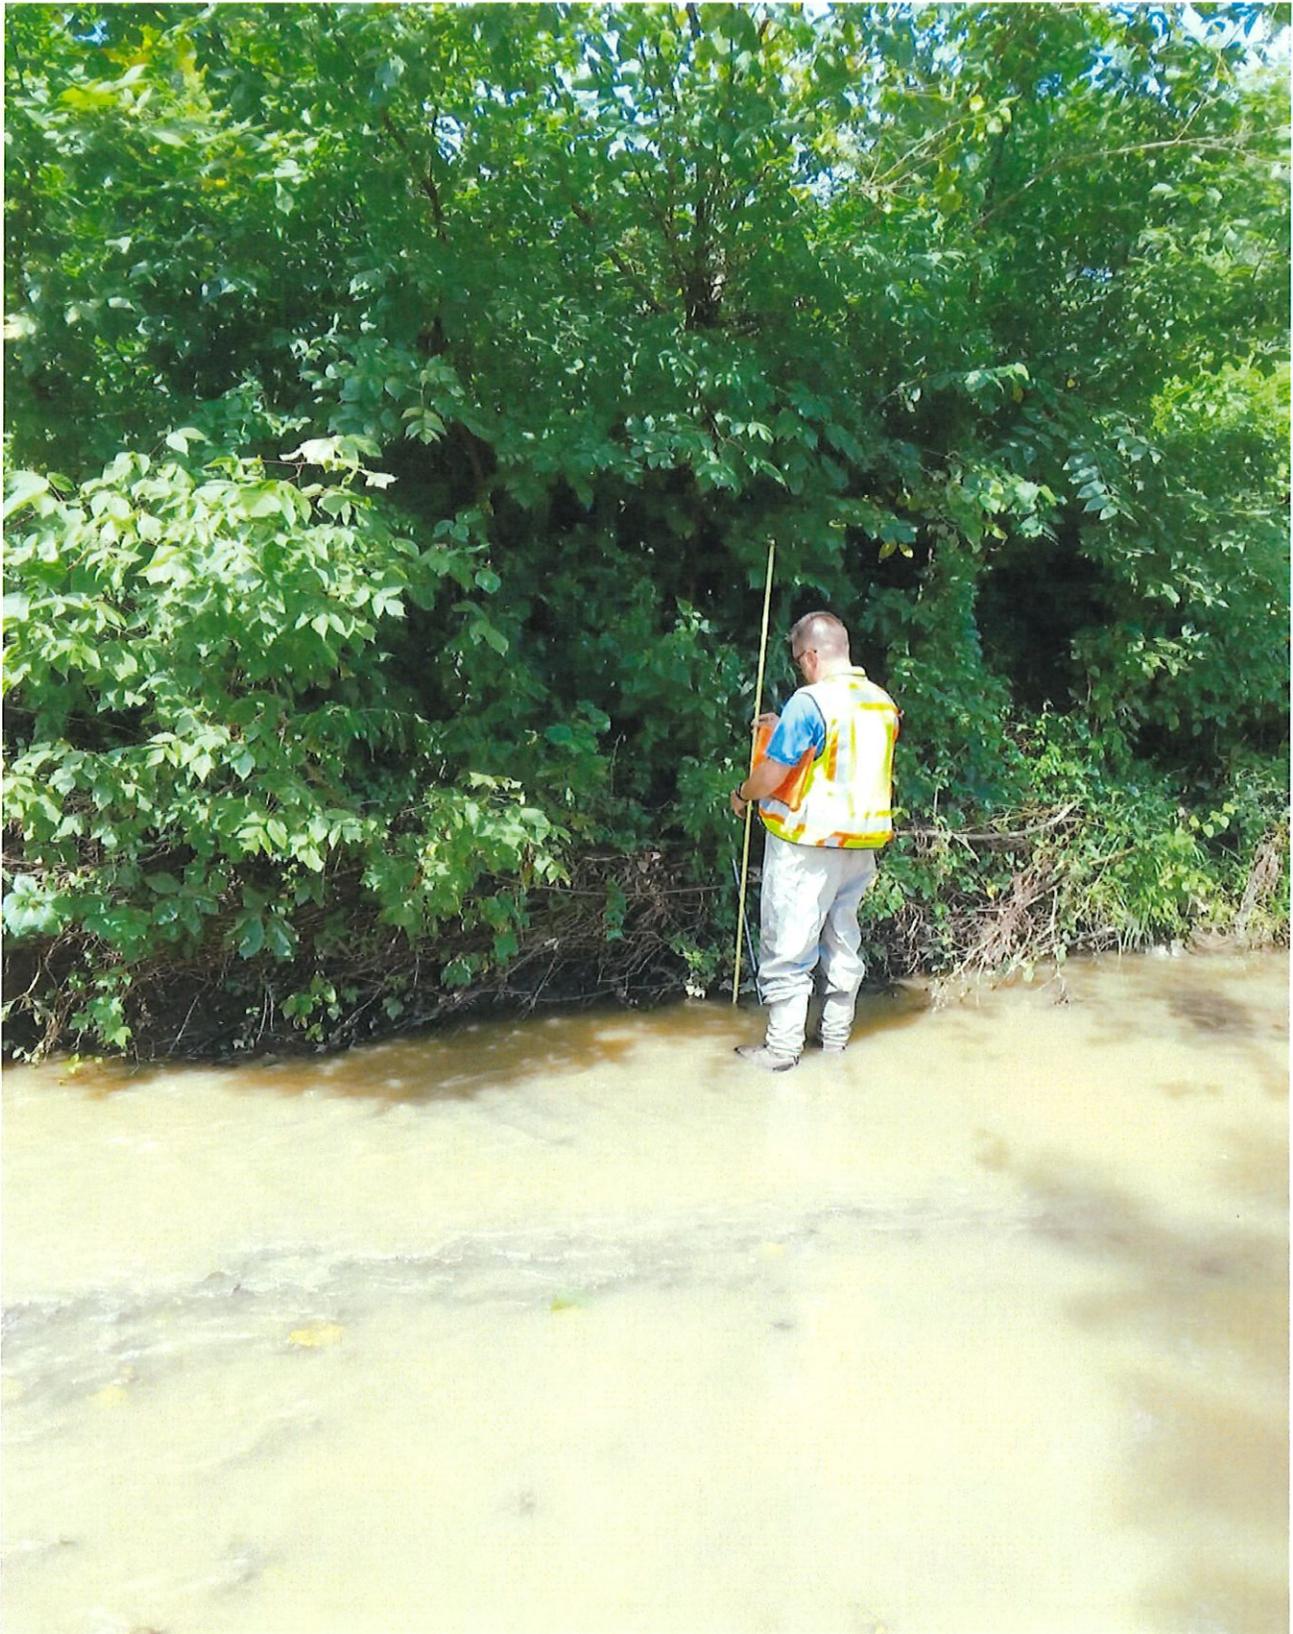
Bank Erosion Hazard Index (BEHI)							
Stream: Fetters Run				Location: Lancaster, Fairfield County, Ohio			
Station: Section 40, Right Bank				Observers: B. Petru, P. Renner			
Date: 8/2/2019		Stream Type:		Valley Type:			
Study Bank Height to Bankfull Height (C)							BEHI Score (Fig. 3-7)
Study Bank Height (ft) =	7.50 (A)	Bankfull Height (ft) =	3.50 (B)	$(A) / (B) =$	2.14 (C)	8.0	
Root Depth to Study Bank Height (E)							
Root Depth (ft) =	1.80 (D)	Study Bank Height (ft) =	7.50 (A)	$(D) / (A) =$	0.24 (E)	6.5	
Weighted Root Density (G)							
Root Density as % =	20.00 (F)	$(F) \times (E) =$			4.8 (G)	9.0	
Bank Angle (H)							
Bank Angle as Degrees =		80 (H)					6.0
Surface Protection (I)							
Surface Protection as % =		60% (I)					3.5
Bank Material Adjustment:							
Bedrock (Overall Very Low BEHI) Boulders (Overall Low BEHI) Cobble (Subtract 10 points if uniform medium to large cobble) Gravel or Composite Matrix (Add 5–10 points depending on percentage of bank material that is composed of sand) Sand (Add 10 points) Silt/Clay (no adjustment unless primarily clay, then subtract 20 points)				Bank Material Adjustment		10

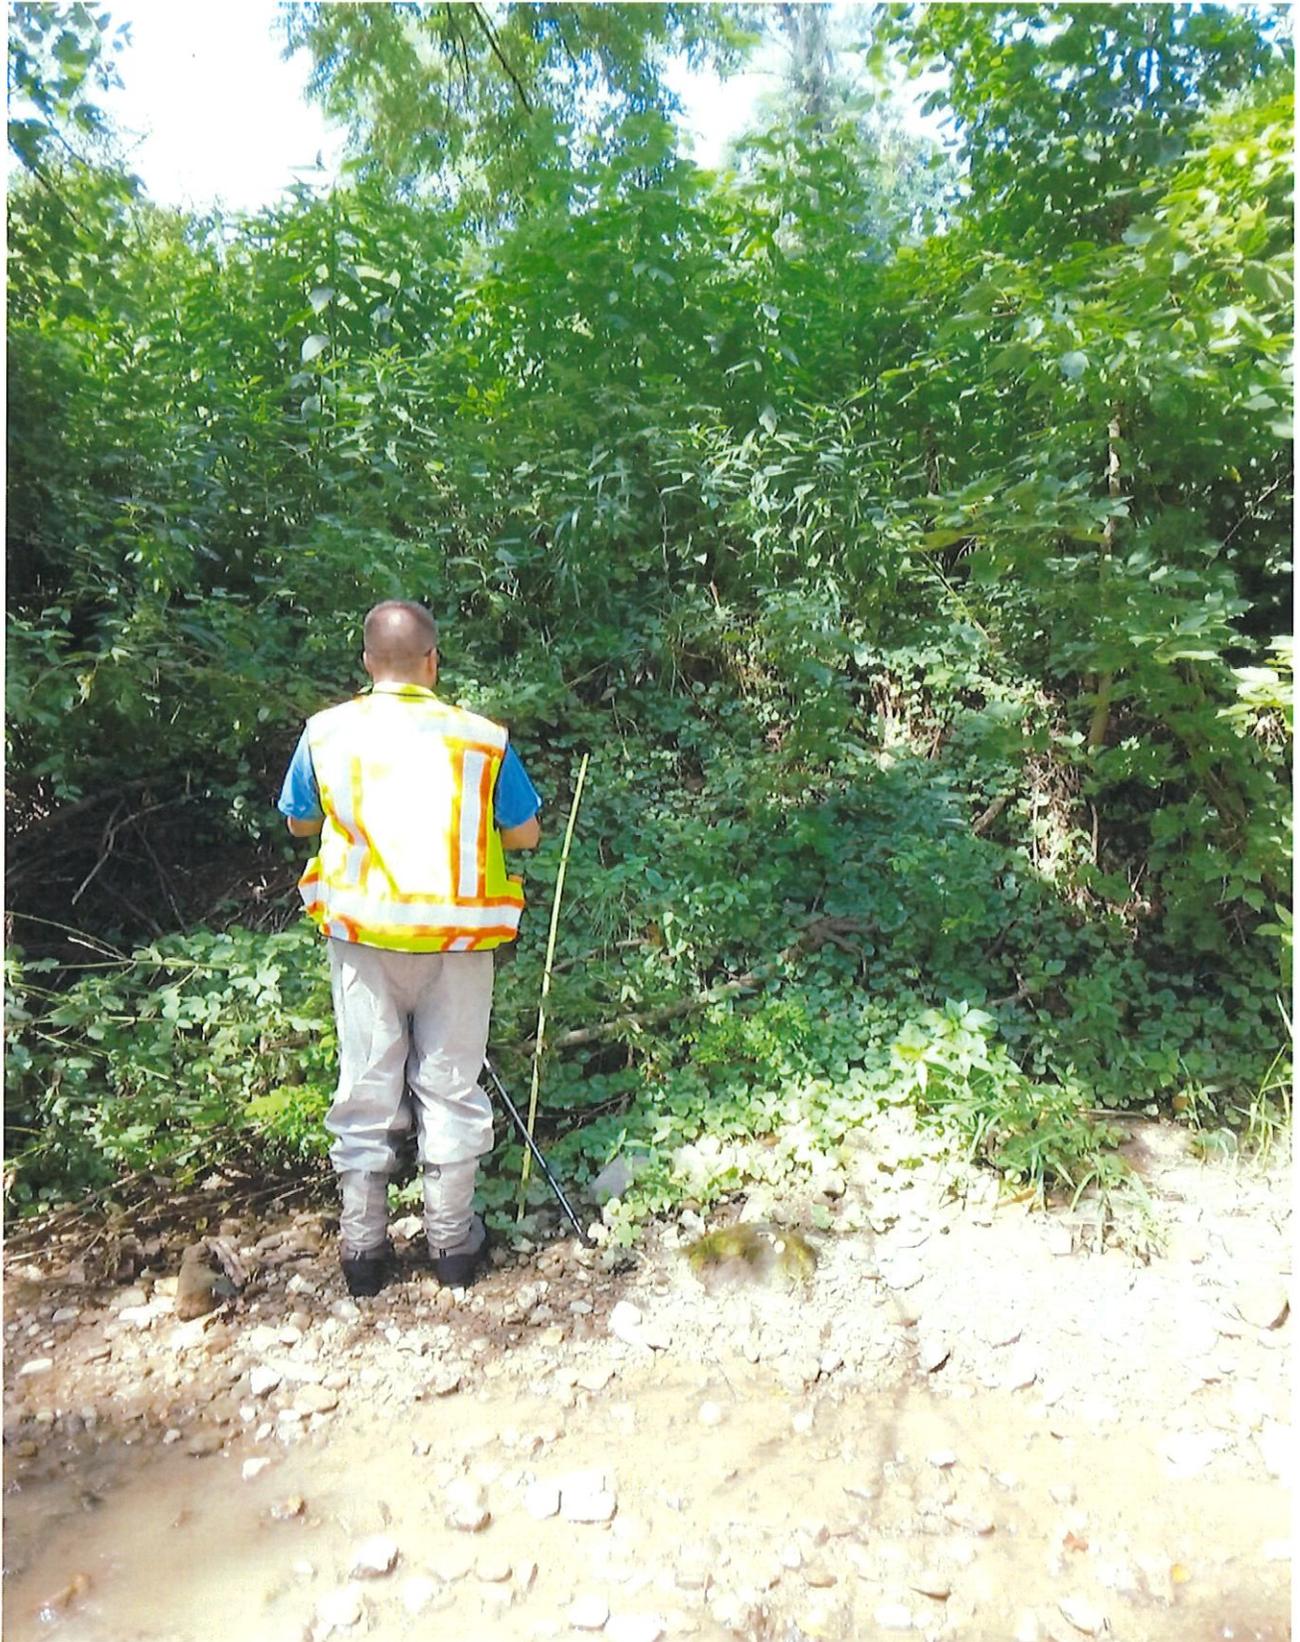
Bank Erosion Hazard Index (BEHI)							
Stream: Fetters Run				Location: Lancaster, Fairfield County, Ohio			
Station: Section 42, Right Bank				Observers: B. Petru, P. Renner			
Date: 8/2/2019		Stream Type:		Valley Type:			
Study Bank Height to Bankfull Height (C)							BEHI Score (Fig. 3-7)
Study Bank Height (ft) =	7.00 (A)	Bankfull Height (ft) =	3.50 (B)	(A) / (B) =	2.00 (C)	8.0	
Root Depth to Study Bank Height (E)							
Root Depth (ft) =	1.20 (D)	Study Bank Height (ft) =	7.00 (A)	(D) / (A) =	0.17 (E)	7.5	
Weighted Root Density (G)							
Root Density as % =	20.00 (F)	(F) x (E) =	3.42857 (G)				9.5
Bank Angle (H)							
Bank Angle as Degrees =	70 (H)						4.5
Surface Protection (I)							
Surface Protection as % =	50% (I)						4.5
Bank Material Adjustment:							
Bedrock (Overall Very Low BEHI) Boulders (Overall Low BEHI) Cobble (Subtract 10 points if uniform medium to large cobble) Gravel or Composite Matrix (Add 5-10 points depending on percentage of bank material that is composed of sand) Sand (Add 10 points) Silt/Clay (no adjustment unless primarily clay, then subtract 20 points)				Bank Material Adjustment		10

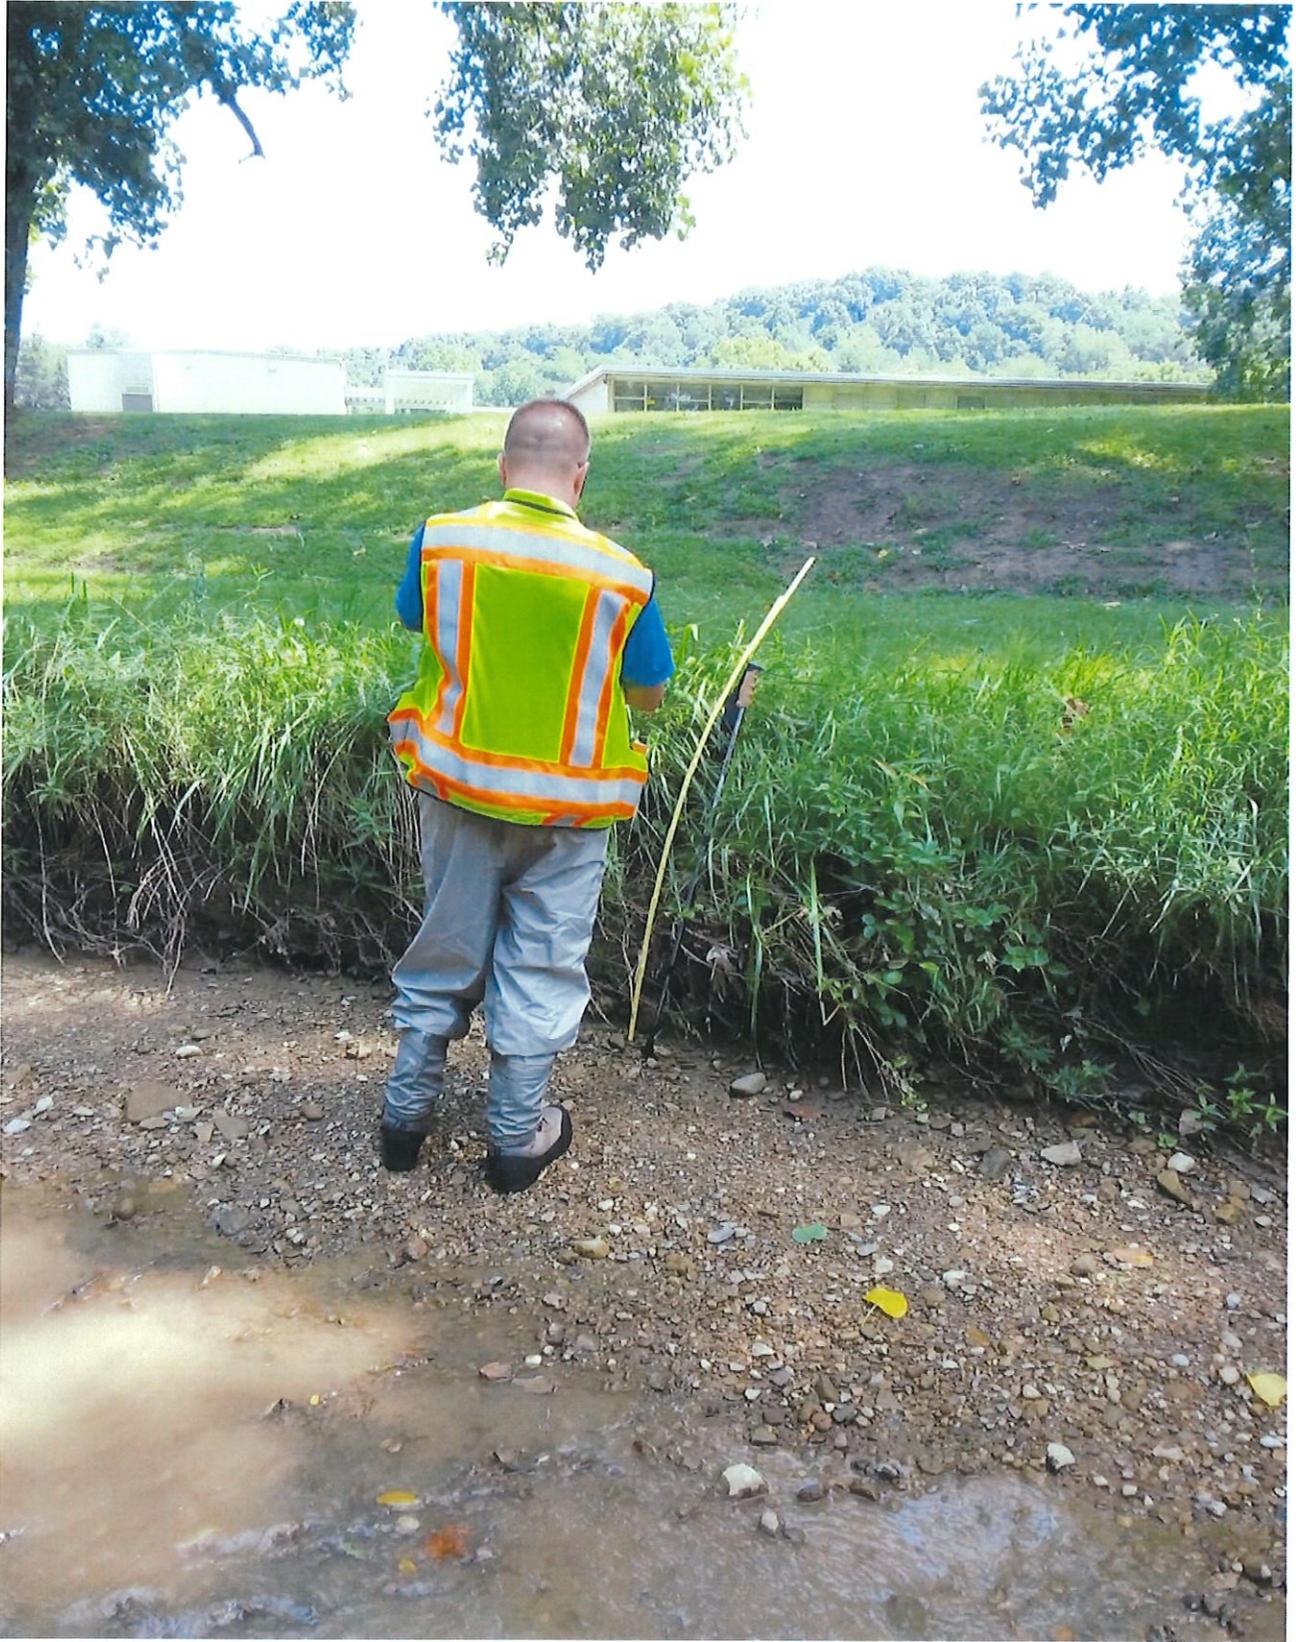
Bank Erosion Hazard Index (BEHI)						
Stream: Fetters Run			Location: Lancaster, Fairfield County, Ohio			
Station: Section 43, Left Bank			Observers: B. Petru, P. Renner			
Date: 8/2/2019		Stream Type:		Valley Type:		
Study Bank Height to Bankfull Height (C)						BEHI Score (Fig. 3-7)
Study Bank Height (ft) =	3.80 (A)	Bankfull Height (ft) =	2.60 (B)	$(A) / (B) =$	1.46 (C)	5.5
Root Depth to Study Bank Height (E)						
Root Depth (ft) =	0.80 (D)	Study Bank Height (ft) =	3.80 (A)	$(D) / (A) =$	0.21 (E)	7.0
Weighted Root Density (G)						
Root Density as % =	15.00 (F)	$(F) \times (E) =$			3.15789 (G)	9.0
Bank Angle (H)						
Bank Angle as Degrees =	90 (H)				8.0	
Surface Protection (I)						
Surface Protection as % =	10% (I)				9.0	
Bank Material Adjustment:						
Bedrock (Overall Very Low BEHI) Boulders (Overall Low BEHI) Cobble (Subtract 10 points if uniform medium to large cobble) Gravel or Composite Matrix (Add 5-10 points depending on percentage of bank material that is composed of sand) Sand (Add 10 points) Silt/Clay (no adjustment unless primarily clay, then subtract 20 points)				Bank Material Adjustment		10
