Fetters Run (College to Fair) Field Assessment

March 25, 2020

Hull & Associates, Inc.

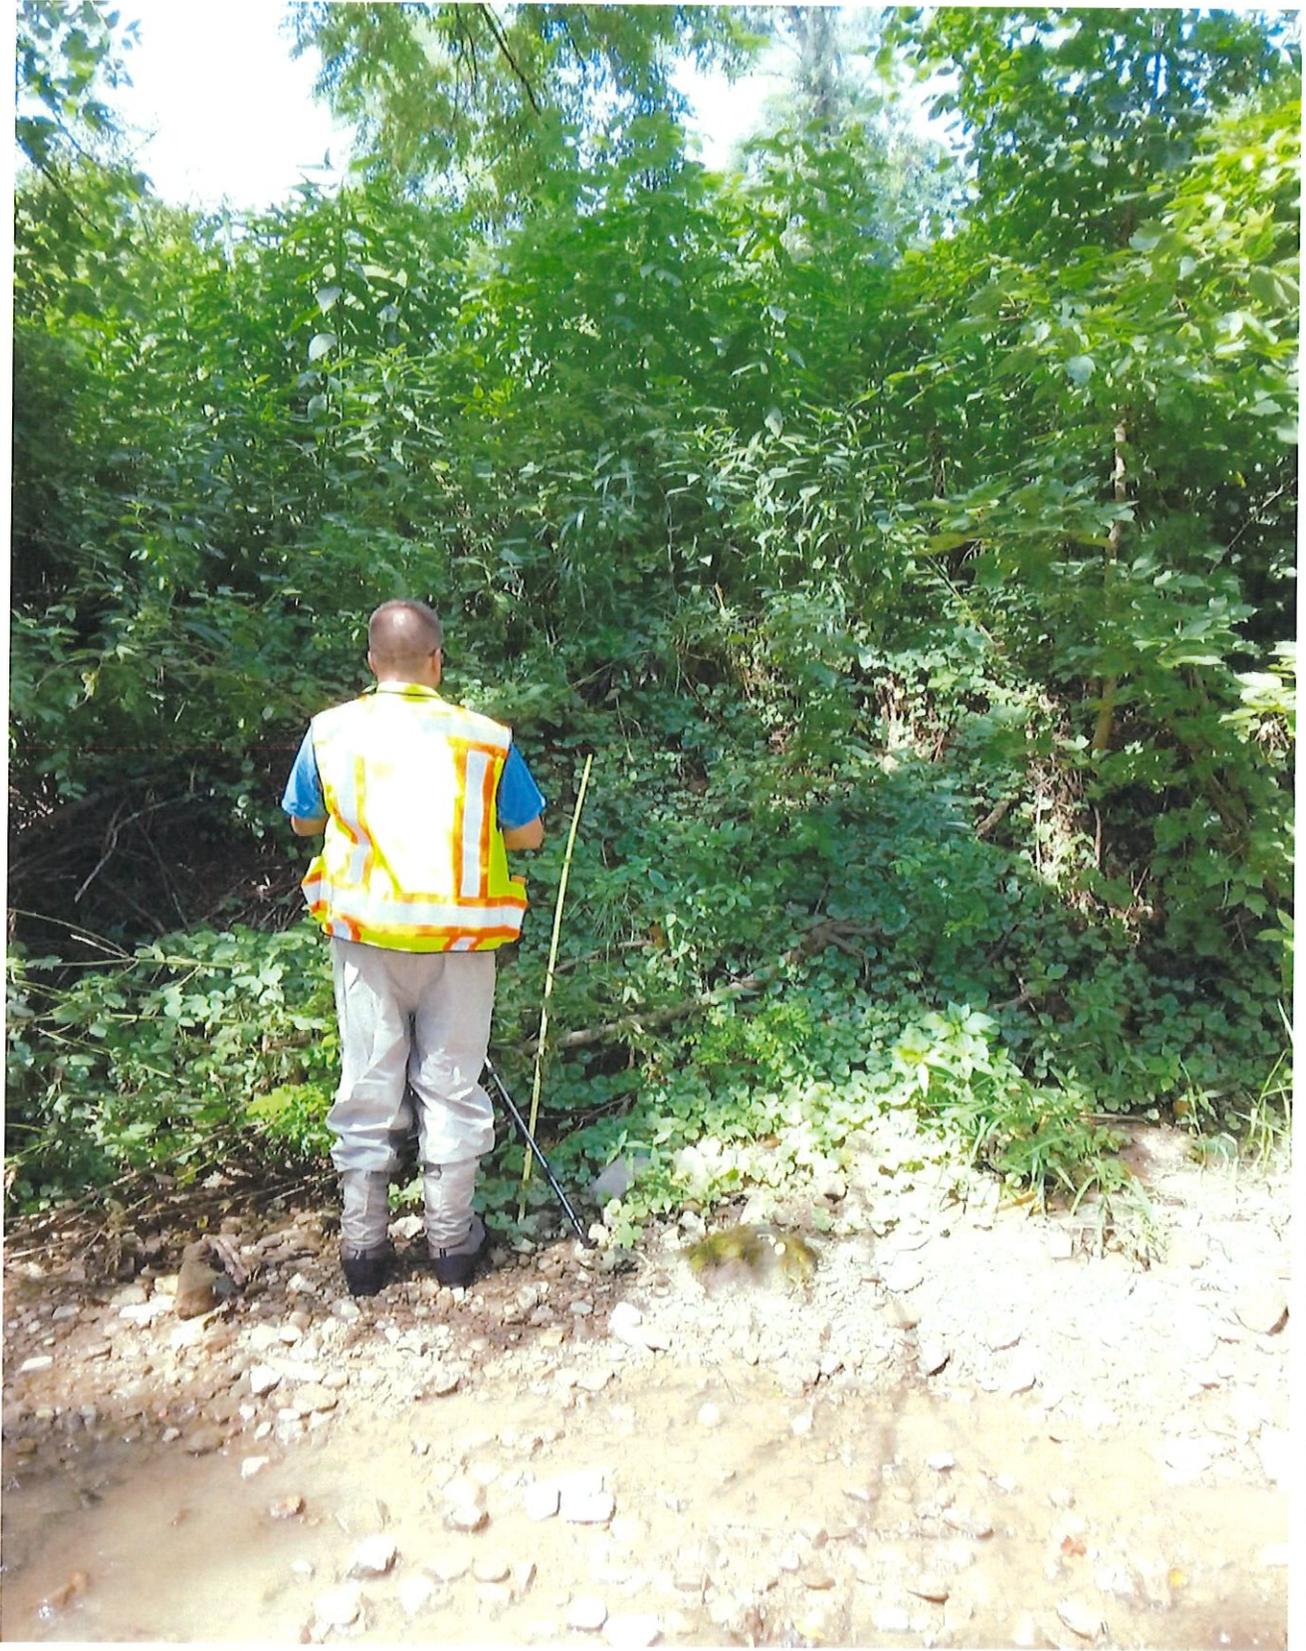
Bank Erosion Hazard Index (BEHI)						
Stream: Fetters Run			Location: Lancaster, Fairfield County, Ohio			
Station: Section 43, Right Bank			Observers: B. Petru, P. Renner			
Date: 8/2/2019		Stream Type:		Valley Type:		
Study Bank Height to Bankfull Height (C)						BEHI Score (Fig. 3-7)
Study Bank Height (ft) =	7.00 (A)	Bankfull Height (ft) =	3.50 (B)	$(A) / (B) =$	2.00 (C)	8.0
Root Depth to Study Bank Height (E)						
Root Depth (ft) =	1.20 (D)	Study Bank Height (ft) =	7.00 (A)	$(D) / (A) =$	0.17 (E)	7.5
Weighted Root Density (G)						
Root Density as % =	20.00 (F)	$(F) \times (E) =$			3.42857 (G)	9.5
Bank Angle (H)						
Bank Angle as Degrees =	70 (H)				4.5	
Surface Protection (I)						
Surface Protection as % =	50% (I)				4.5	
Bank Material Adjustment:						
Bedrock (Overall Very Low BEHI) Boulders (Overall Low BEHI) Cobble (Subtract 10 points if uniform medium to large cobble) Gravel or Composite Matrix (Add 5–10 points depending on percentage of bank material that is composed of sand) Sand (Add 10 points) Silt/Clay (no adjustment unless primarily clay, then subtract 20 points)				Bank Material Adjustment		10

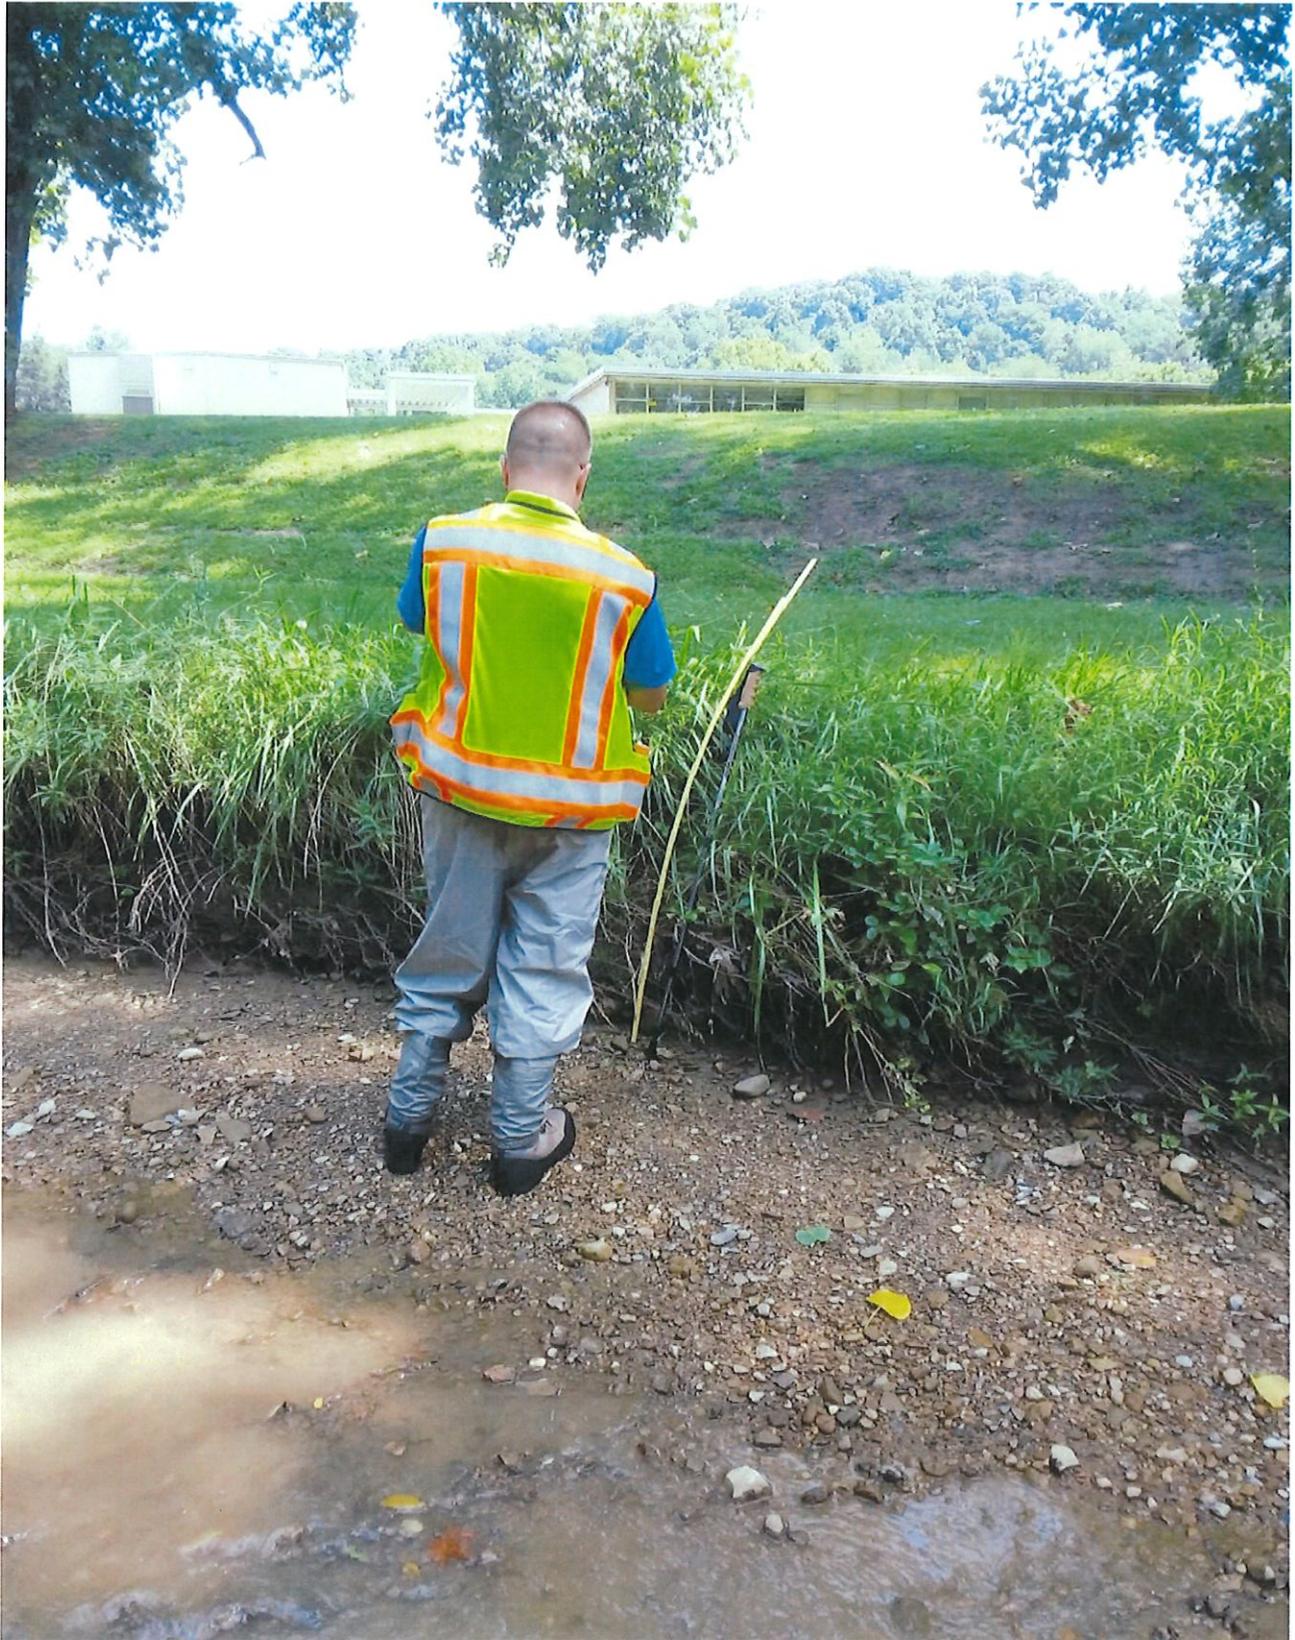
Bank Erosion Hazard Index (BEHI)								
Stream: Fetters Run				Location: Lancaster, Fairfield County, Ohio				
Station: Section 44, Left Bank				Observers: B. Petru, P. Renner				
Date: 8/2/2019		Stream Type:		Valley Type:				
Study Bank Height to Bankfull Height (C)							BEHI Score (Fig. 3-7)	
Study Bank Height (ft) =	3.80 (A)	Bankfull Height (ft) =	2.60 (B)	$(A) / (B) =$		1.46 (C)	5.5	
Root Depth to Study Bank Height (E)								
Root Depth (ft) =	0.80 (D)	Study Bank Height (ft) =	3.80 (A)	$(D) / (A) =$		0.21 (E)	7.0	
Weighted Root Density (G)								
Root Density as % =	15.00 (F)	$(F) \times (E) =$				3.15789 (G)	9.0	
Bank Angle (H)								
Bank Angle as Degrees =	90 (H)					8.0		
Surface Protection (I)								
Surface Protection as % =	10% (I)					9.0		
Bank Material Adjustment:								
Bedrock (Overall Very Low BEHI) Boulders (Overall Low BEHI) Cobble (Subtract 10 points if uniform medium to large cobble) Gravel or Composite Matrix (Add 5-10 points depending on percentage of bank material that is composed of sand) Sand (Add 10 points) Silt/Clay (no adjustment unless primarily clay, then subtract 20 points)							Bank Material Adjustment	10

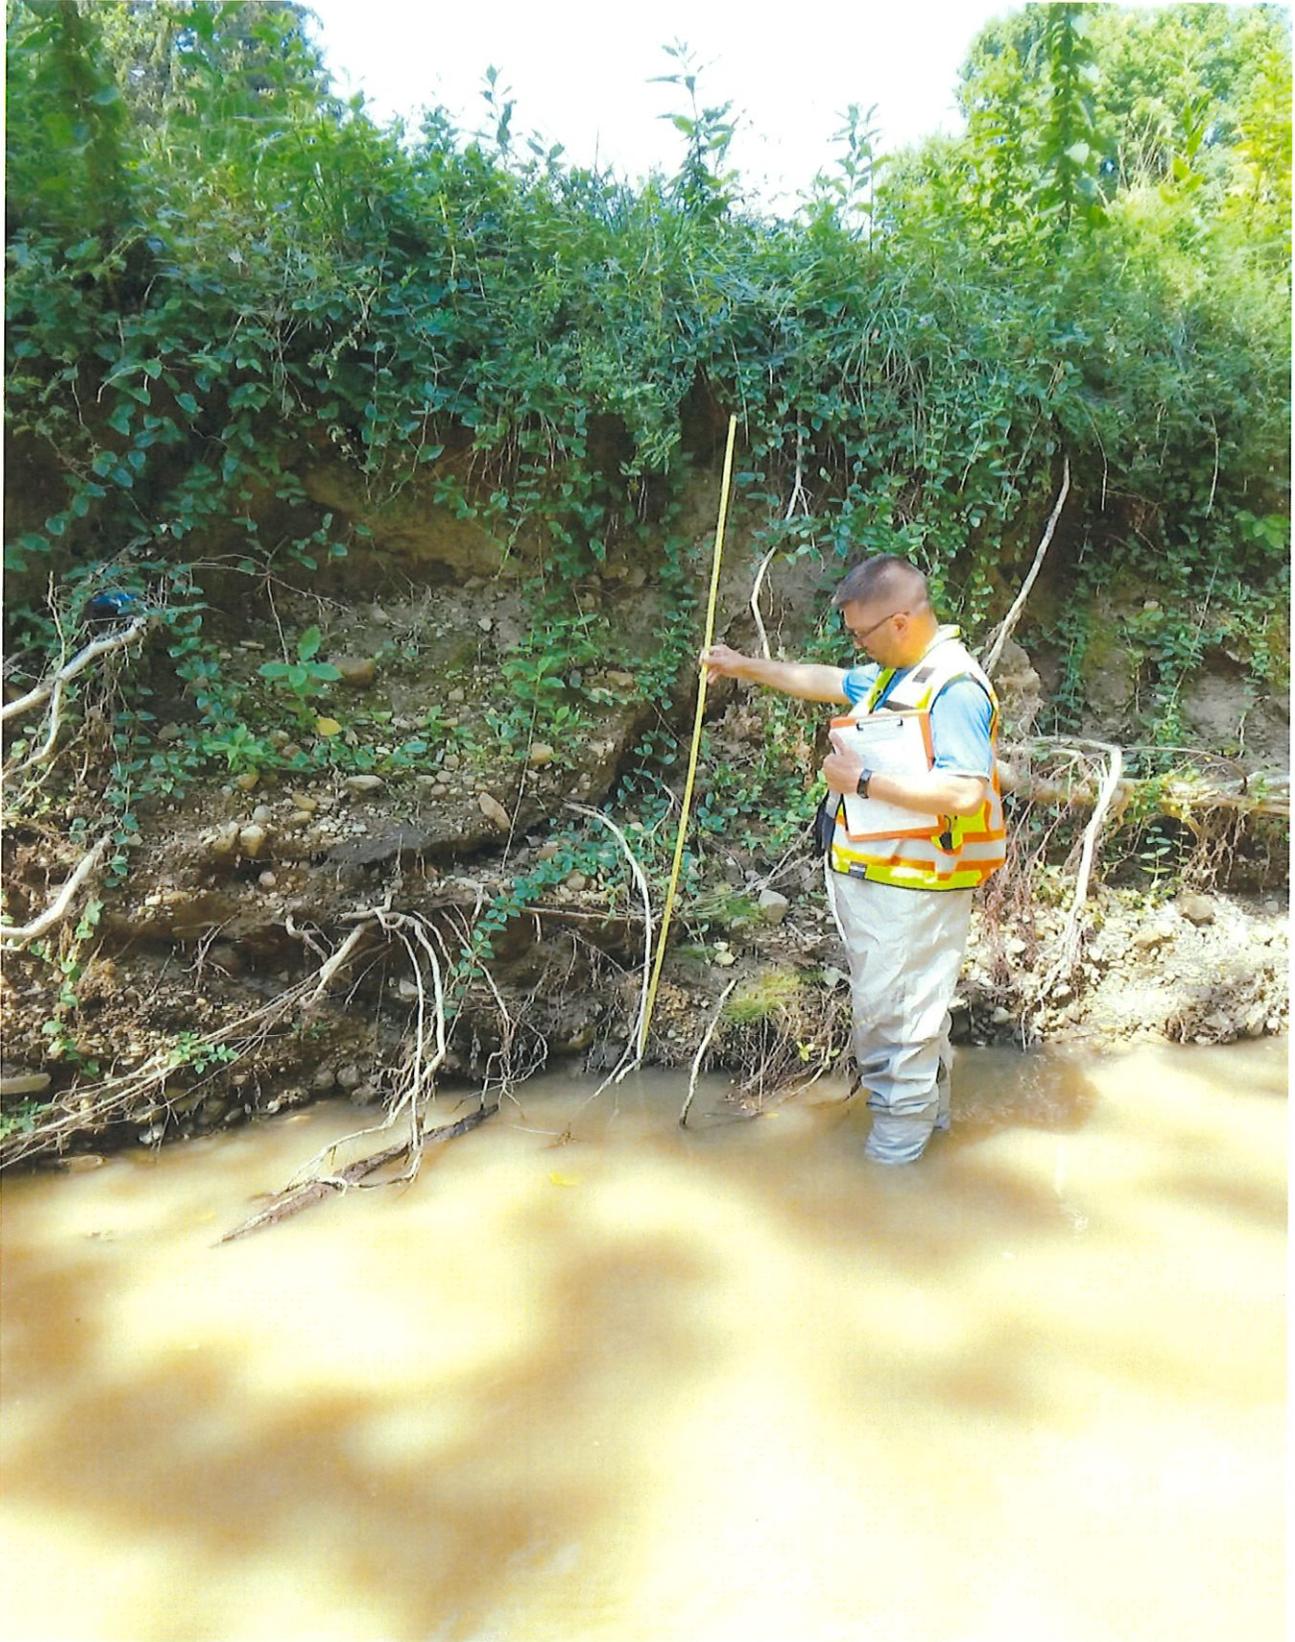
Bank Erosion Hazard Index (BEHI)							
Stream: Fetters Run				Location: Lancaster, Fairfield County, Ohio			
Station: Section 45, Right Bank				Observers: B. Petru, P. Renner			
Date: 8/2/2019		Stream Type:		Valley Type:			
Study Bank Height to Bankfull Height (C)							BEHI Score (Fig. 3-7)
Study Bank Height (ft) =	9.40	(A)	Bankfull Height (ft) =	2.90	(B)	$(A) / (B) =$	3.24

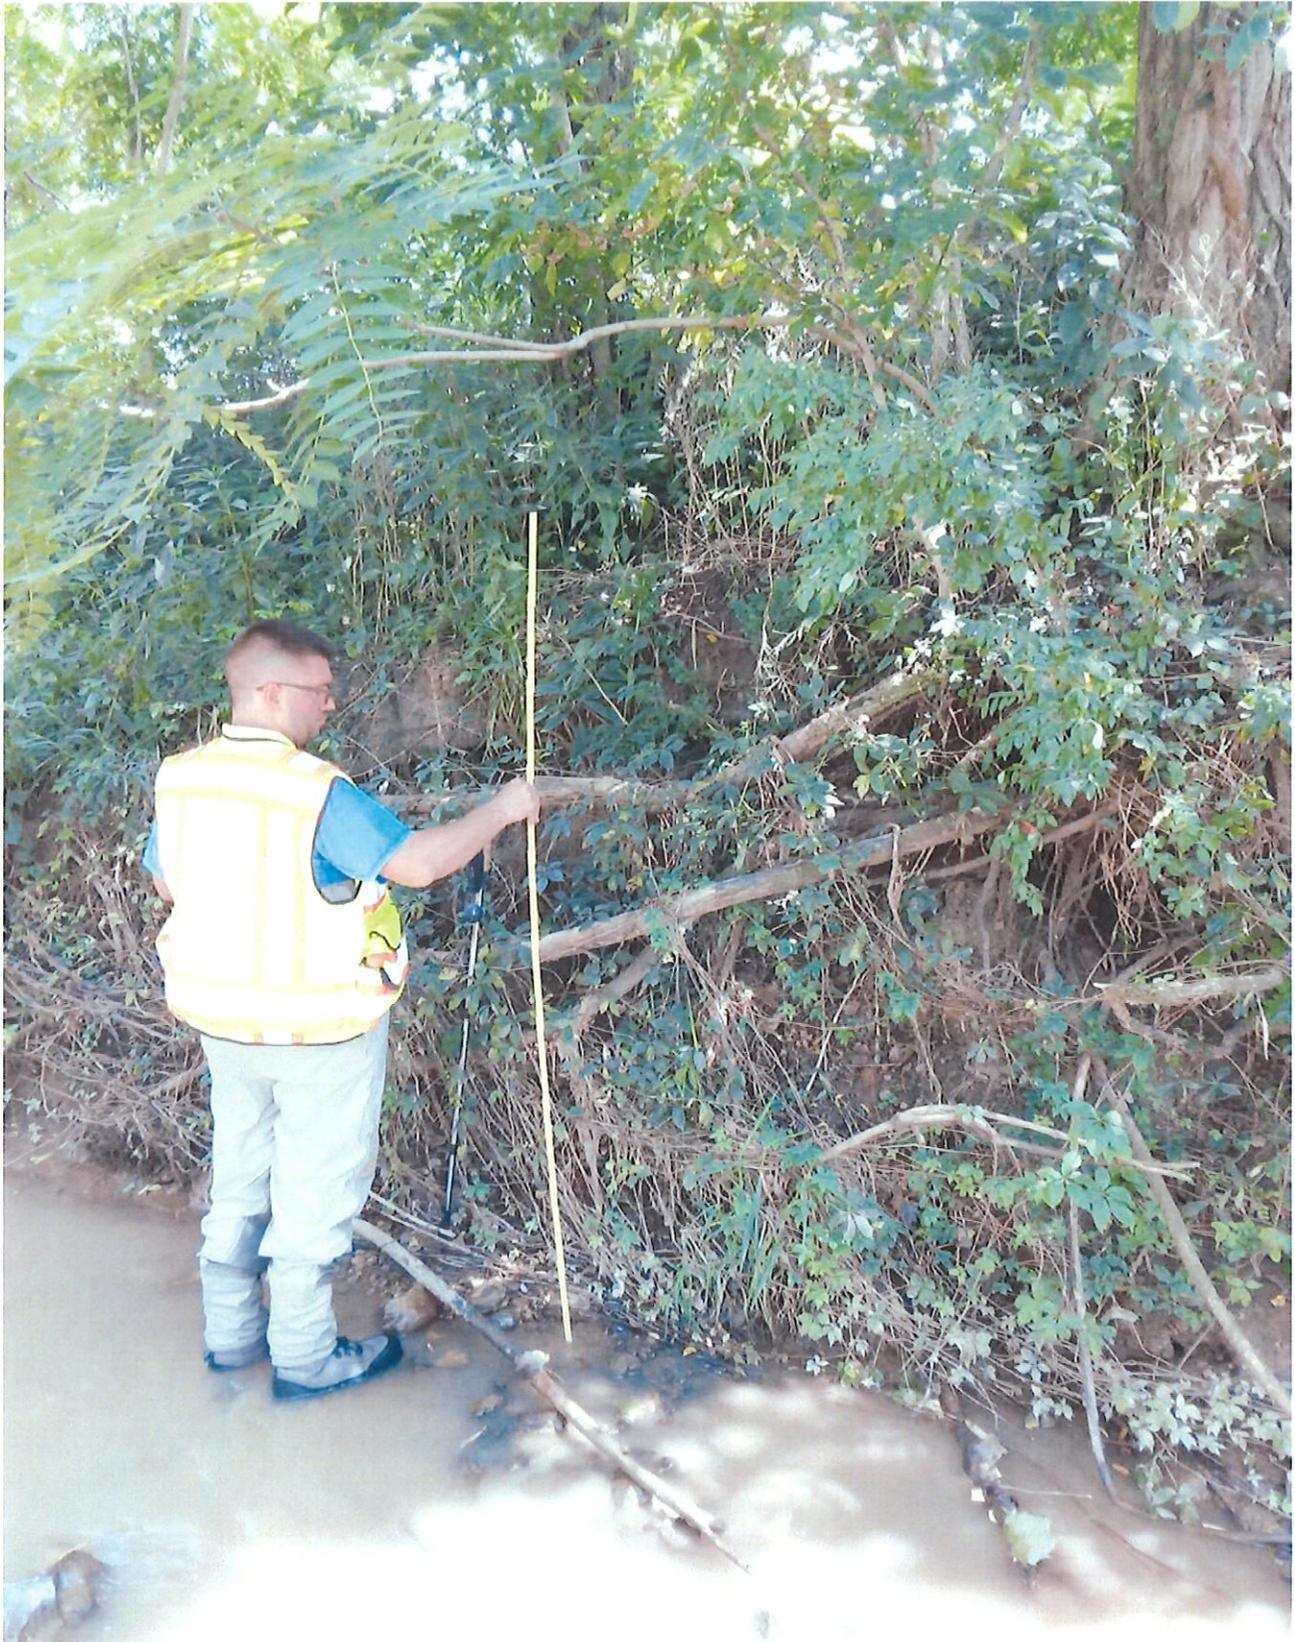
Bank Erosion Hazard Index (BEHI)							
Stream: Fetters Run				Location: Lancaster, Fairfield County, Ohio			
Station: Section 46, Left Bank				Observers: B. Petru, P. Renner			
Date: 8/2/2019		Stream Type:		Valley Type:			
Study Bank Height to Bankfull Height (C)							BEHI Score (Fig. 3-7)
Study Bank Height (ft) =	10.50 (A)	Bankfull Height (ft) =	3.30 (B)	(A) / (B) =	3.18 (C)	9.5	
Root Depth to Study Bank Height (E)							
Root Depth (ft) =	2.20 (D)	Study Bank Height (ft) =	10.50 (A)	(D) / (A) =	0.21 (E)	7.0	
Weighted Root Density (G)							
Root Density as % =	25.00 (F)	(F) × (E) =				5.2381 (G)	9.0
Bank Angle (H)							
Bank Angle as Degrees =	80 (H)					6.0	
Surface Protection (I)							
Surface Protection as % =	35% (I)					5.5	
Bank Material Adjustment: Bedrock (Overall Very Low BEHI) Boulders (Overall Low BEHI) Cobble (Subtract 10 points if uniform medium to large cobble) Gravel or Composite Matrix (Add 5–10 points depending on percentage of bank material that is composed of sand) Sand (Add 10 points) Silt/Clay (no adjustment unless primarily clay, then subtract 20 points)				Bank Material Adjustment 10		Stratification Adjustment Add 5–10 points, depending on position of unstable layers in relation to bankfull stage 10

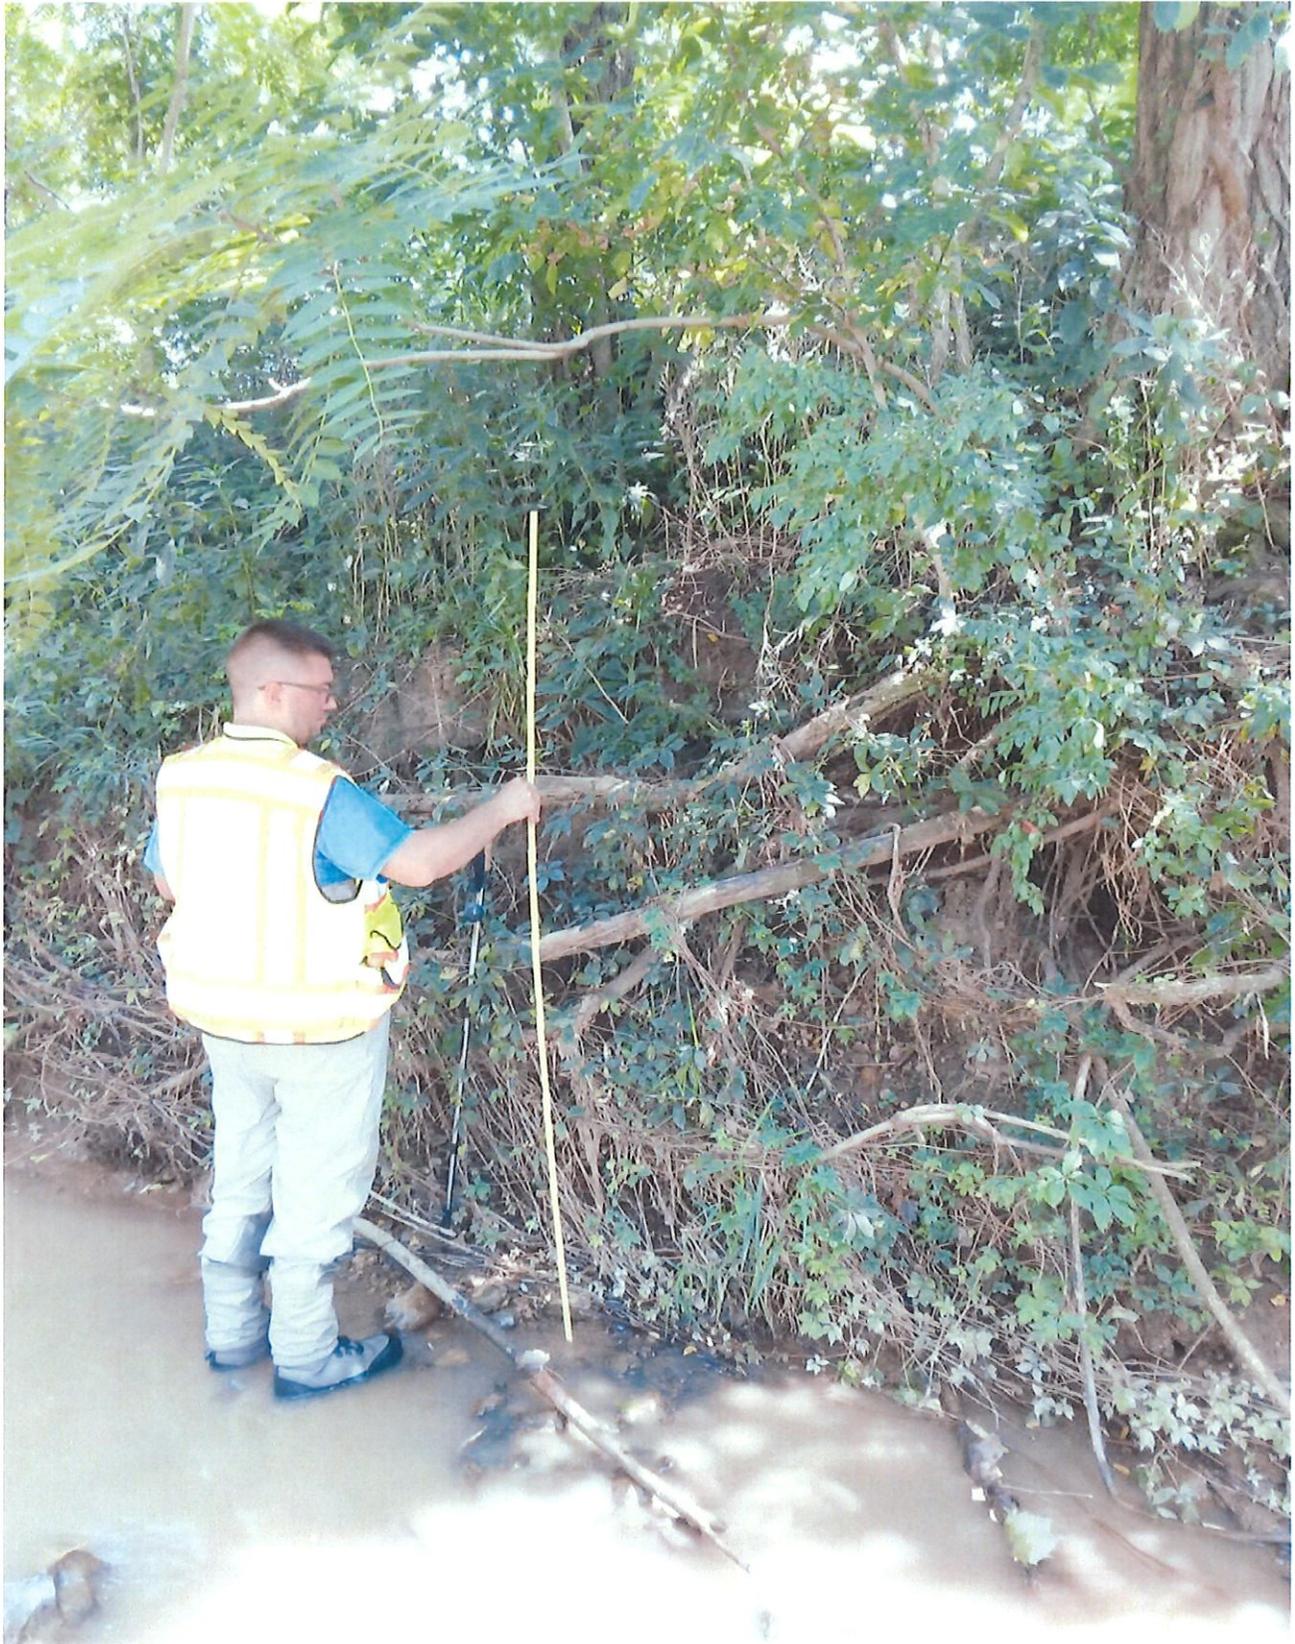
Bank Erosion Hazard Index (BEHI)						
Stream: Fetters Run			Location: Lancaster, Fairfield County, Ohio			
Station: Section 47, Left Bank			Observers: B. Petru, P. Renner			
Date: 8/2/2019		Stream Type:		Valley Type:		
Study Bank Height to Bankfull Height (C)						BEHI Score (Fig. 3-7)
Study Bank Height (ft) =	10.50 (A)	Bankfull Height (ft) =	3.30 (B)	(A) / (B) =	3.18 (C)	9.5
Root Depth to Study Bank Height (E)						
Root Depth (ft) =	2.20 (D)	Study Bank Height (ft) =	10.50 (A)	(D) / (A) =	0.21 (E)	7.0
Weighted Root Density (G)						
Root Density as % =	25.00 (F)			(F) × (E) =	5.2381 (G)	9.0
Bank Angle (H)						
Bank Angle as Degrees =			80 (H)			6.0
Surface Protection (I)						
Surface Protection as % =			35% (I)			5.5
Bank Material Adjustment:						
Bedrock (Overall Very Low BEHI) Boulders (Overall Low BEHI) Cobble (Subtract 10 points if uniform medium to large cobble) Gravel or Composite Matrix (Add 5–10 points depending on percentage of bank material that is composed of sand) Sand (Add 10 points) Silt/Clay (no adjustment unless primarily clay, then subtract 20 points)						Bank Material Adjustment

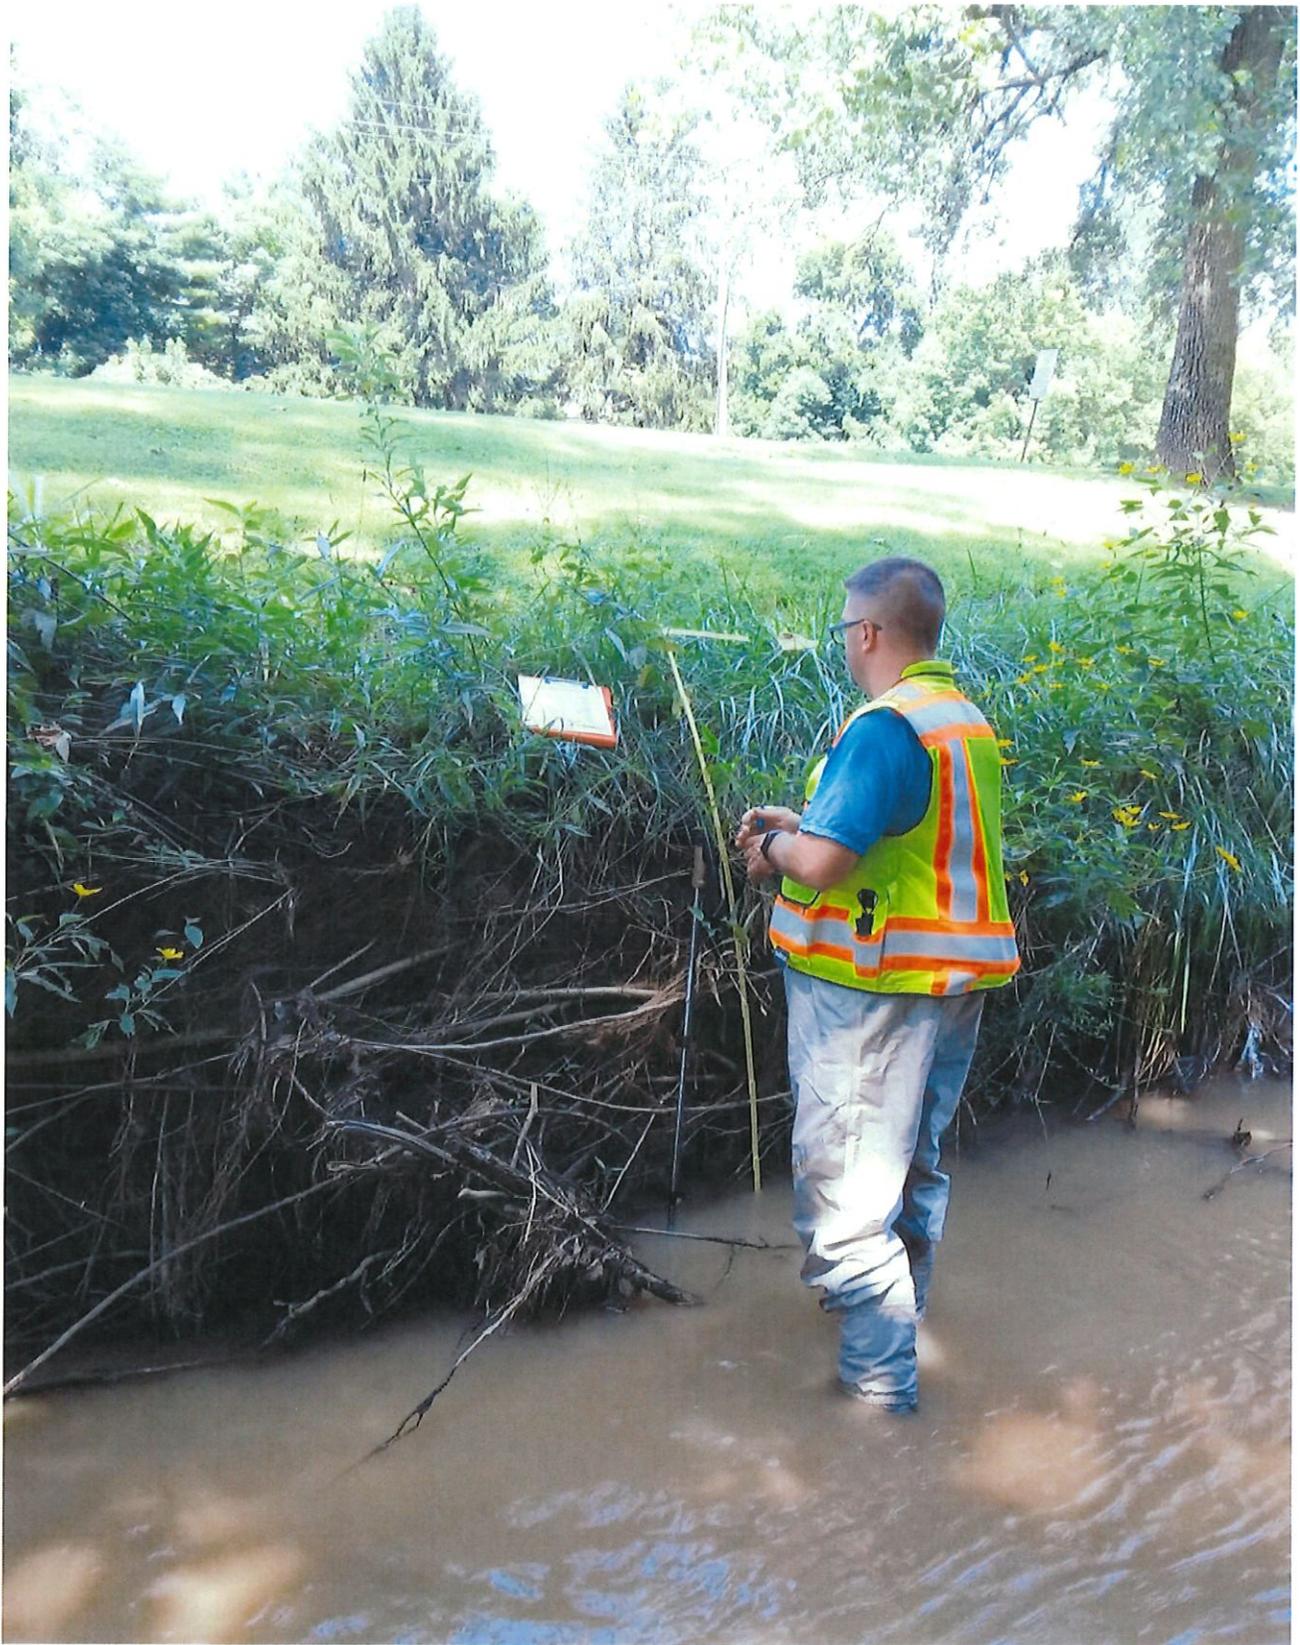
Bank Erosion Hazard Index (BEHI)						
Stream: Fetters Run			Location: Lancaster, Fairfield County, Ohio			
Station: Section 47, Right Bank			Observers: B. Petru, P. Renner			
Date: 8/2/2019		Stream Type:		Valley Type:		
Study Bank Height to Bankfull Height (C)						BEHI Score (Fig. 3-7)
Study Bank Height (ft) =	4.80 (A)	Bankfull Height (ft) =	3.20 (B)	$(A) / (B) =$	1.50 (C)	6.0
Root Depth to Study Bank Height (E)						
Root Depth (ft) =	1.30 (D)	Study Bank Height (ft) =	4.80 (A)	$(D) / (A) =$	0.27 (E)	6.5
Weighted Root Density (G)						
Root Density as % =	20.00 (F)	$(F) \times (E) =$			5.41667 (G)	9.0
Bank Angle (H)						
Bank Angle as Degrees =	90 (H)				8.0	
Surface Protection (I)						
Surface Protection as % =	10% (I)				9.0	
Bank Material Adjustment:						
Bedrock (Overall Very Low BEHI) Boulders (Overall Low BEHI) Cobble (Subtract 10 points if uniform medium to large cobble) Gravel or Composite Matrix (Add 5–10 points depending on percentage of bank material that is composed of sand) Sand (Add 10 points) Silt/Clay (no adjustment unless primarily clay, then subtract 20 points)				Bank Material Adjustment		10

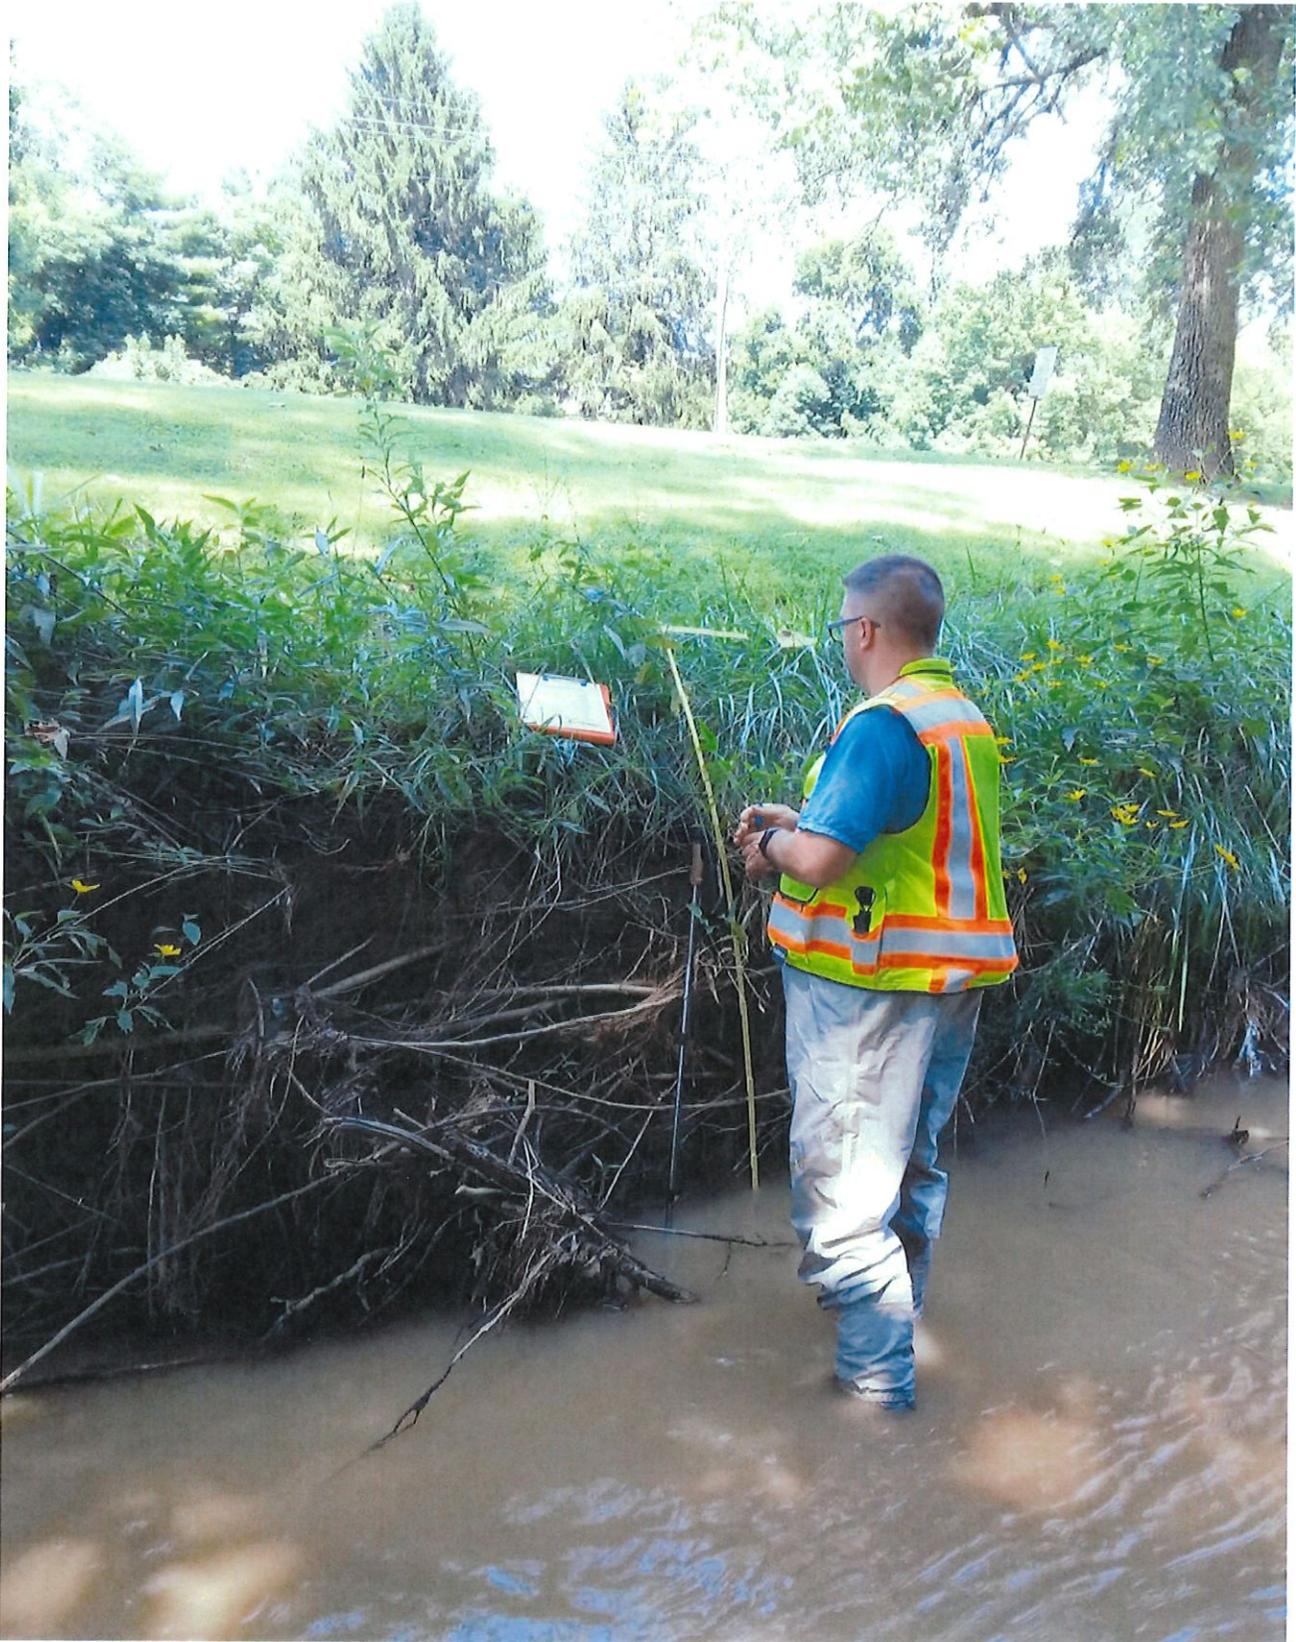
Bank Erosion Hazard Index (BEHI)								
Stream: Fetters Run				Location: Lancaster, Fairfield County, Ohio				
Station: Section 48, Right Bank				Observers: B. Petru, P. Renner				
Date: 8/2/2019		Stream Type:		Valley Type:				
Study Bank Height to Bankfull Height (C)							BEHI Score (Fig. 3-7)	
Study Bank Height (ft) =	4.80 (A)	Bankfull Height (ft) =	3.20 (B)	$(A) / (B) =$	1.50 (C)	6.0		
Root Depth to Study Bank Height (E)								
Root Depth (ft) =	1.30 (D)	Study Bank Height (ft) =	4.80 (A)	$(D) / (A) =$	0.27 (E)	6.5		
Weighted Root Density (G)								
Root Density as % =	20.00 (F)	$(F) \times (E) =$			5.41667 (G)	9.0		
Bank Angle (H)								
Bank Angle as Degrees =	90 (H)					8.0		
Surface Protection (I)								
Surface Protection as % =	10% (I)					9.0		
Bank Material Adjustment: Bedrock (Overall Very Low BEHI) Boulders (Overall Low BEHI) Cobble (Subtract 10 points if uniform medium to large cobble) Gravel or Composite Matrix (Add 5–10 points depending on percentage of bank material that is composed of sand) Sand (Add 10 points) Silt/Clay (no adjustment unless primarily clay, then subtract 20 points)							Bank Material Adjustment	10

Stratification Adjustment Add 5–10 points, depending on position of unstable layers in relation to bankfull stage							Stratification Adjustment	10
Very Low	Low	Moderate	High	Very High	Extreme	Adjective Rating and Total Score	Extreme	
5 – 9.5	10 – 19.5	20 – 29.5	30 – 39.5	40 – 45	46 – 50	Total Score	58.5
